Pipe Behaviour in Bottom Ash Slurry Systems

Joseph Kovago, USA

Summary

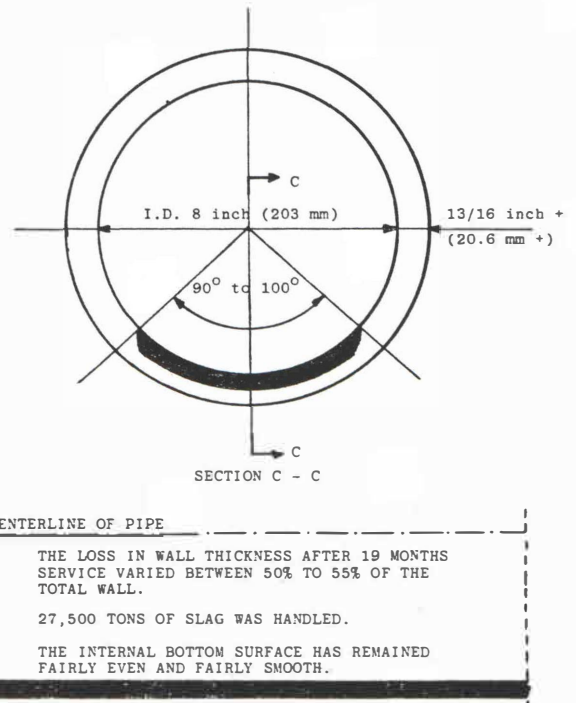
Due to severe erosive-corrosive deterioration, all these pipes failed within 2.5 to 4 years in all the above systems. The typical wear patterns are shown in Figs. 3, 4 and 5. When the pipe depicted in Fig. 5 was rotated about 180°, double wear developed at both sides around the horizontal center plane. Due to this double wear, one pipe section, shown in Fig. 6, actually broke into two parts. The extremely rough bottom portion of this pipe section played an important role in this study when the friction coefficient between the pipe and slurry was studied.

Fig. 3: Typical wear pattern observed in pipes "W", "X", and "Y" at Deepwater Station

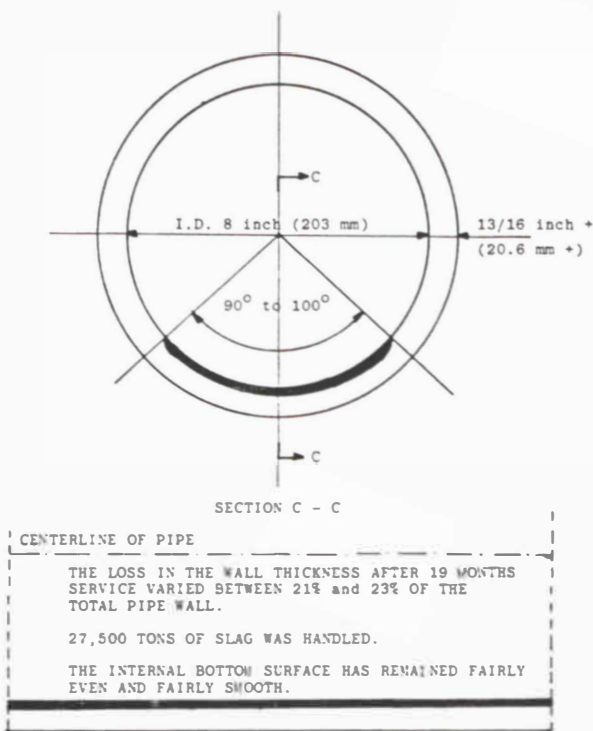
Fig. 4: Typical wear pattern observed in pipe "Z" at Deepwater Station

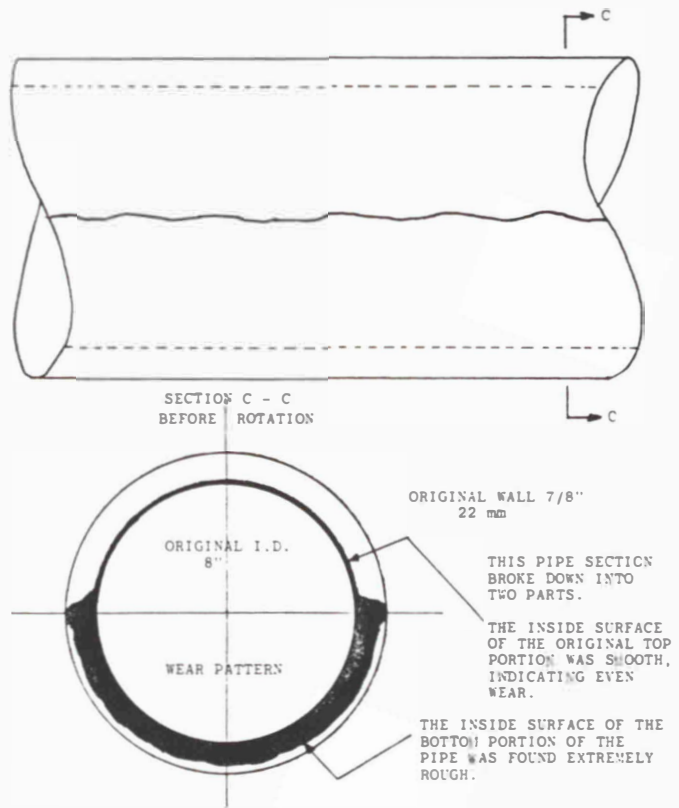
Fig. 6: The failure of a type "Y" pipe section at B.L. England Station

Static friction coefficient tests were conducted by a physics lab method on extremely rough and extremely smooth surfaces. The broken cast iron pipe which was shown in Fig. 6, and an Abresist pipe section after 34 months service, were used to represent those two extreme surface conditions. The results showed for the extremely rough pipe surface $\mu = 4.16$ and for the extremely smooth pipe surface $\mu = 0.87$. The ratio between the above two static friction coefficients was found to be 4.78.

effort worthless. This was already illustrated in Fig. 6, and another case is shown in Fig. 14. In this light, the best rule is to try to select a pipe which requires no maintenance whatsoever; no rotation and no replacement for at least ten years, to be warranted by the manufacturer.

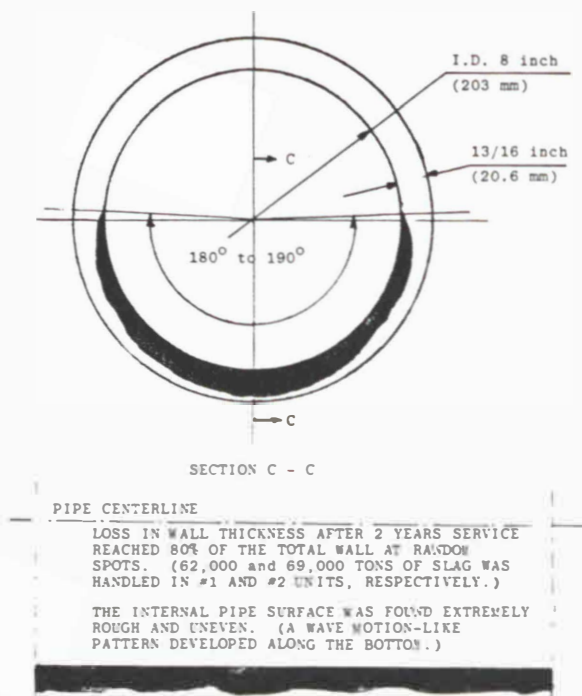
Fig. 5: Typical wear pattern observed in all types of cast iron pipe at B.L. England Station

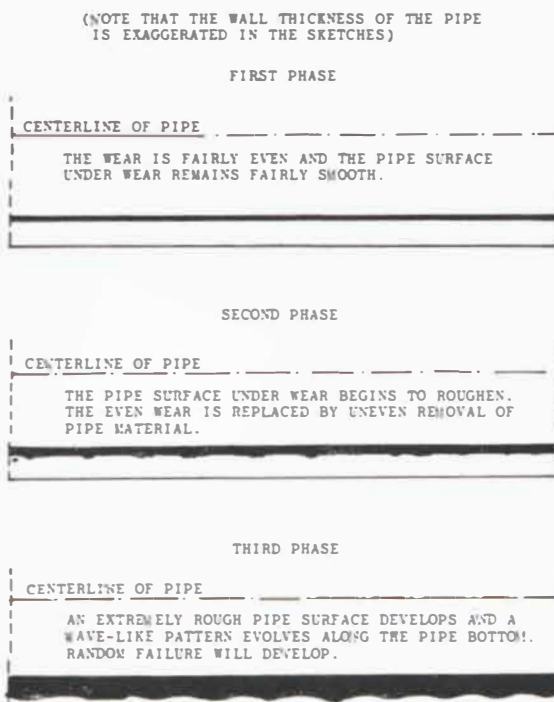
Fig. 7: The sequence of abrasive deterioration in cast iron pipe

Observations revealed that all cast iron pipes showed three phases of deterioration as illustrated in Fig. 7. In the first phase, the wear in the cast iron pipes was even and created a smooth surface. In the second phase, the pipe surface became rough. Finally, in the third phase, an extremely rough surface developed followed by random pipe failure after a few years of service.

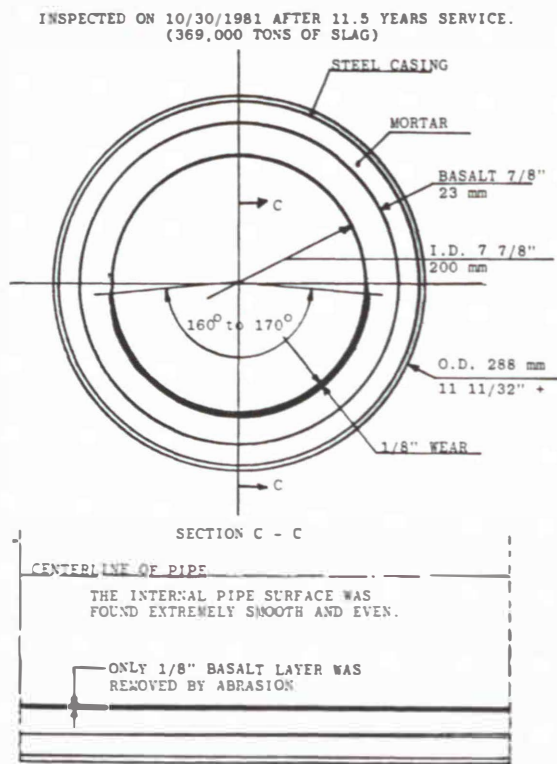
The following most important characteristics of this pipe have emerged: It wears evenly with an extremely low rate and the surface under wear becomes extremely smooth. These characteristics were revealed by numerous inspections. The typical pipe condition after 11.5 years of service is shown in

Fig. 11. Only 1/8" basalt layer was removed by abrasion. The pipe surface under wear has become extremely smooth and even. Around 370,000 tons of slag were transported in this pipe which could yield 20 more years of maintenance free service. (These statements are related to the straight portions of the piping systems only.)

Fig. 11: Abresist pipe section at B. L. England Station of Location A

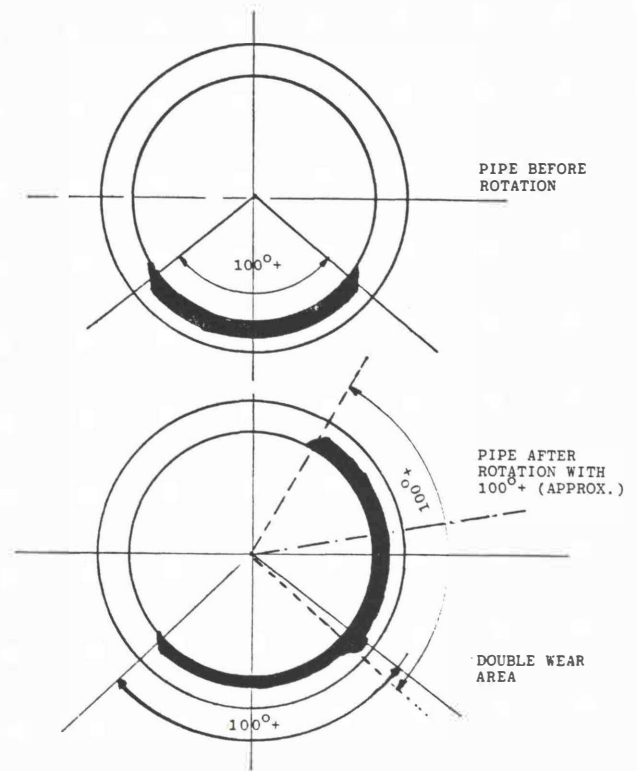
Two major factors may cause considerable maintenance efforts; replacement of leaking pipe sections and rotation of the pipe in order to extend service life. Rotation is usually an expensive and time consuming effort which may not be rewarded with the expected results. Unless it is done with geometric exactitude, which is rarely permitted by actual field conditions, double wear occurs, rendering the entire

Fig. 14: Double wear caused by rotation at Deepwater Station
