Violent Failure

Hidden Causes for Destruction of a Grain Silo

G.E. Blight and B. Hoogendijk, South Africa

The sudden destruction of a silo at a grain depot in South Africa posed a number of questions. In-depth examination of the silo remains and detailed analysis showed that the silo failure was not caused by structural weakness, but by a 'hidden' dust explosion.

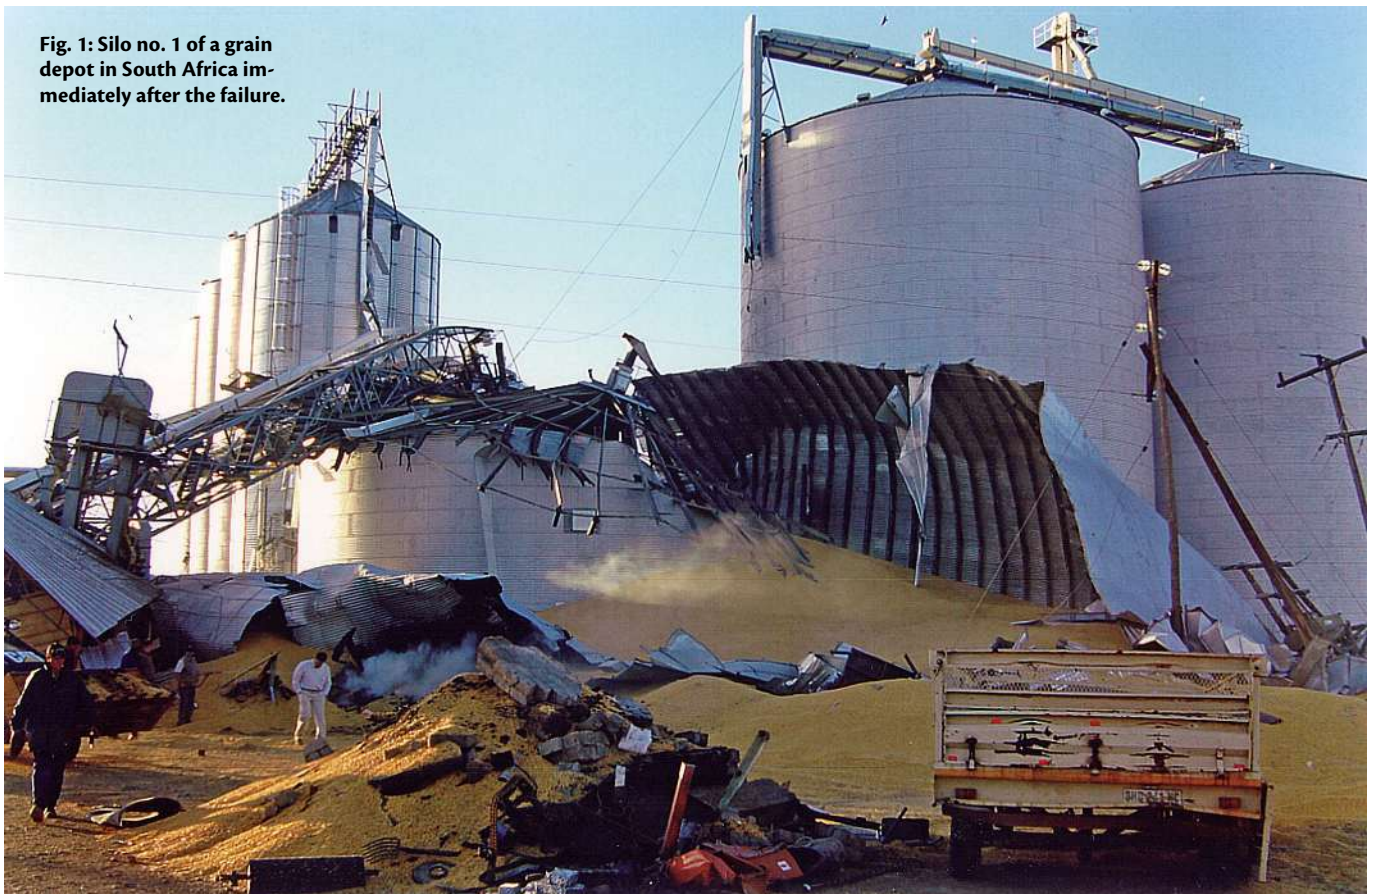
Fortunately, although the cab of the truck was partially flattened, the driver survived with only minor injuries. Fig. 1 shows the scene after the failure had occurred, with the skeleton of the silo roof in the centre of the field of view, on top of the remains of the silo, and the spread-out remains of the upper parts of the walls that had been projected away from the silo to the left and right.

Fig. 1: Silo no. 1 of a grain depot in South Africa immediately after the failure.

The detached portion of the silo wall had split from top to bottom in two places, almost diametrically opposite each other, and had partially split in a number of other places, one of which can be seen in Fig. 1, lining up with the centre-line of silo no. 2, to the right.

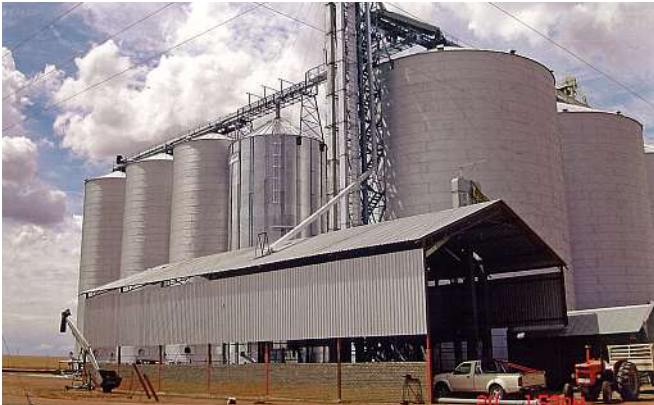
Early on the morning of August 12, 2009, a truck was standing in the loading shed of a small grain depot in rural South Africa (Fig. 2), with the driver sitting in the cab and a worker shoveling grain in the body of the truck. Without warning, the silo closest to the camera in Fig. 2 (silo no. 1) failed violently, flattening the loading shed, killing the unfortunate worker and strewing the grain contained by the almost full silo over a radius of 50 metre.

Fig. 2: The silo complex before the failure.

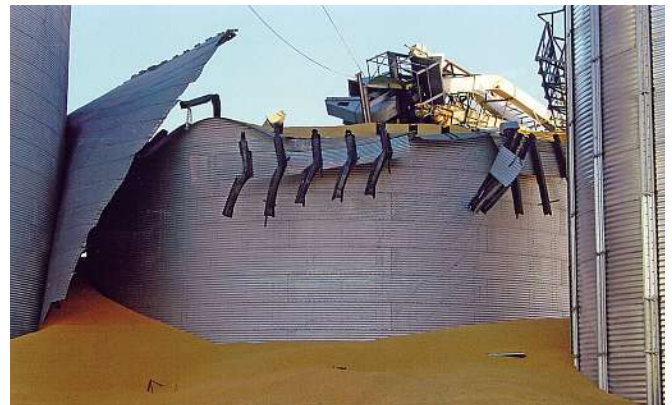
Fig. 3 shows the short stubby remains of the silo, surrounded by spilt grain. From this view it can be seen that the internal stiffeners of the bolted corrugated sheet steel walls had been forced outwards as the upper wall sections parted from the lower part of the silo.

The section of wall leaning between the two silos had been flung violently against the neighbouring silo, indenting its walls with impressions of the bolt-heads in the failed portion which,

Fig. 3: Remains of silo no. 1 viewed from opposite side to Fig. 2.

in turn, showed indentations of bolt heads from the neighbouring silo.

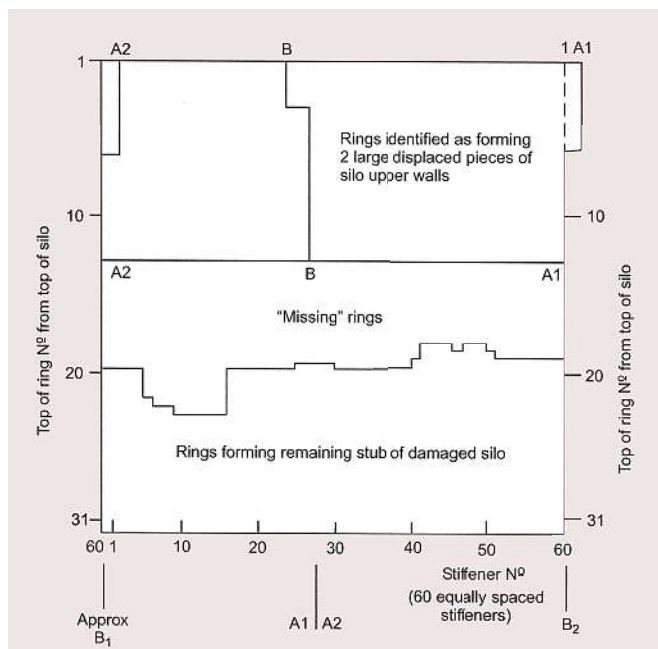
The two largely intact pieces of upper wall seen in Figs. 1 and 3 extended down to ring 13, while the top of the stub of silo was generally at ring 22. After the clean-up of wreckage, rings 14 to 21 were 'missing'. Actually, they were unidentifiable, being in a mixed pile of wreckage recovered from the failure with no attempt having been made to mark their origin.

Fig. 6 is a developed elevation of silo no. 1 showing the relative positions of the two largely intact segments of upper wall, the remaining stub of the silo and the 'missing rings' in between. Fig. 7 is a plan showing the positions of silo nos. 1, 2 and the reconstructed silo no. 4 and the lines (A1 – B1 and A2 – B2) taken up during the failure by the lower end of the two segments of upper wall.

Fig. 6: Accounting for silo rings after the failure; view from outside of silo.

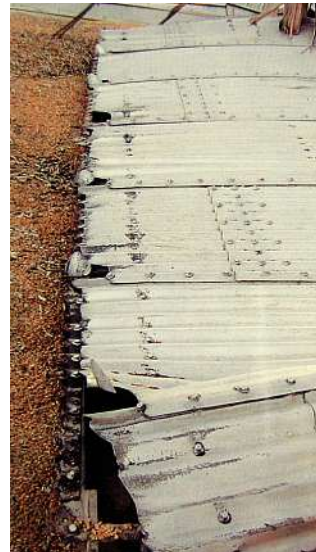
Fig. 4 shows the line of detachment that lay at the extreme right in Fig. 1. It can be seen that the wall plates all failed in a combination of tension and bearing.

Fig. 4: Line of rupture of wall to right of Fig. 2.

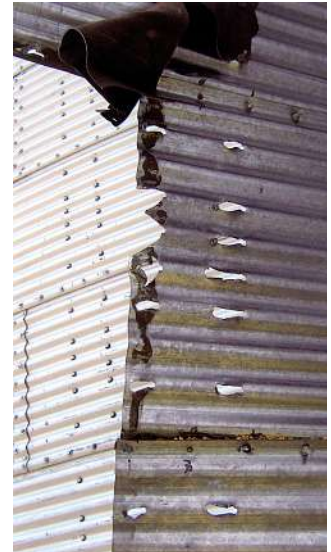
Fig. 5 shows part of the diametrically opposite line of detachment. Here, some of the plates had obviously failed in bearing where a splice had been made across one of the top-hat stiffeners. Examination of Fig. 4 will show that every second plate was also spliced across the stiffener at this location and appears to have failed in the same way.

Fig. 5: Line of rupture to left of Fig. 3.

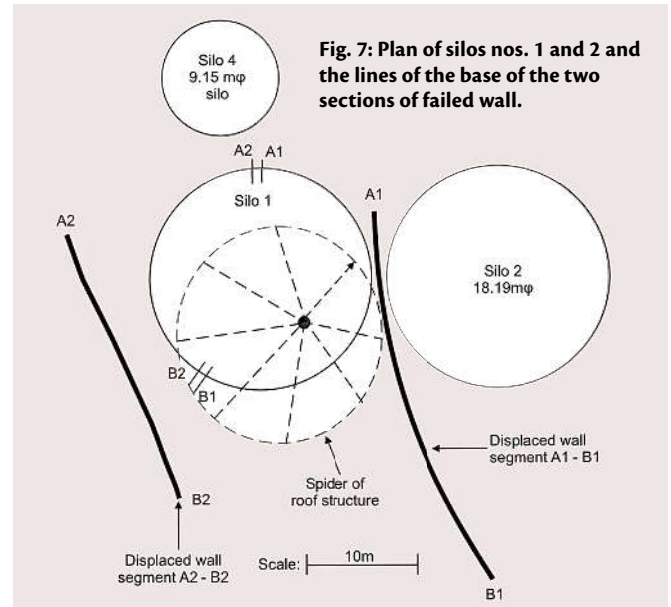
The two separations must have occurred simultaneously. If one separation, say A1 – A2 in Fig. 7, had occurred first, the hoop tension would have been released by the failure and the second failure could not have occurred. The only way in which hoop tension could have been retained in the wall would be by horizontal friction along the inside of the wall.

Fig. 7: Plan of silos nos. 1 and 2 and the lines of the base of the two sections of failed wall.

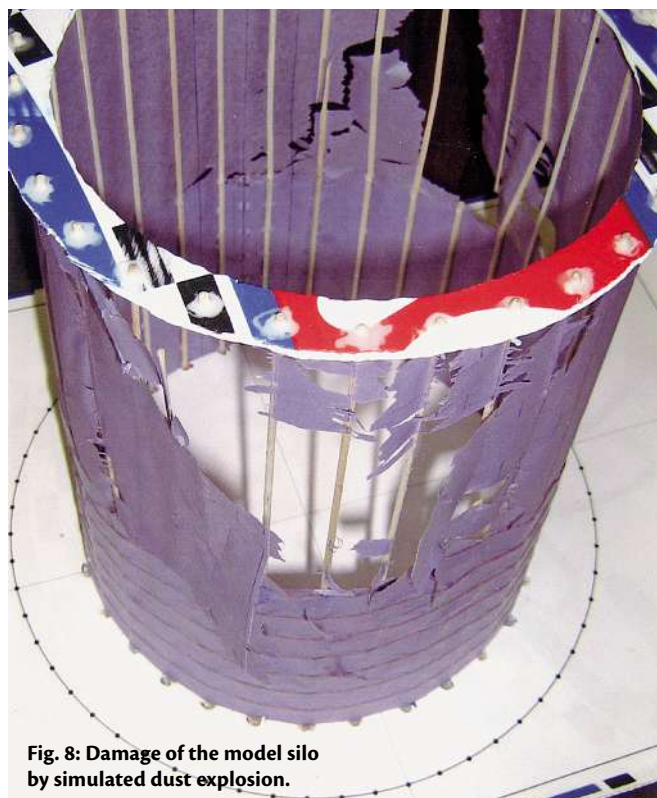
The model was filled with uniform dry sand and a small fire-cracker was embedded in the top of the sand. To provide a reaction to the explosion, the top of the model was covered by a circular 10 mm thick plate of a slightly larger diameter than the silo. Fig. 8 shows the result of electrically detonating the cracker.

The upper two thirds of the walls were split in two diametrically opposite positions with some of the balsa-wood stiffeners being broken. The remainder of the model was relatively undamaged. Hence the effects of an explosion at the top of a full silo had successfully been reproduced in the model.

Fig. 8: Damage of the model silo by simulated dust explosion.
