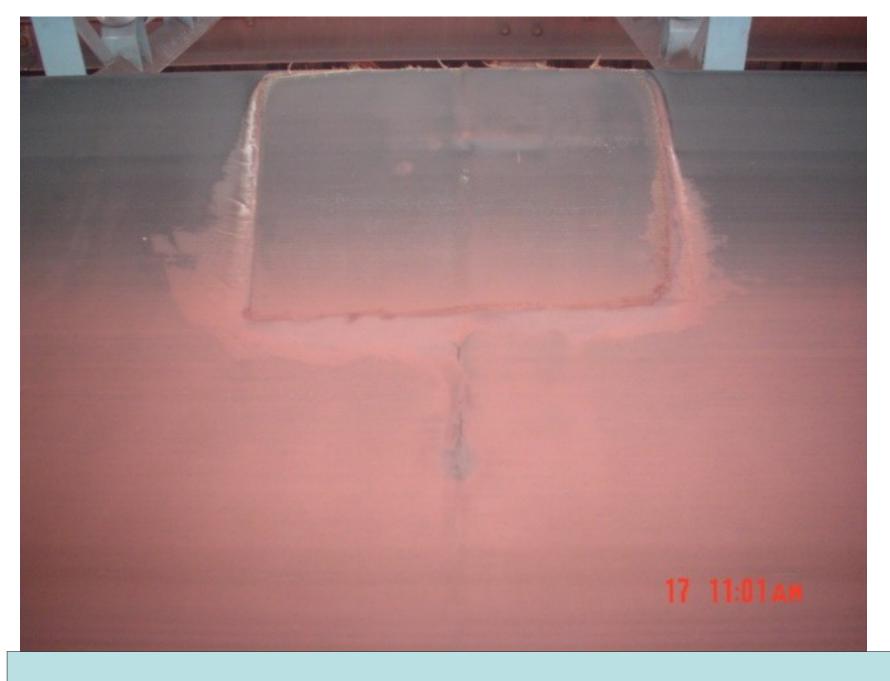
5F 1.55 conv. Top rubber & ply cut across the width

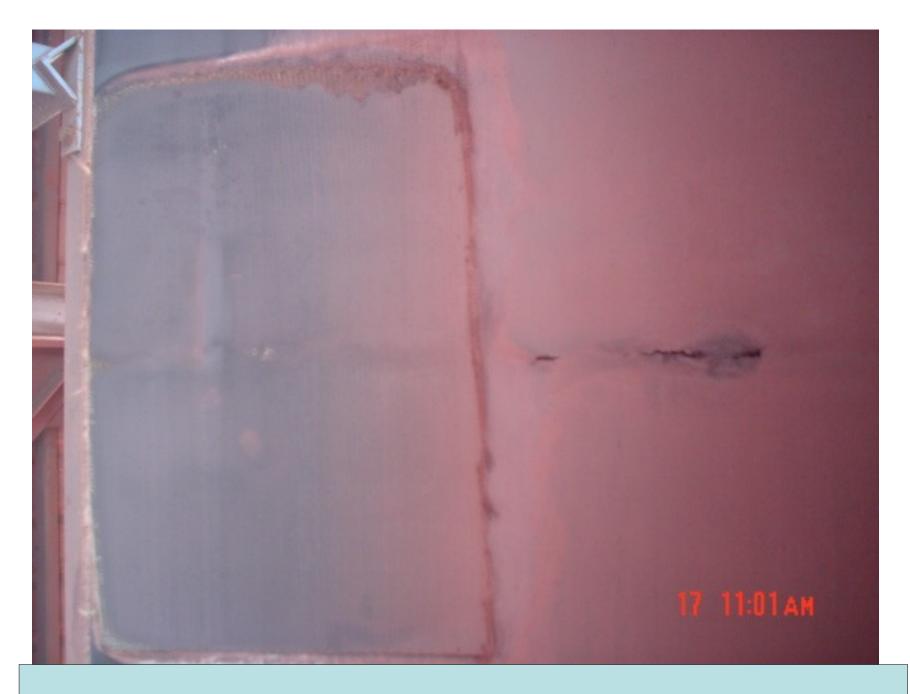
5F 1.55 conv. Top rubber & ply cut across the width

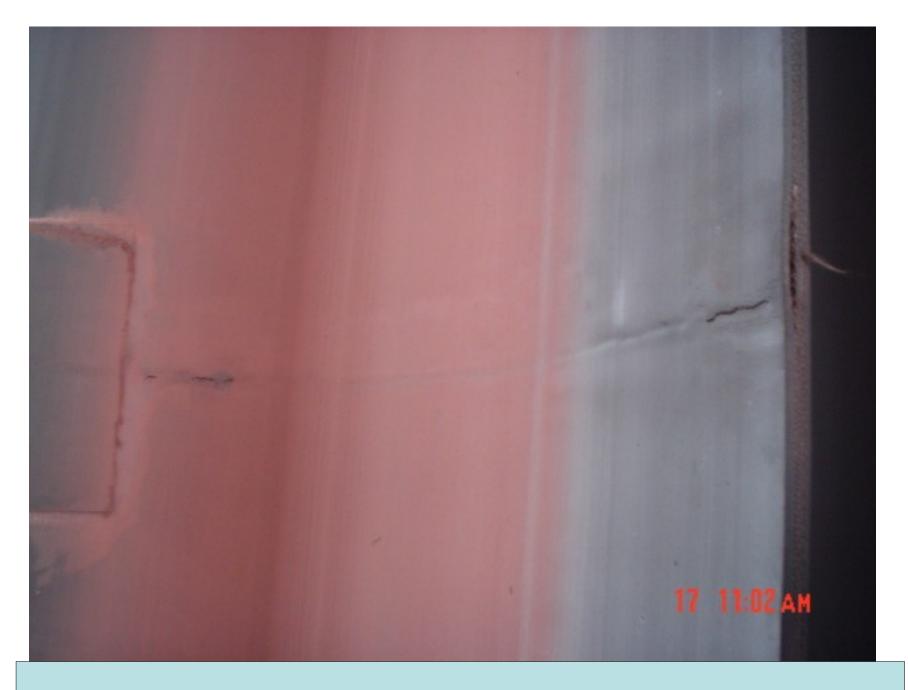
5F 1.55 conv. Top rubber & ply cut across the width, thickness reduced at that area

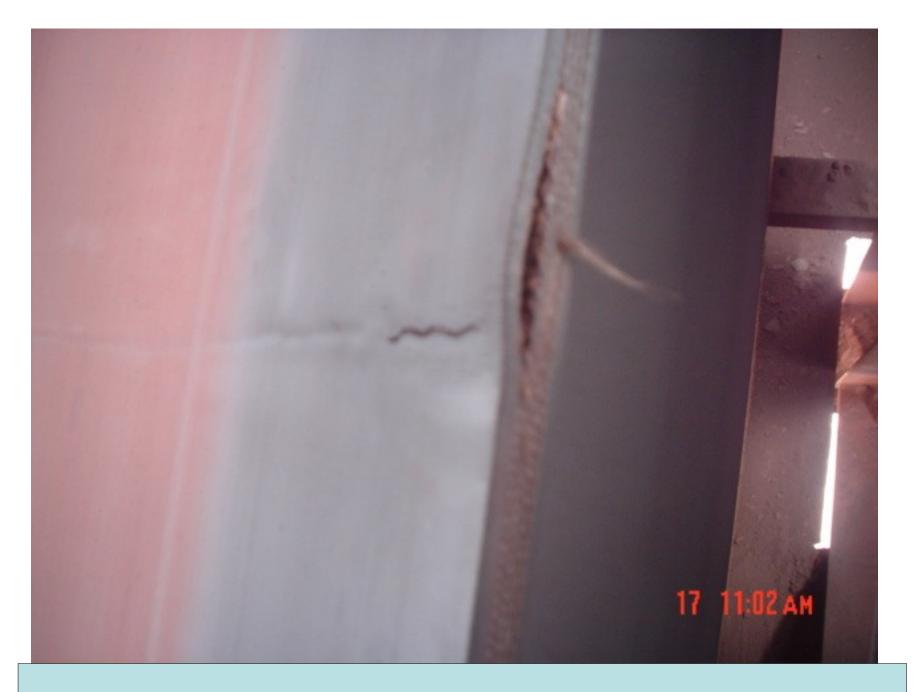
5F 1.55 conv. Top rubber & ply cut across the width

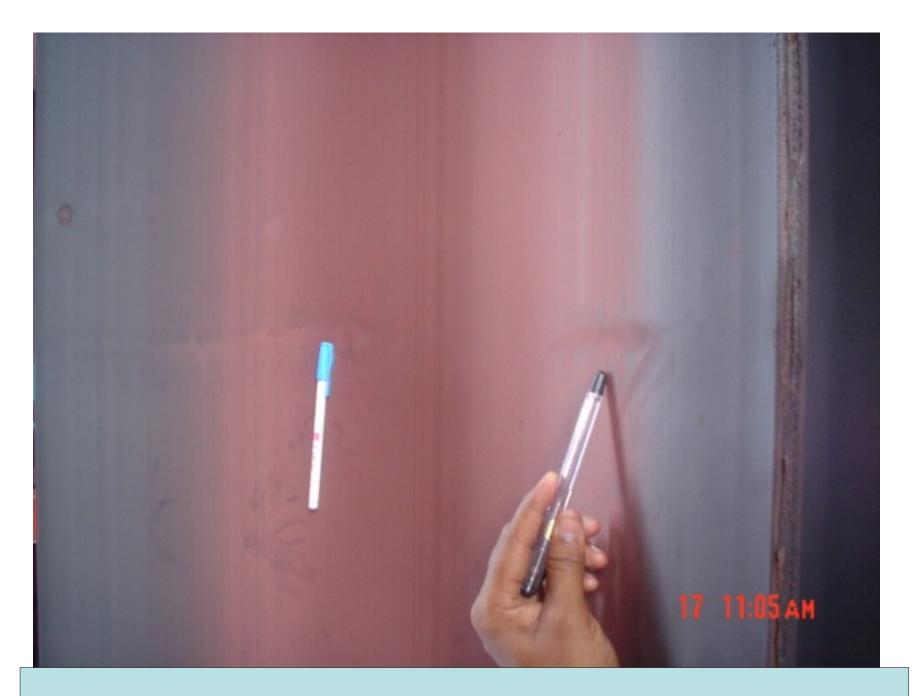
5F 1.55 conv. Belt thickness reduced across the width at many location

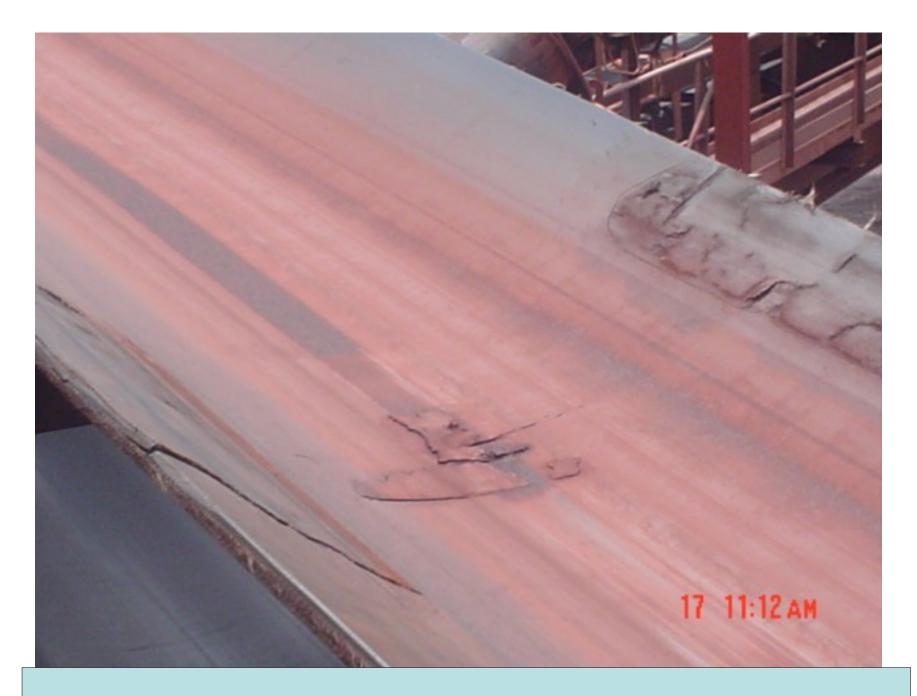
TF 1.31 conv. Same problem, ply is not in continuation cause the cut in top rubber

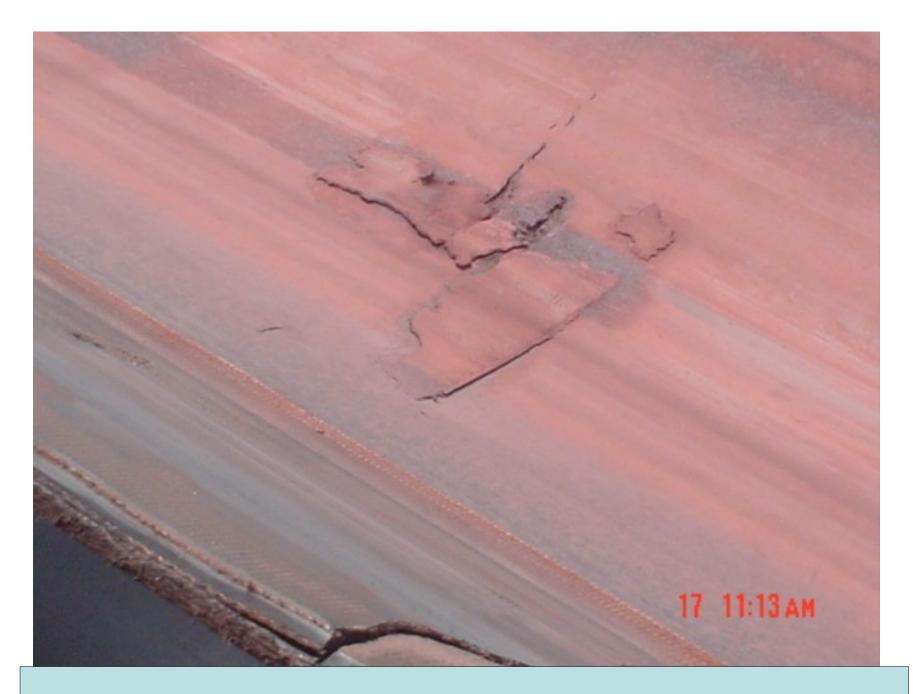
TF 1.31 conv. Same problem, ply is not in continuation cause the cut in top rubber

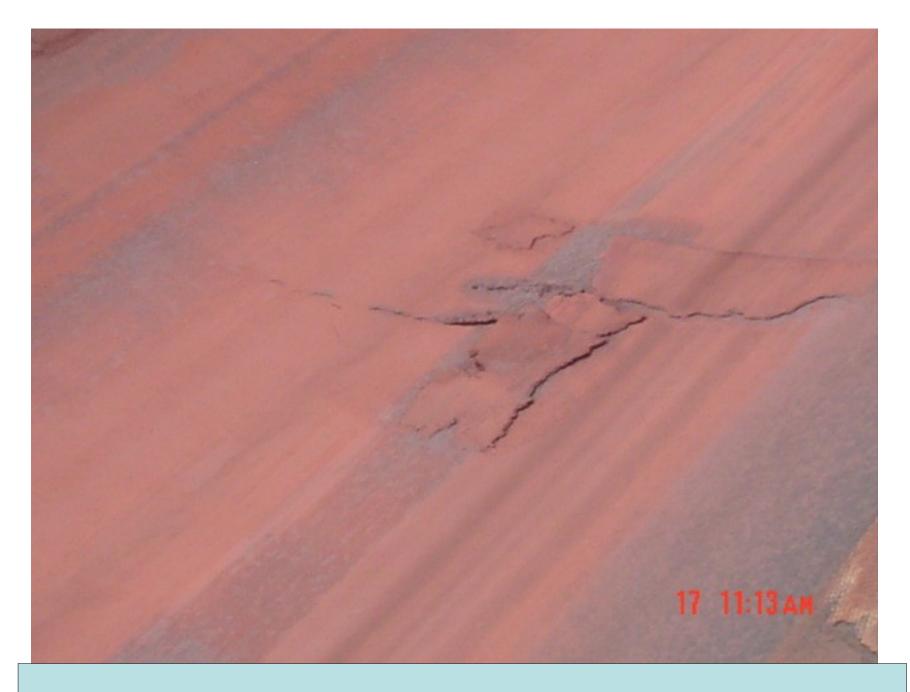
TF 1.31 conv. ply is not in continuation cause the cut across the width in top rubber
