Case Study

BFM® fitting solves Dust and Downtime Issues for Minerals Processor

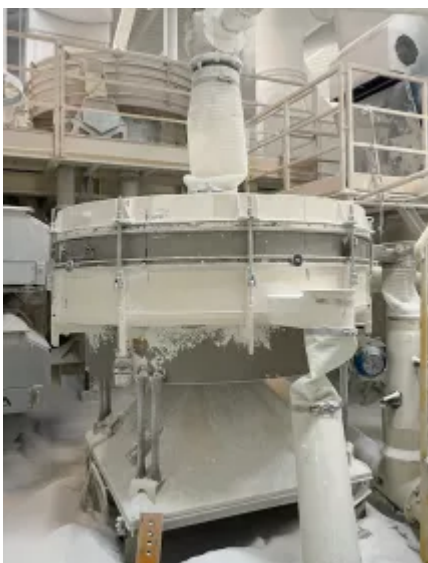
Before the switch to BFM® fitting, the customer experienced a lot of dust and material loss from their sifters. (Pictures: ©BFM® fitting)

In the initial part of their refining process, after crushing and before milling, the customer was experiencing a lot of dust and material loss from their sifters. The old-style, clamped flexible connectors they used at the inlet and outlets of the sifters constantly leaked, with product spilling out and piling up around the sifters, requiring frequent clean-ups.

The abrasive nature of the calcium carbonate powder also took its toll on the connector material, and they wore out extremely quickly, barely lasting a month at a time.

Local BFM® fitting distributor Rocom recommended installing BFM® fitting's durable Seeflex 040E blue-band connectors on each sifter inlet and outlet. They also suggested standardizing all diameters and connector lengths to be the same for ease of maintenance and inventory control.

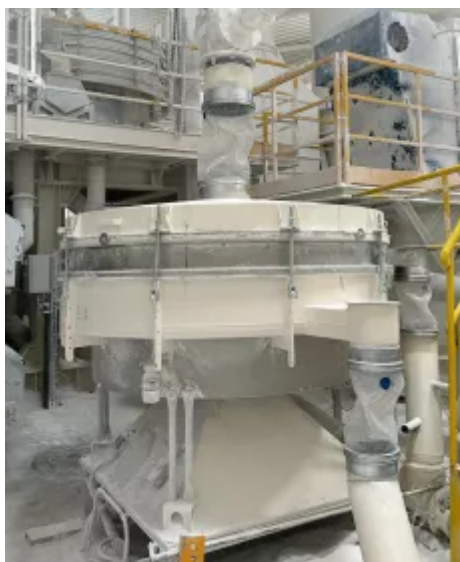
The switch to BFM® fitting stopped the leakage of the fine powder.

The elimination of excessive downtime for replacements is just one of the advantages experienced by the plant. Although abrasive, the leakage of the fine powder has been stopped thanks to the internal seal of the BFM® fitting snap-fit system and the durability of the Seeflex 040E material.

To help support a long-term, sustainable approach, the IG (Installation Gap) was accurately adjusted for all the sieves, so now, only one standard-sized connector needs to be held in stock.
