White Paper

Conveyor Dust and Spillage: The Importance of Skirtboard Sealing Systems

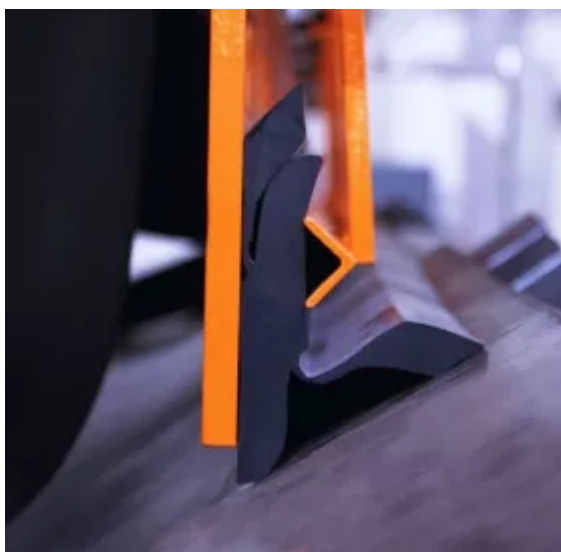
ApronSeal™ Double Skirting offers a dual seal and can be flipped for extended equipment life. (Pictures: ©Martin Engineering)

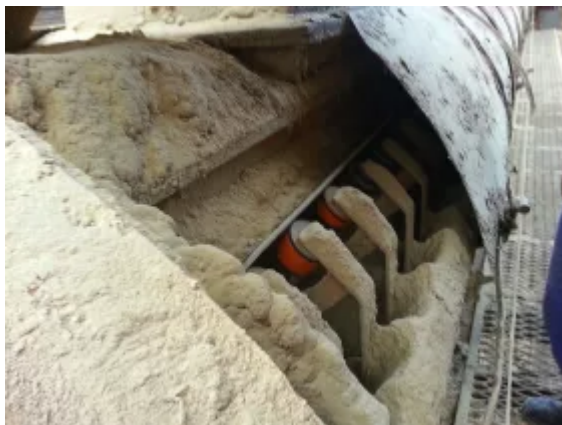
Dust and spillage clogs idlers, requiring them to be replaced and raising the cost of operation.
