Case Study

## **BFM® fitting solves Dust and Downtime Issues for Minerals Processor**

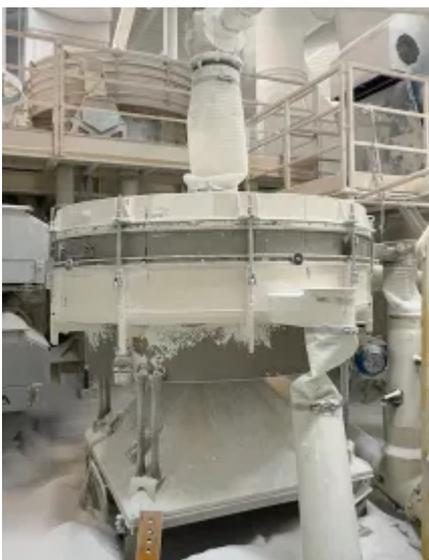
Before the switch to BFM® fitting, the customer experienced a lot of dust and material loss from their sifters. (Pictures: ©BFM® fitting)

In the initial part of their refining process, after crushing and before milling, the customer was experiencing a lot of dust and material loss from their sifters. The old-style, clamped flexible connectors they used at the inlet and outlets of the sifters constantly leaked, with product spilling out and piling up around the sifters, requiring frequent clean-ups.

The abrasive nature of the calcium carbonate powder also took its toll on the connector material, and they wore out extremely quickly, barely lasting a month at a time.

Local BFM® fitting distributor Rocom recommended installing BFM® fitting's durable Seeflex 040E blue-band connectors on each sifter inlet and outlet. They also suggested standardizing all diameters and connector lengths to be the same for ease of maintenance and inventory control.

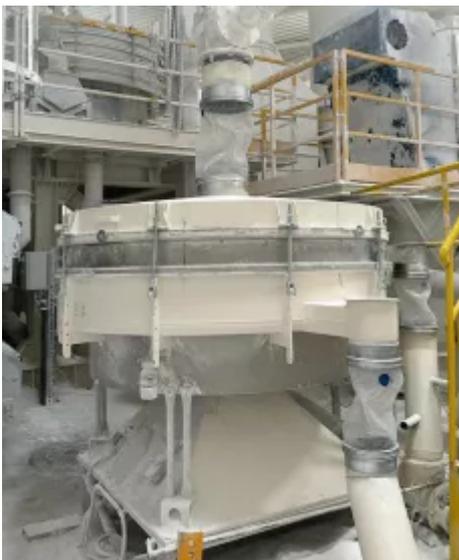
The switch to BFM® fitting stopped the leakage of the fine powder.

The elimination of excessive downtime for replacements is just one of the advantages experienced by the plant. Although abrasive, the leakage of the fine powder has been stopped thanks to the internal seal of the BFM® fitting snap-fit system and the durability of the Seeflex 040E material.
