White Paper

Many sticky Returns - A Gold Mine seeks Solution to Carryback

[Published in bulk solids handling, Vol. 35 \(2015\) No. 5](#)

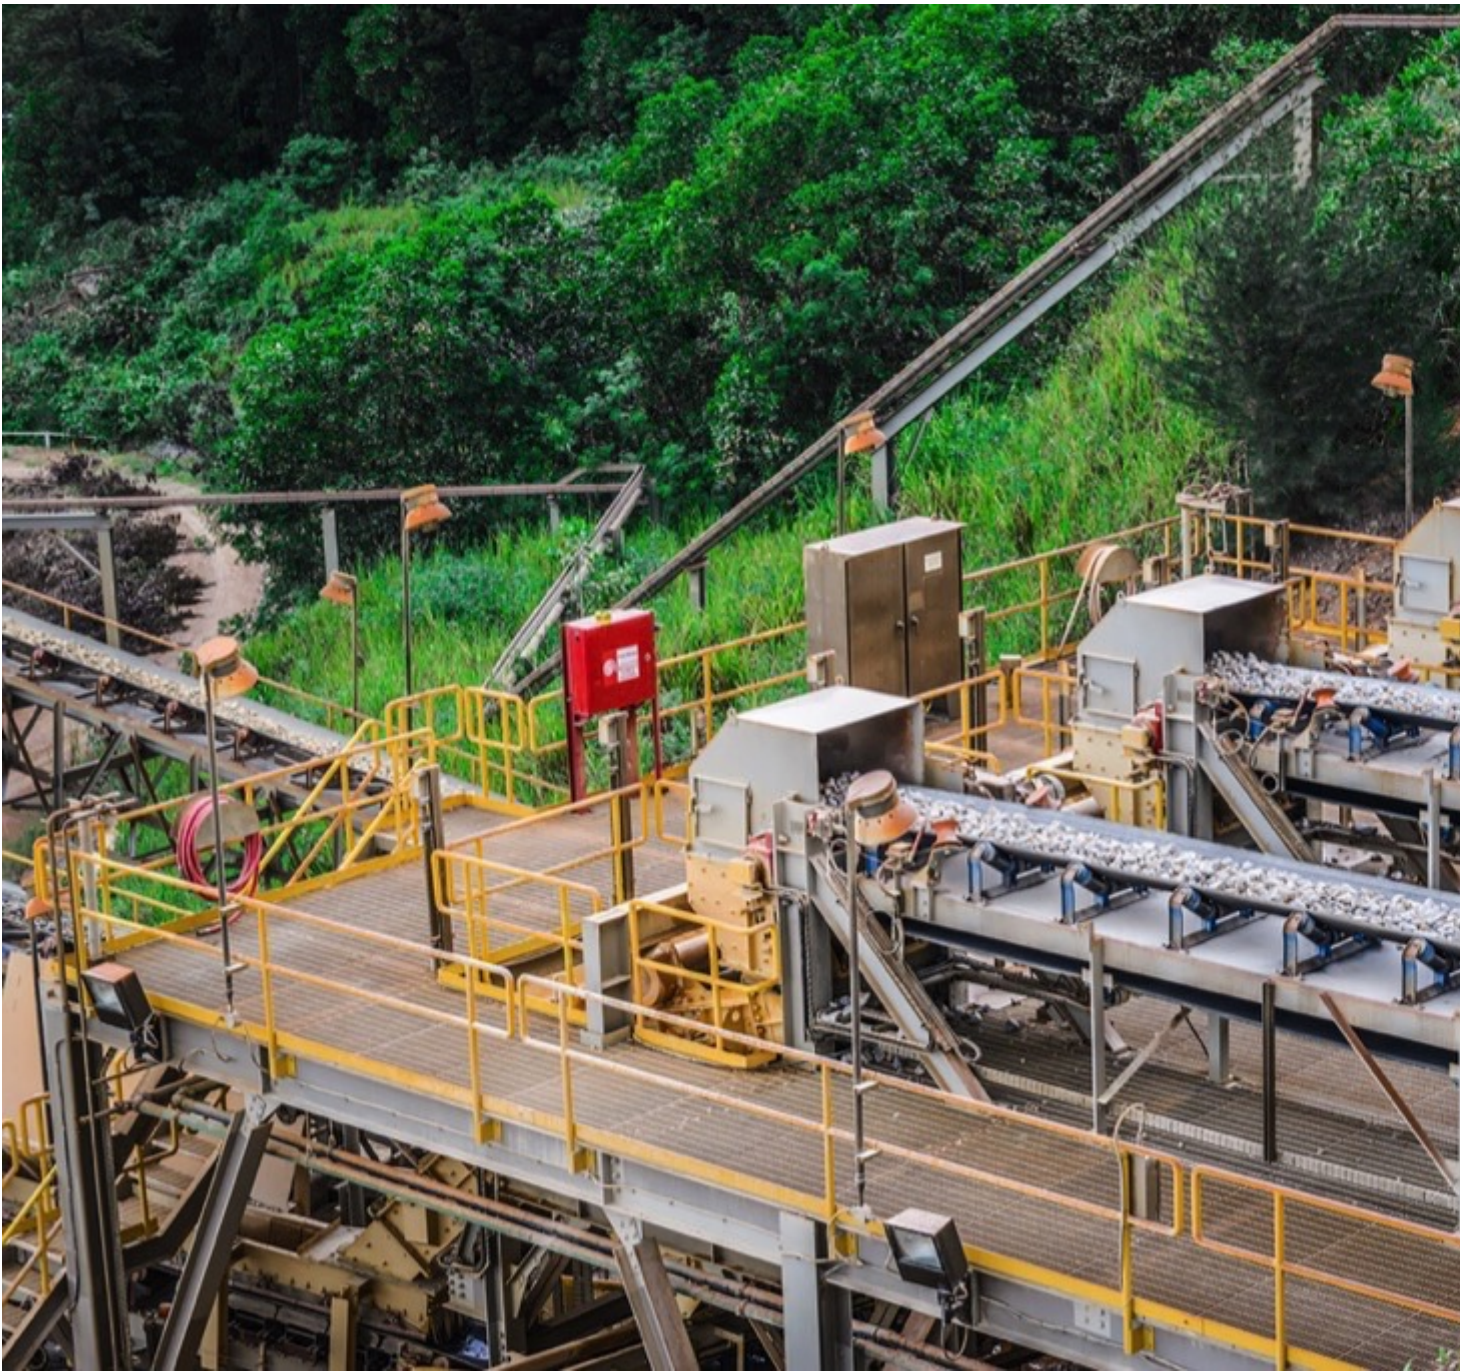
The original conveyor belt cleaners could not manage the overburden, resulting in carryback that caused

equipment failures and downtime.

The original primary and secondary belt cleaners and dust suppression systems were not adequately addressing the overburden. "Our search for a solution included Martin Engineering, due to their reputation in the industry," said Power. "We wanted to quality test all of our options, so we also included the original equipment manufacturer and a third supplier. "Martin Engineering representatives created a full site report, complete with assessments and equipment recommendations. Along with the report, the team added a presentation containing budget and timeline to help site managers explain the issues, needs and solutions to company executives. Once the corporate office gave the green light, technicians from each competitor attached belt cleaners to three of the site's main discharge points. Martin Engineering equipment was installed on the large discharge belt that presented the most carryback. "The superior product was immediately apparent once the quality testing phase started," Lenart said. "Though testing lasted for weeks, the Martin product was more effective, hands down."

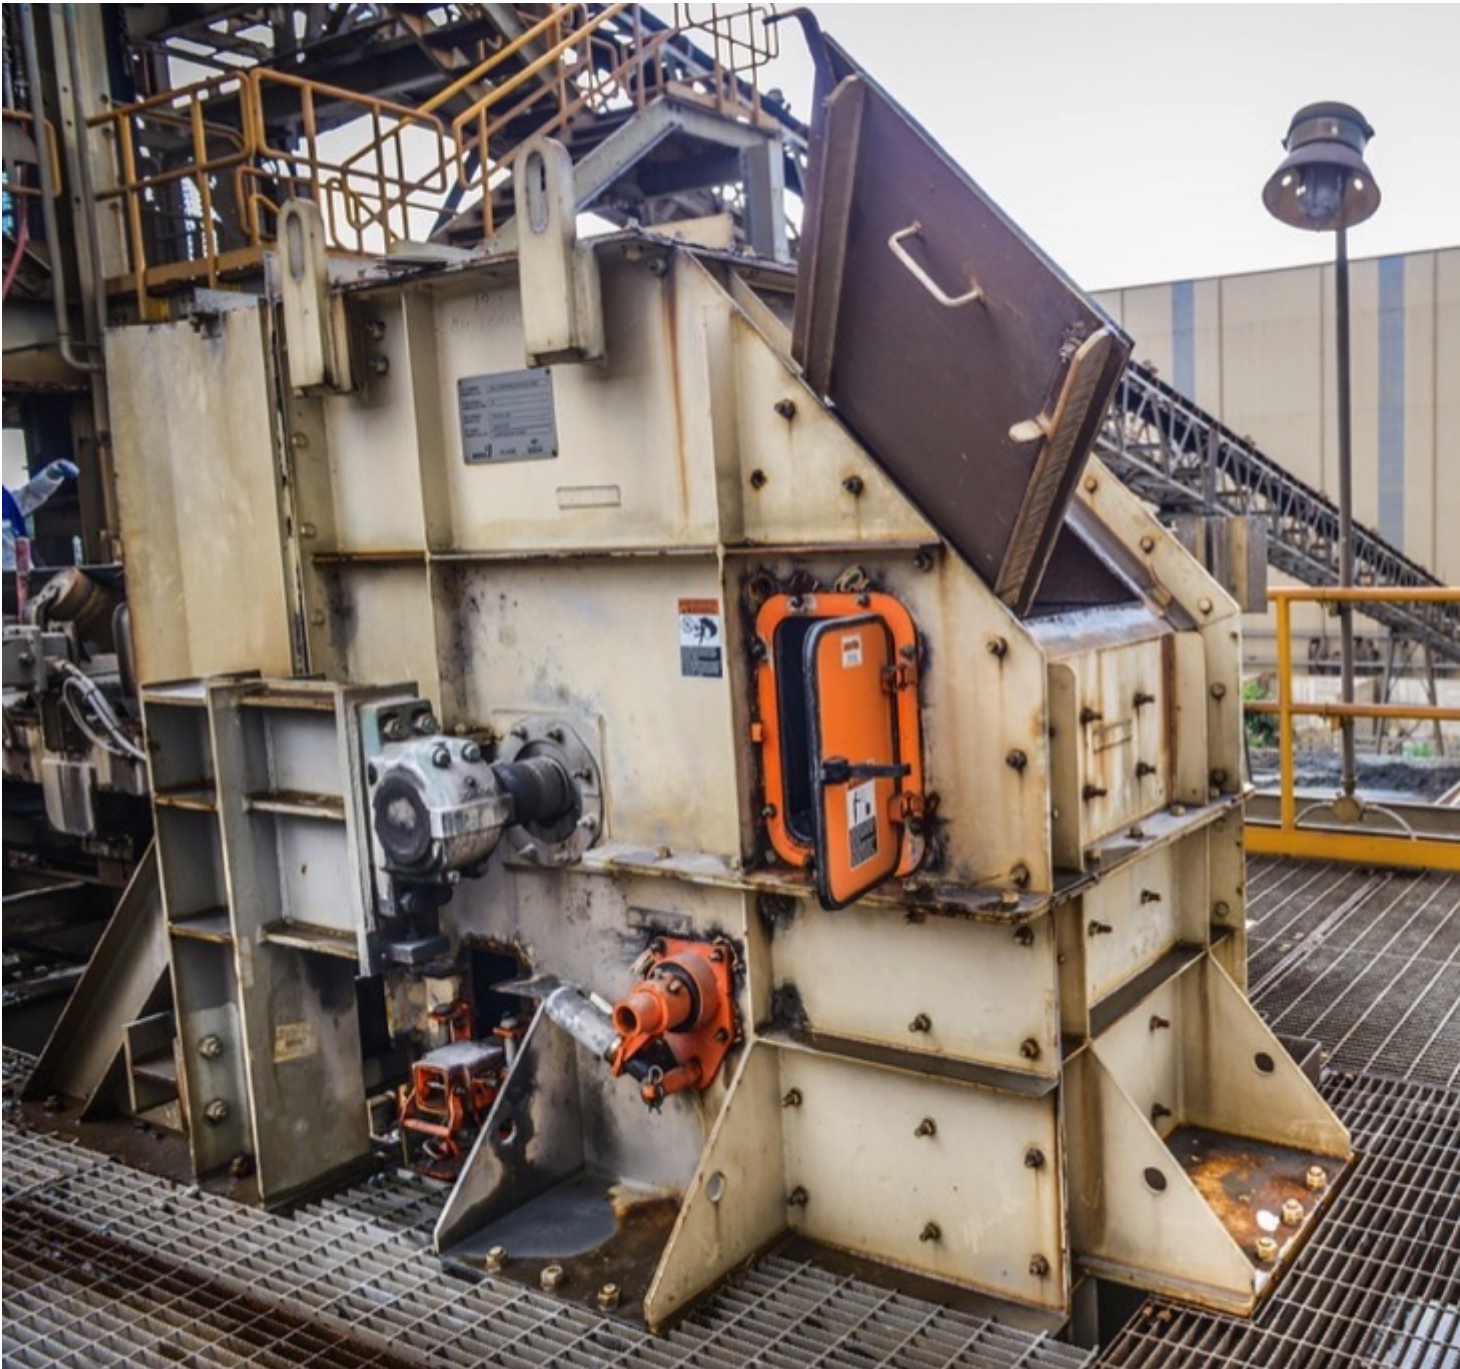
Access doors and view points facilitate routine observation of potential trouble spots and contribute to easier maintenance.
