Product News

Martin Engineering: Controlling Fugitive Dust at Limestone Conveyor Transfer

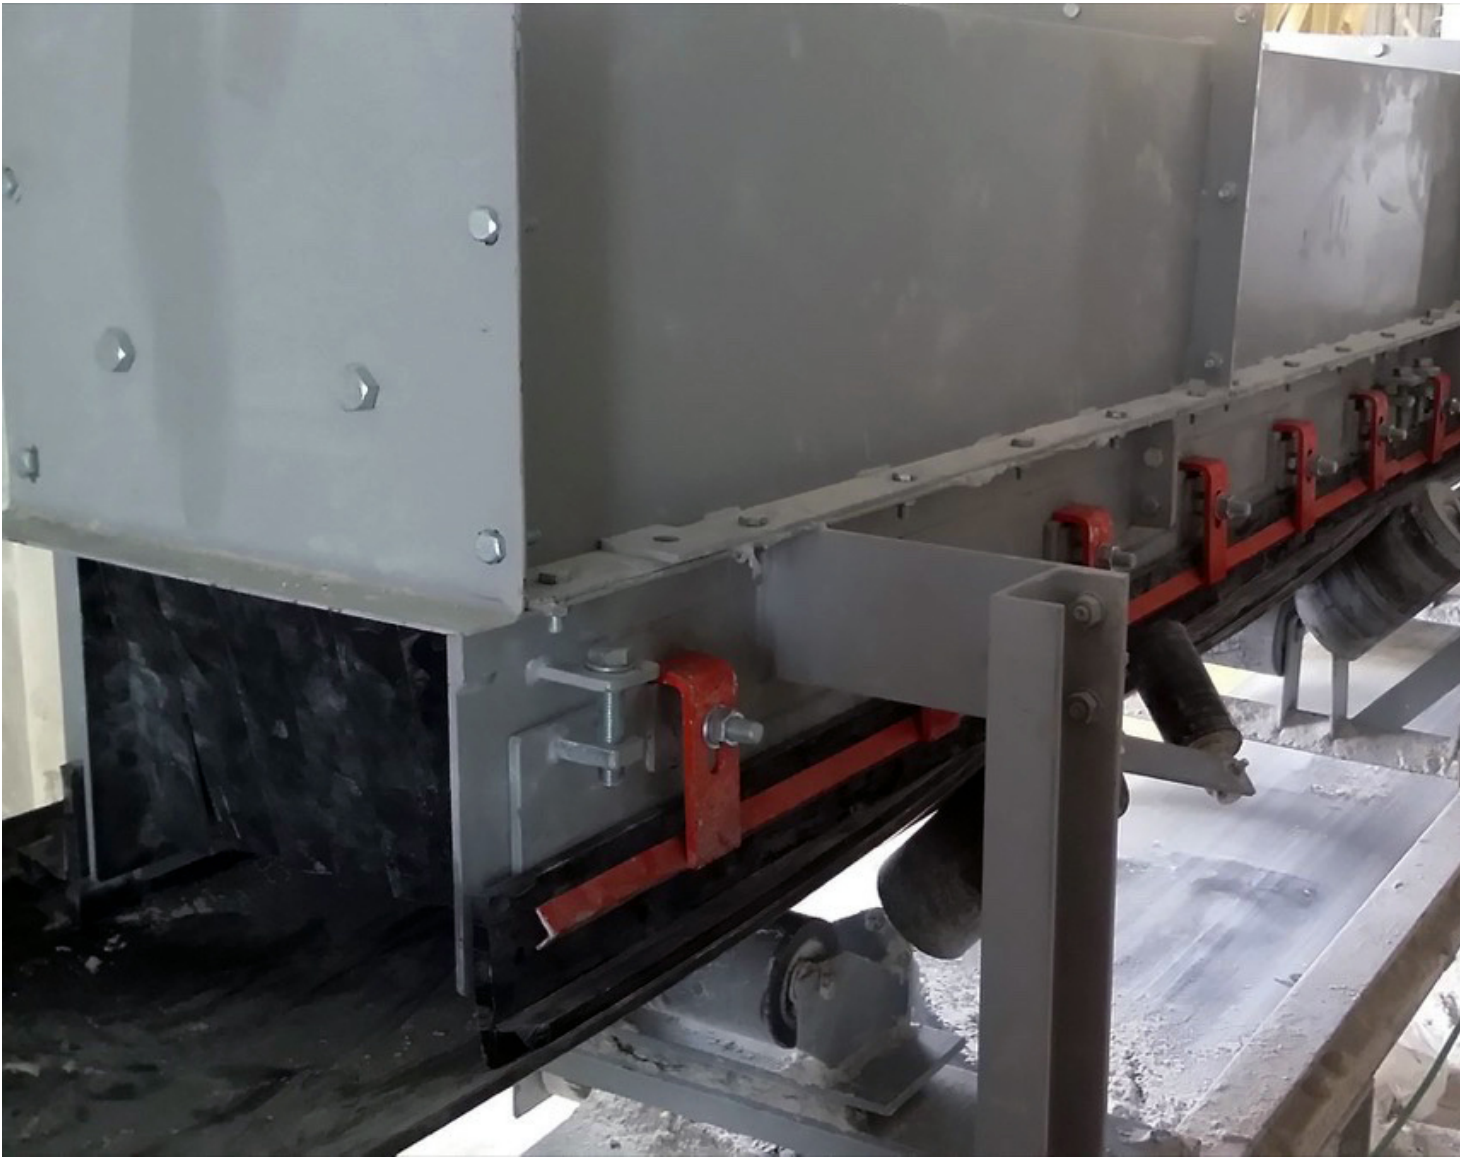
The external wear liner and apron seal help prevent damage to the chute wall.

The new design raised the chute 102 mm (4 in.) from its previous position to accommodate the new wear liner. Mounting brackets with jackscrews provided a secure mount, with precision adjustment of the wear liner to reduce spillage. This system closes the gap between the liner and the sealer, thus eliminating abrasion from trapped material without interfering with existing supports. When accompanied by the skirting and clamps, the system forms a tight belt seal, delivering outstanding fugitive material control. Special mounting tabs allow the liner and skirt seal to be adjusted or replaced from outside the chute, requiring no confined space entry.

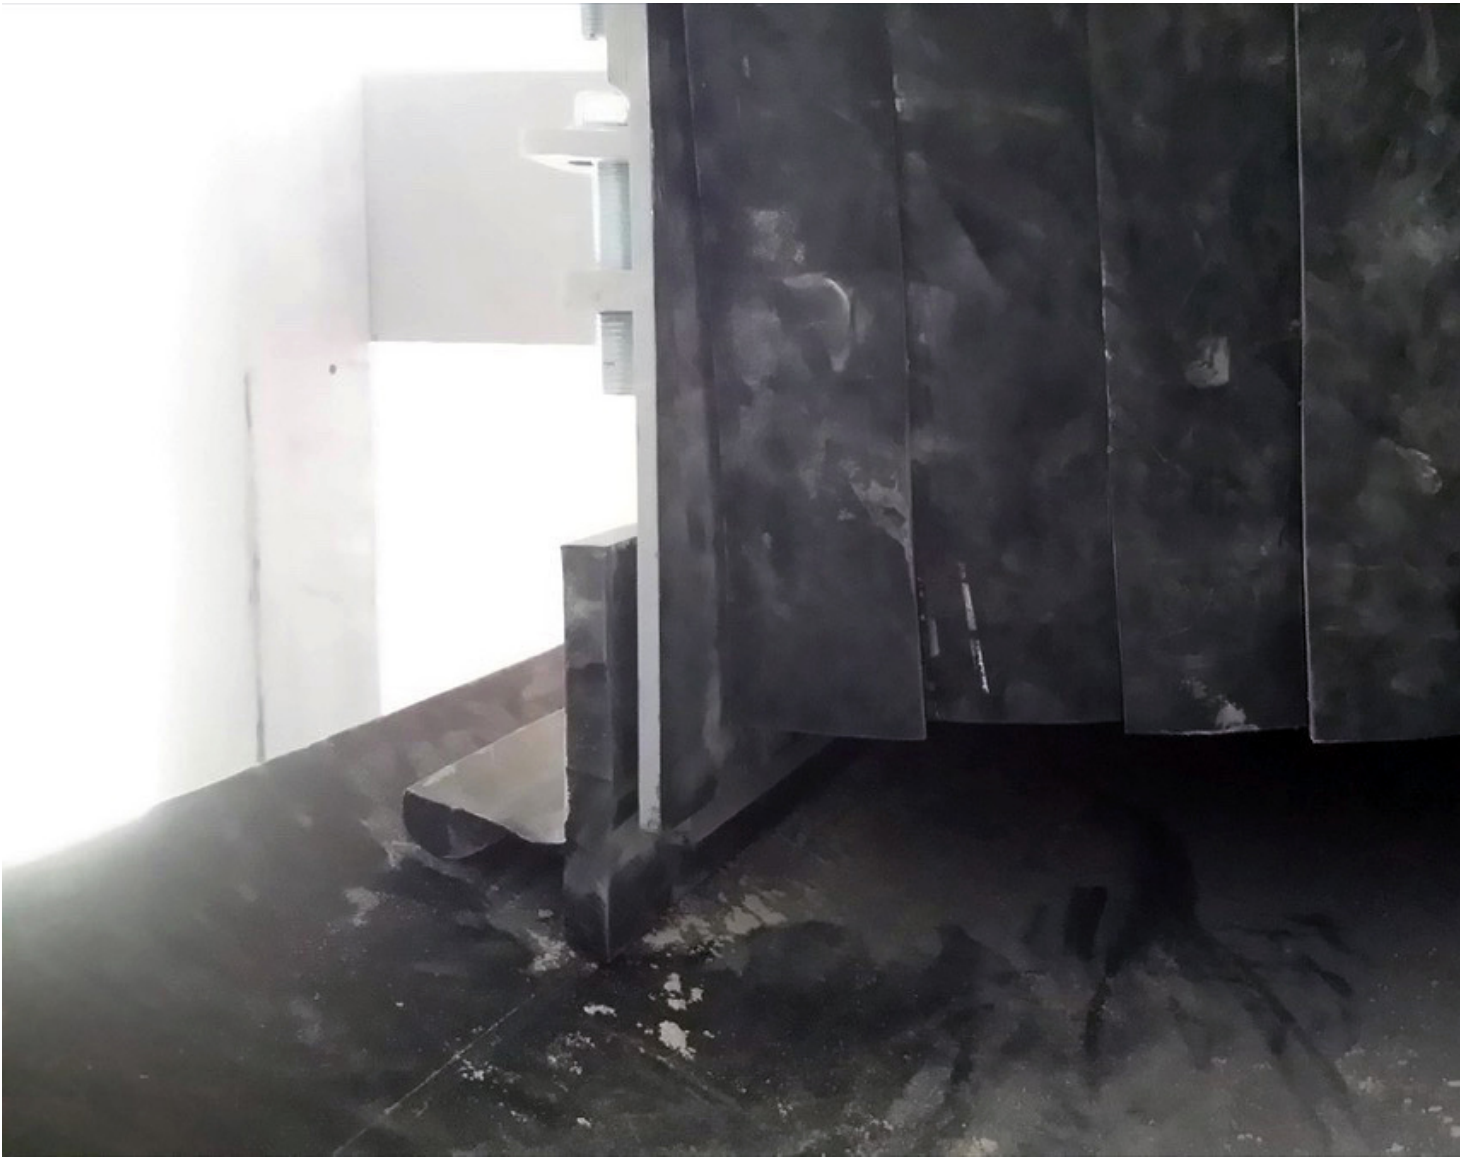
Dust curtains slow down the air flow and reduce fugitive particle emissions.

According to Whelpton, spillage and accumulation along walkways and around the mainframe have been eliminated. There has been no encapsulation of the belt or tail pulley since installation, and rolling components are far less prone to fouling due to dust and spillage. Protective suits are no longer required for people to enter the area, as they need only PPE masks to protect against trace particles emitted through normal operation. "This has led to a morale boost for the plant staff," he pointed out. In addition to the complete turnaround of the operating environment and its effect on morale, managers were impressed by the reduced labor costs and improved safety due to external adjustment and replacement of the chute's wear parts. Operators report the cleaning and maintenance schedule has been adjusted accordingly, freeing up staff for other assignments. The time and cost for replacement of rolling components and chute accessories is a
