Anwenderbericht

Metal Detectors prevent Plant Damage at Plasmor

Plasmor has installed three Bunting metal detectors to locate tramp metal and prevent damage to processing plant at their building block manufacturing site in Heck, East Yorkshire/UK.

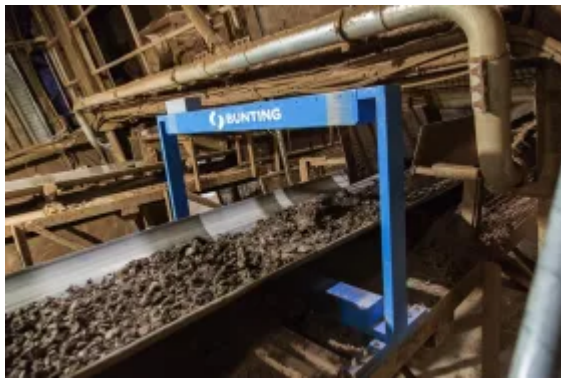
TN77 metal detector prior to the extruder (Pictures: ©Bunting)

The model TN77 metal detector detects damaging tramp metal such as tramp iron and low-grade manganese steel (e.g. digger teeth). The widely-used TN77 is easy to install and simple to operate.

The TN77 metal detector sensitivity is set specifically to find tramp metal that would damage the extruder. As with the meTRON metal detector, tramp metal passing through the detector stops the conveyor and sets off a visual and audible alarm, allowing the maintenance team to find and remove the metal.

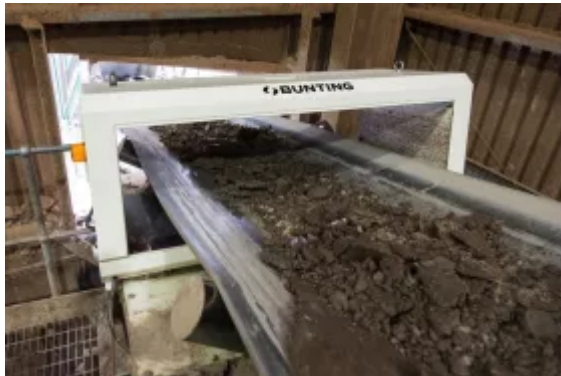
On the primary 1.2 m wide feed conveyor carrying quarried clay into the plant, Plasmor installed a meTRON 05D tunnel metal detector. The clay received into the plant is occasionally contaminated with damaging tramp metal, which if left undetected would damage plant later in the process.

The meTRON Metal Detector on the primary feed conveyor

The divisible tunnel-type meTRON 05D metal detector detects both ferrous and non-ferrous metals present in the conveyed clay. The sensitivity of the metal detector is adjusted to suit the application, focusing on the size and type of tramp metal that could cause damage to processing plant. The 'divisible' design enables simple and quick installation without needing to cut the conveyor belt.

In operation, tramp metal passing through the metal detector triggers a change in the detector's magnetic field, which registers in the control panel. In this installation, the identification of tramp metal results in the stopping of the conveyor and the sounding of an audible and visual alarm. Once detected, the problematic metal is manually removed. The metal detector is then reset and the process restarted.

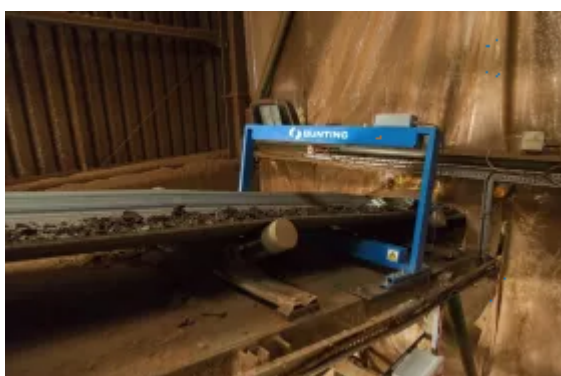
The second TN77 metal detector

The TN77 metal detectors are both mounted around 0.8-metre-wide conveyors, each handling approximately 15 t/h of clay. These metal detectors are installed to locate any tramp metal contamination, but especially metal parts that had broken away from equipment earlier in the process, such as the tips of the rotating blades that break up the clay as it feeds onto the conveyor.
