Anwenderbericht

## **Conveyor Transfer Point Upgrade controls Dust at Brazil Port**

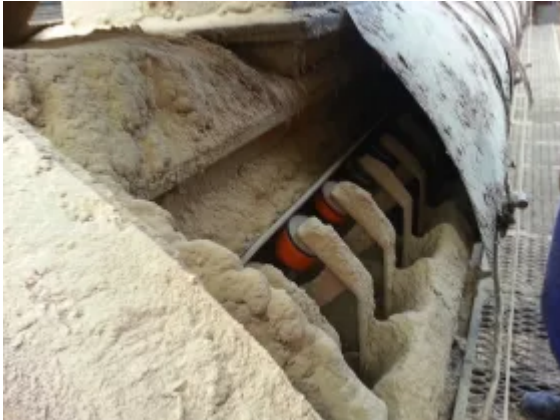
Dust and fines piled along the belt path, fouling rolling components.

discovered that, due to the height of the transfer chute, when cargo hit the belt, the pressure within the loading chute increased, pushing particulates at a high velocity out of any gap that was not sealed. Moreover, because of inadequate belt cleaning, carryback on the return run of the conveyor led to spillage and dust along the entire structure.

The result was large amounts of fugitive dust in the area, reducing air quality and visibility, settling on all surfaces and fouling rolling components. Seizing idlers contributed to belt mistracking and spillage, further increasing operating costs for cleaning, maintenance and downtime.

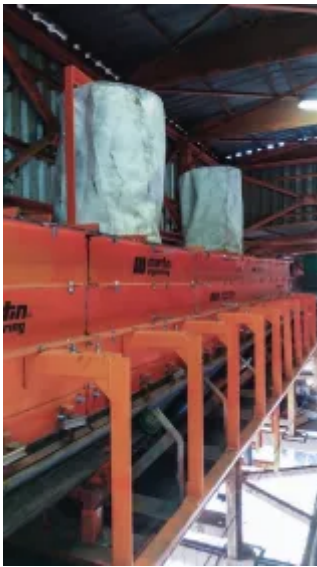
The skirtboard cover is shown with two dust bags.

After constructing a longer sealed enclosure with the ability to control airflow and give dust extra space to settle, technicians added several other critical components. A heavy-duty impact cradle was installed to protect against impact and friction wear on the belt, which reduces maintenance and prolongs operational life. It features a top layer of slick UHMW polymer molded to a base of impact-absorbing SBR rubber, all reinforced with a steel support structure able to withstand as much as 17,000 pounds (53.4 to 75.6 kN) of force.

When the conveyor was activated, operators immediately observed significant results. As material moved through the system, particulates remained within the enclosure and either collected in the dust bags or settled back into the cargo flow. With less carryback on the return side of the belt, dust was drastically reduced in the immediate area around the conveyor system at both the loading and discharge zones.

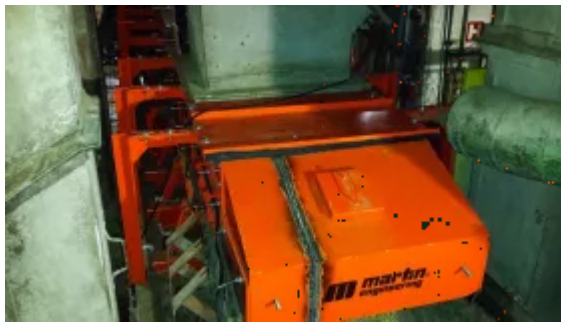
The customized tailbox minimizes emissions at the back of the chute.
