Whitepaper

## **Conveyor Drop Points - Preventing Damage and Spillage**

[Published in bulk solids handling, Vol. 36 \(2016\) No. 7](#)

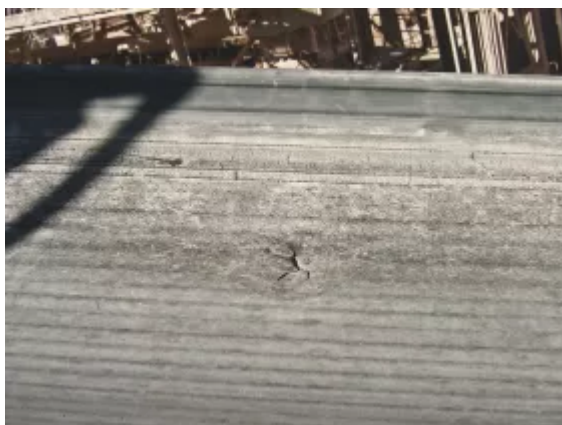
A receiving belt can experience severe damage from material transfers if it's not supported properly. (Pictures: ©Martin Engineering)

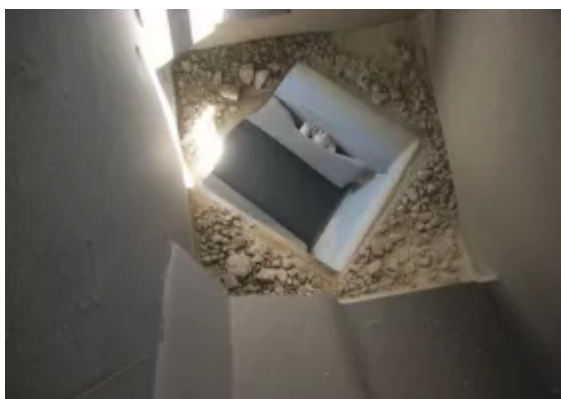
A rock box acts like a shelf, catching and distributing falling material onto the impact cradle.

After their analysis, the Martin Engineering team presented a detailed proposal offering a solution that involved several components working in concert to address the entire belt issue. “Our first recommendation was installing a rock box,” Cole explained. “Set three feet above the belt, it would work like a shelf, catching and distributing the limestone softly onto an impact cradle.”

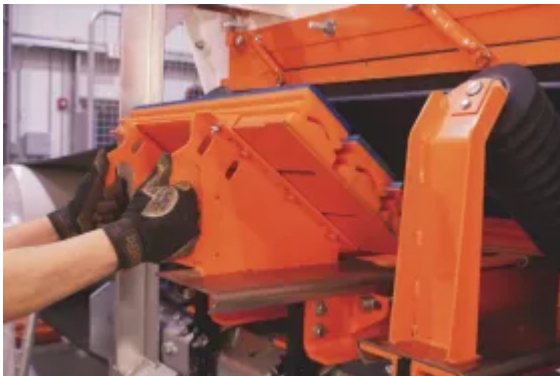
The modular impact cradle absorbs the impact of the falling load, yet slides in and out for easy service.

Located directly under the chute, the impact cradle is mounted on four rugged steel I-beam supports, able to sustain an impact force of 5443 Kg (12 000 lbs) by crushed material dropped from heights of up to 7.9 m (26 ft). The specially engineered impact bars are based on an aluminum T-slot design, which is surrounded by a layer of energy-absorbing 83A durometer urethane and coated with low-friction UHMW plastic to reduce friction and belt fraying. Wing supports adjust to a 5 percent fine-tuning angle, allowing the cradle to be precisely matched to the idler profile, assuring a tight belt seal and avoiding material shift on impact.
