Whipped into Shape - Concrete Mixing Plant Relieves Pressures with Silo Cleaning Service

Published in bulk solids handling, Vol. 34 (2014) No. 2

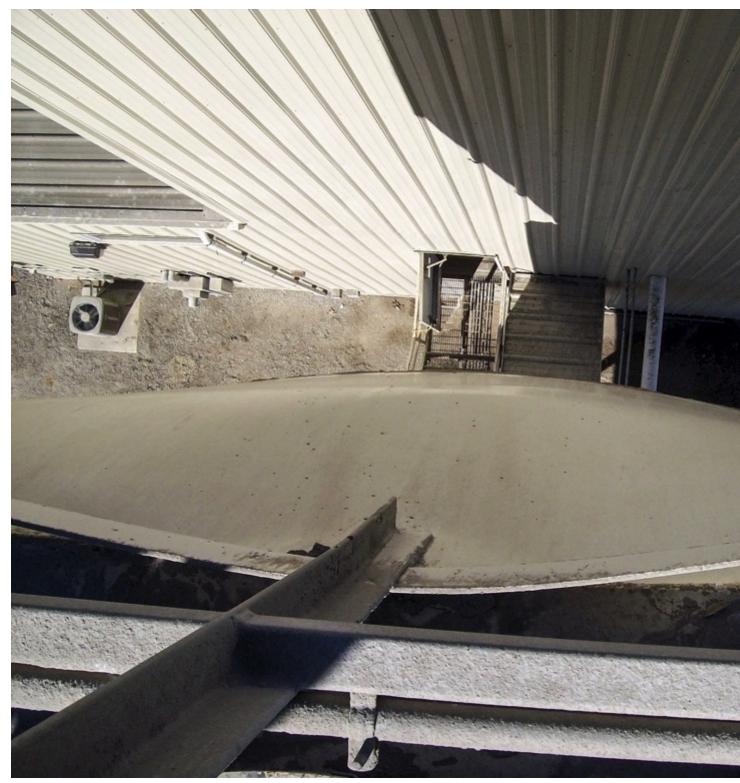
Silo walls bulged, due to increased internal pressures. (Pictures: ©Martin Engineering)

time, material dust in the three pneumatically-loaded silos gradually built up, first on walls and ridges and eventually clinging to all the interior surfaces," explained Concrete Production Manager Jeff Jackson. "As a result, the air flow became constricted, raising the pressure within the silos and exerting greater force on the structure, connections and piping."The compacted build-up continued to collect particles, effectively shrinking the internal space as the pneumatic blower forced more material through the silos. The severity of the problem became apparent to system operators when they noticed the walls of the silos actually starting to bulge outward. During a shutdown and inspection, the staff could observe interior damage and decided that over-pressurization had compromised the structural integrity of the three storage vessels. The need for repairs was clear and immediate, but the material build-up presented a serious obstacle. Remembering a recent article on silo cleaning authored by Martin Engineering that he had seen in a trade publication, Jackson contacted the company about the problem. Already familiar with Martin from using its conveyor belt cleaners and other components, he briefly explained the problem and the urgency of a resolution. Stark received a phone response the same day, and a Martin Engineering Field Supervisor scheduled a site visit for Saturday, during which he visually assessed the situation.

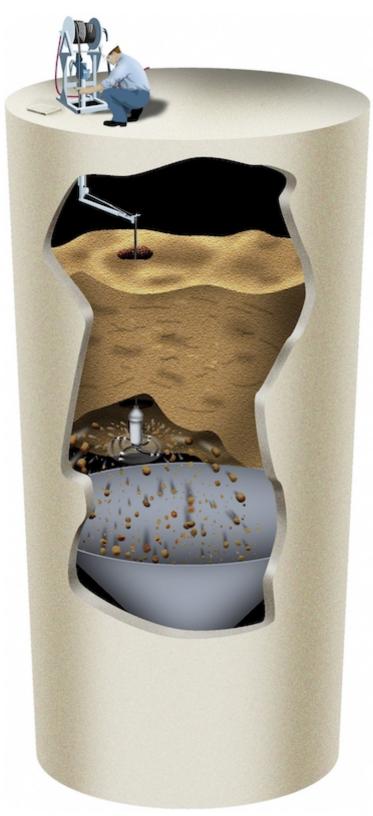
Utilisation of the heavy duty whip in a clogged silo avoids the need for personnel to enter the silo.

The Martin heavy duty whip is a portable, remote-controlled tool that can be lowered into storage containers through a manhole opening. Powered by compressed air, the patented motor can use a variety of different flails and cutting edges to knock down accumulated material without damaging storage

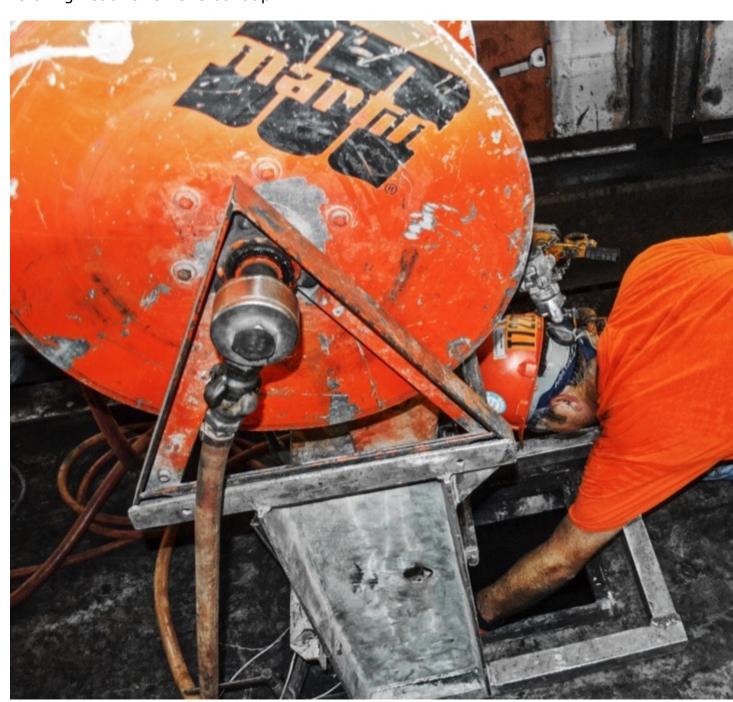
The drive of the whip is installed on top of the silo. It works through a 450 mm diameter hole.

The technicians secured the equipment over an access hatch at the top of each vessel at Commercial Acres. Though all Martin silo cleaning crews are OSHA and MSHA certified for confined space entry, they instead used remote control from outside the bin to safely guide the cleaning head. The 2-man crew lowered the whip through an opening in the blockage, starting at the bottom and undercutting the material as they worked their way up. In most cases, the technique allows material to be recaptured and returned to the material stream, and Stark was able to salvage the entire 40 tons of cementitious product removed from the silos. The entire process required just a one-day outage for the service. The silo restoration will include removing all internal horizontal supports, pulling all sidewalls back to their original flat position, then replacing the horizontal bracing and adding further dimensional support. Exit feedback from Stark management was a clear indication of the company's satisfaction with Martin Silo Services, which helped the facility quickly resolve a difficult issue and prepare for the required repairs as soon as possible. The report showed work was completed in a safe and timely manner, precisely on the predicted schedule.
