Anwenderbericht

## **GKD: Sewage Treatment Plant enjoys greater Planning Reliability for its Belt Press**

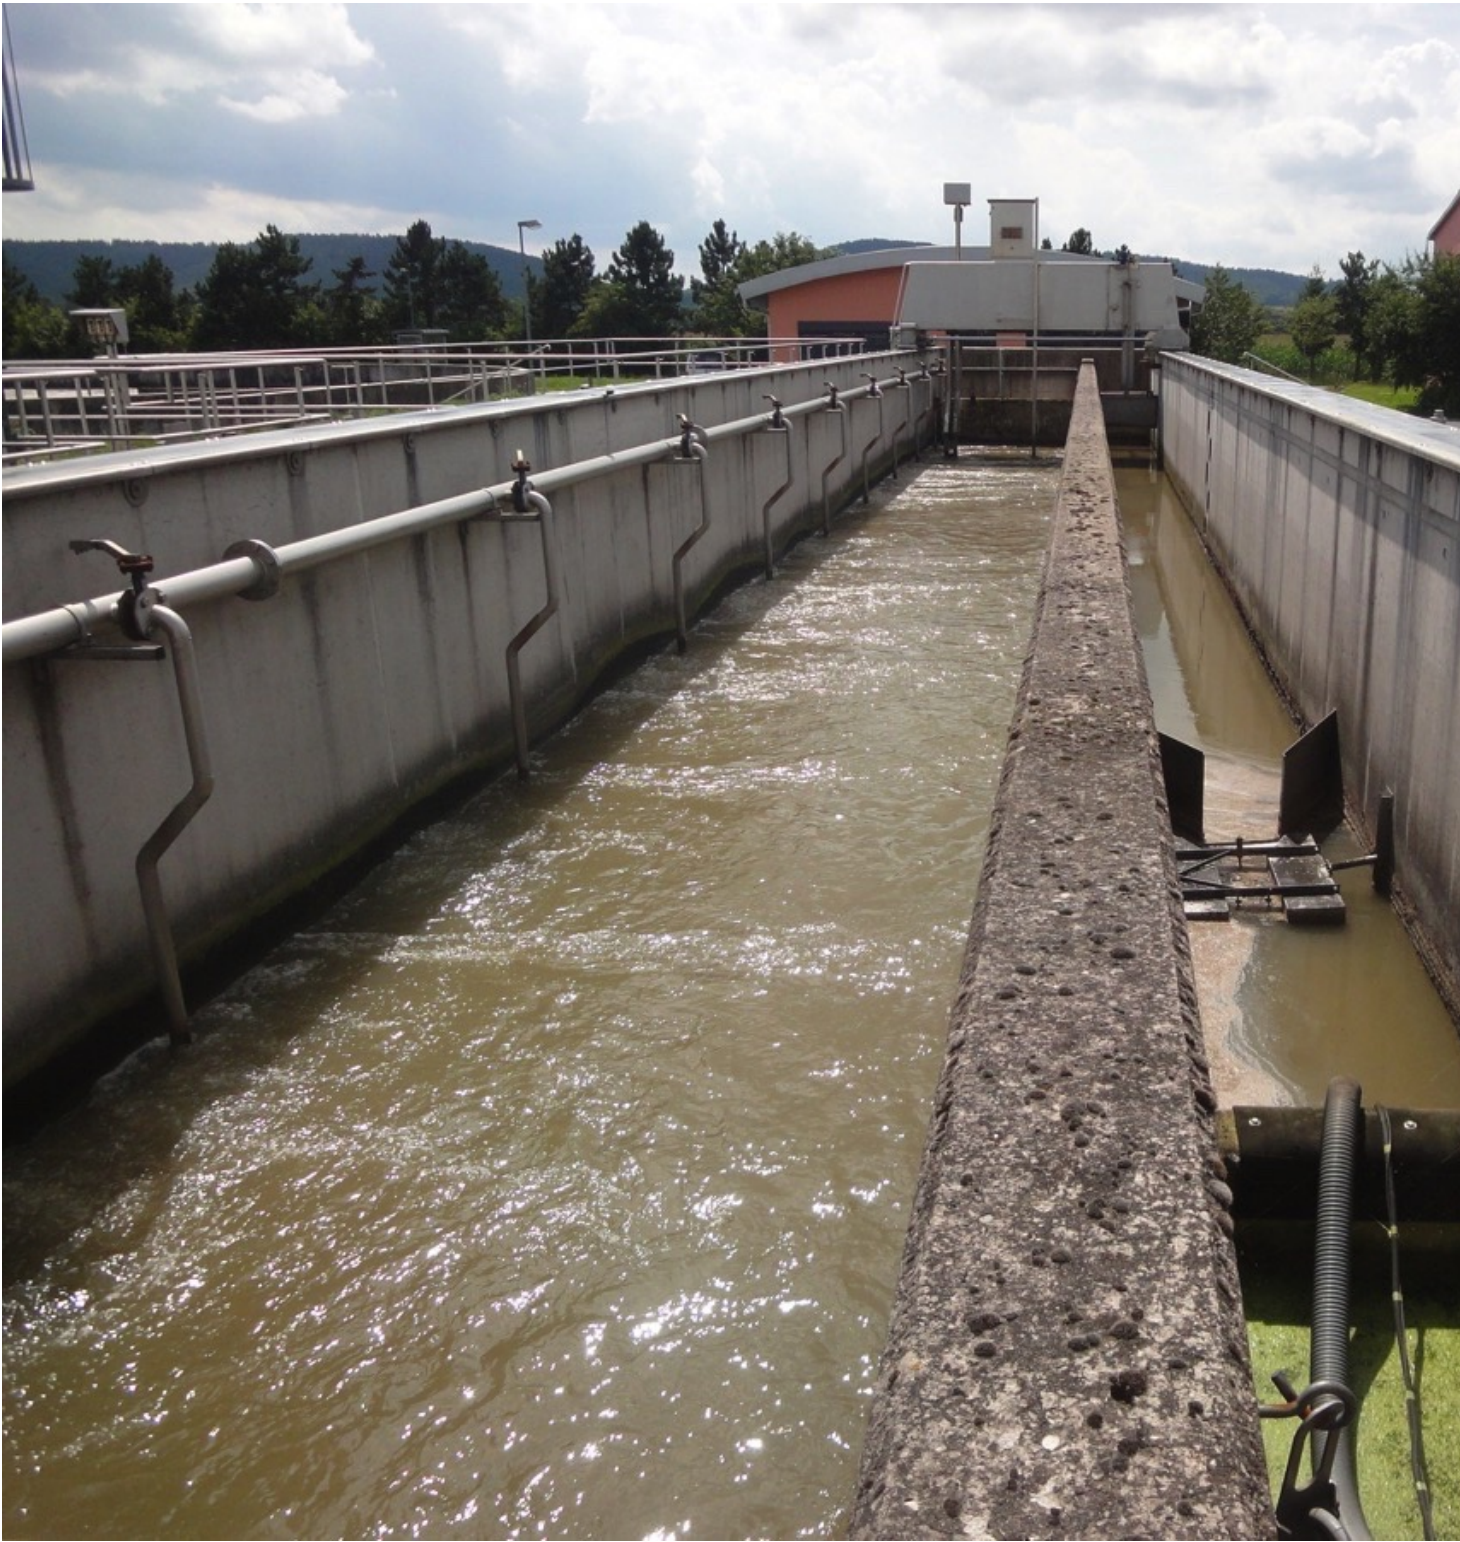
In the sand trap any sand in the material is released, washed and dewatered, allowing it to be used as backfill material in ditch and trench digging operations. (Picture: ©GKD)

At the four plants, mechanical cleaning is initially performed using a rake system with screw compactor for dewatering the raked material. In the ventilated sand trap with sand washer, any sand in the material is released, washed and dewatered, allowing it to be used as backfill material in ditch and trench digging operations. At the same time, light substances such as oils and greases are removed here.

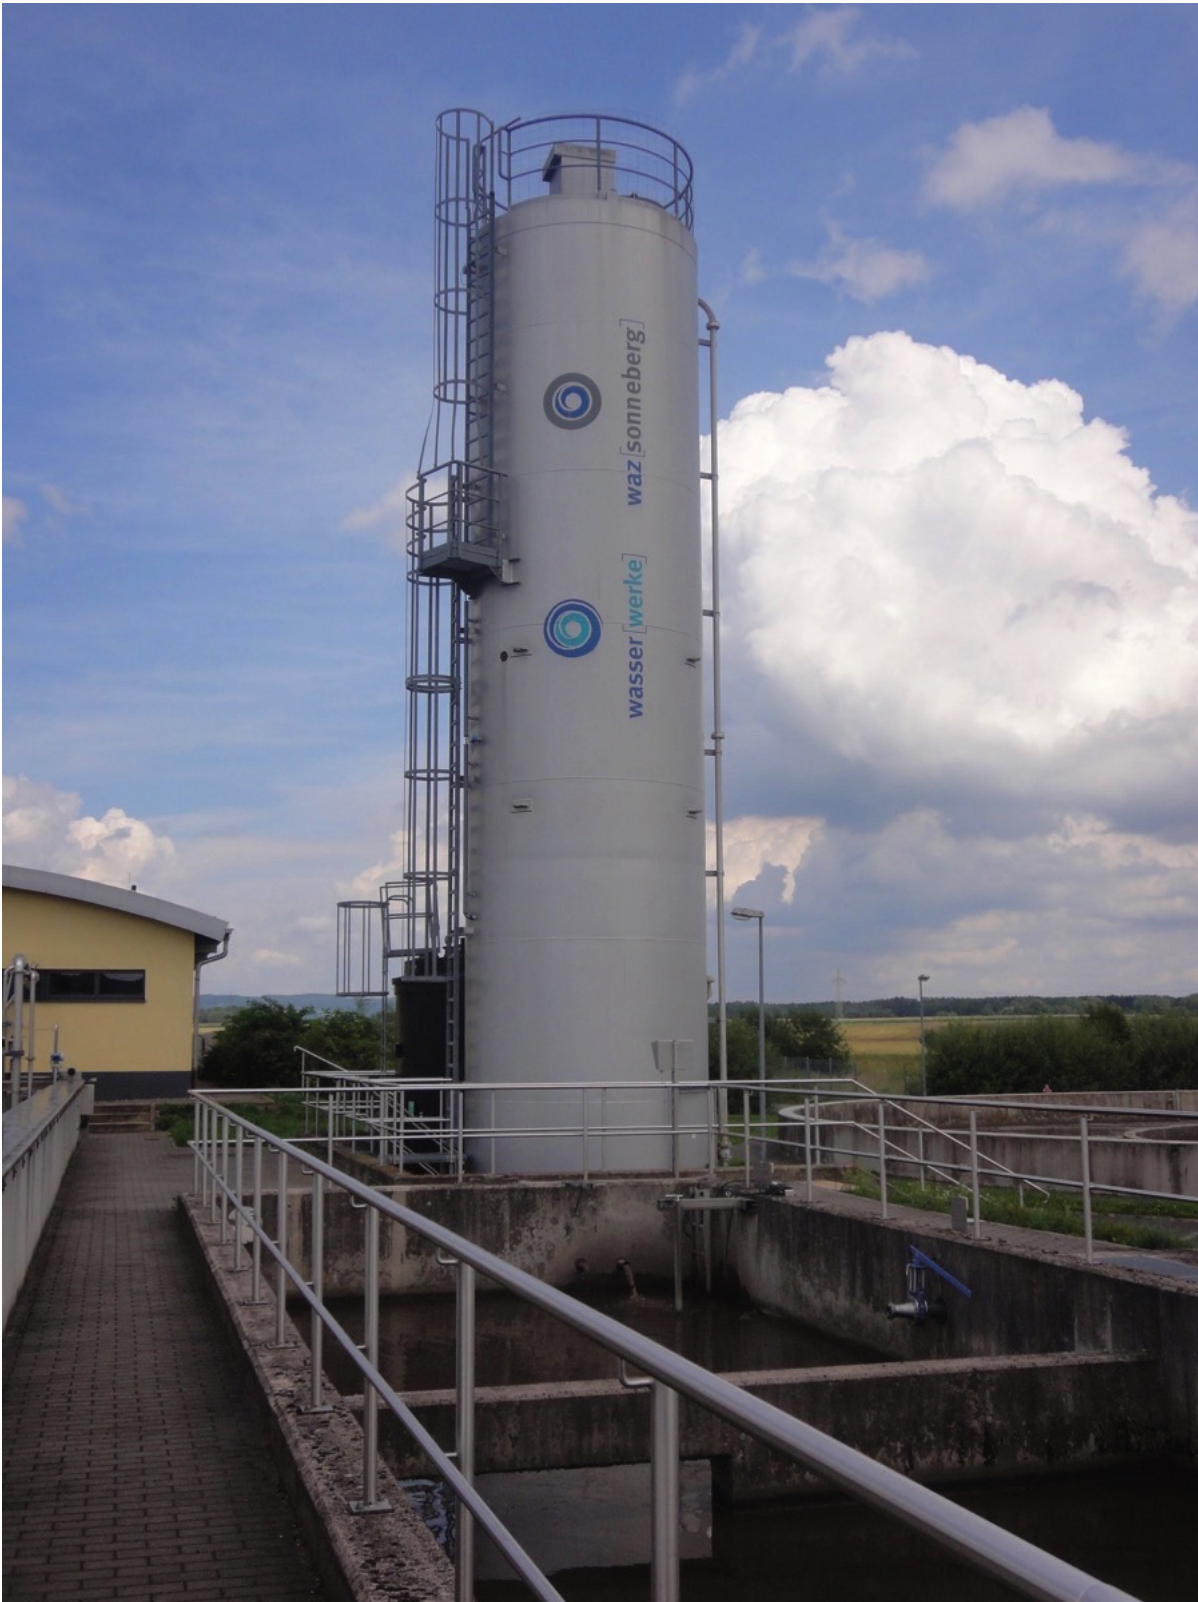
Lime hydrate must be added to the wastewater due to the very soft nature of the water in Sonneberg. (Picture: ©GKD)

bacteria and associated formation of bulking sludge stimulated by the large volume of fecal sludge. In two aeration tanks, designed as circulation basins measuring 95 meters in length and boasting an effective volume of 13,540 cubic meters, the nitrogen contained in the waste water is removed and the sludge aerobically stabilized. A blower station with five rotary piston blowers guarantees pressure ventilation of the basin. Two blowers supply each basin, while the fifth serves as a reserve unit and is also used to cover peak loads. The blowers are operated intermittently. The organic carbon is removed and the nitrogen nitrified during the ventilation phases. Denitrification is performed in the non-ventilated phases. To stabilize it, lime hydrate must be added to the wastewater in the second phase of the selector basin due to the very soft nature of the water in Sonneberg. It is metered from a 70 cubic meter lime silo that is heated in winter.

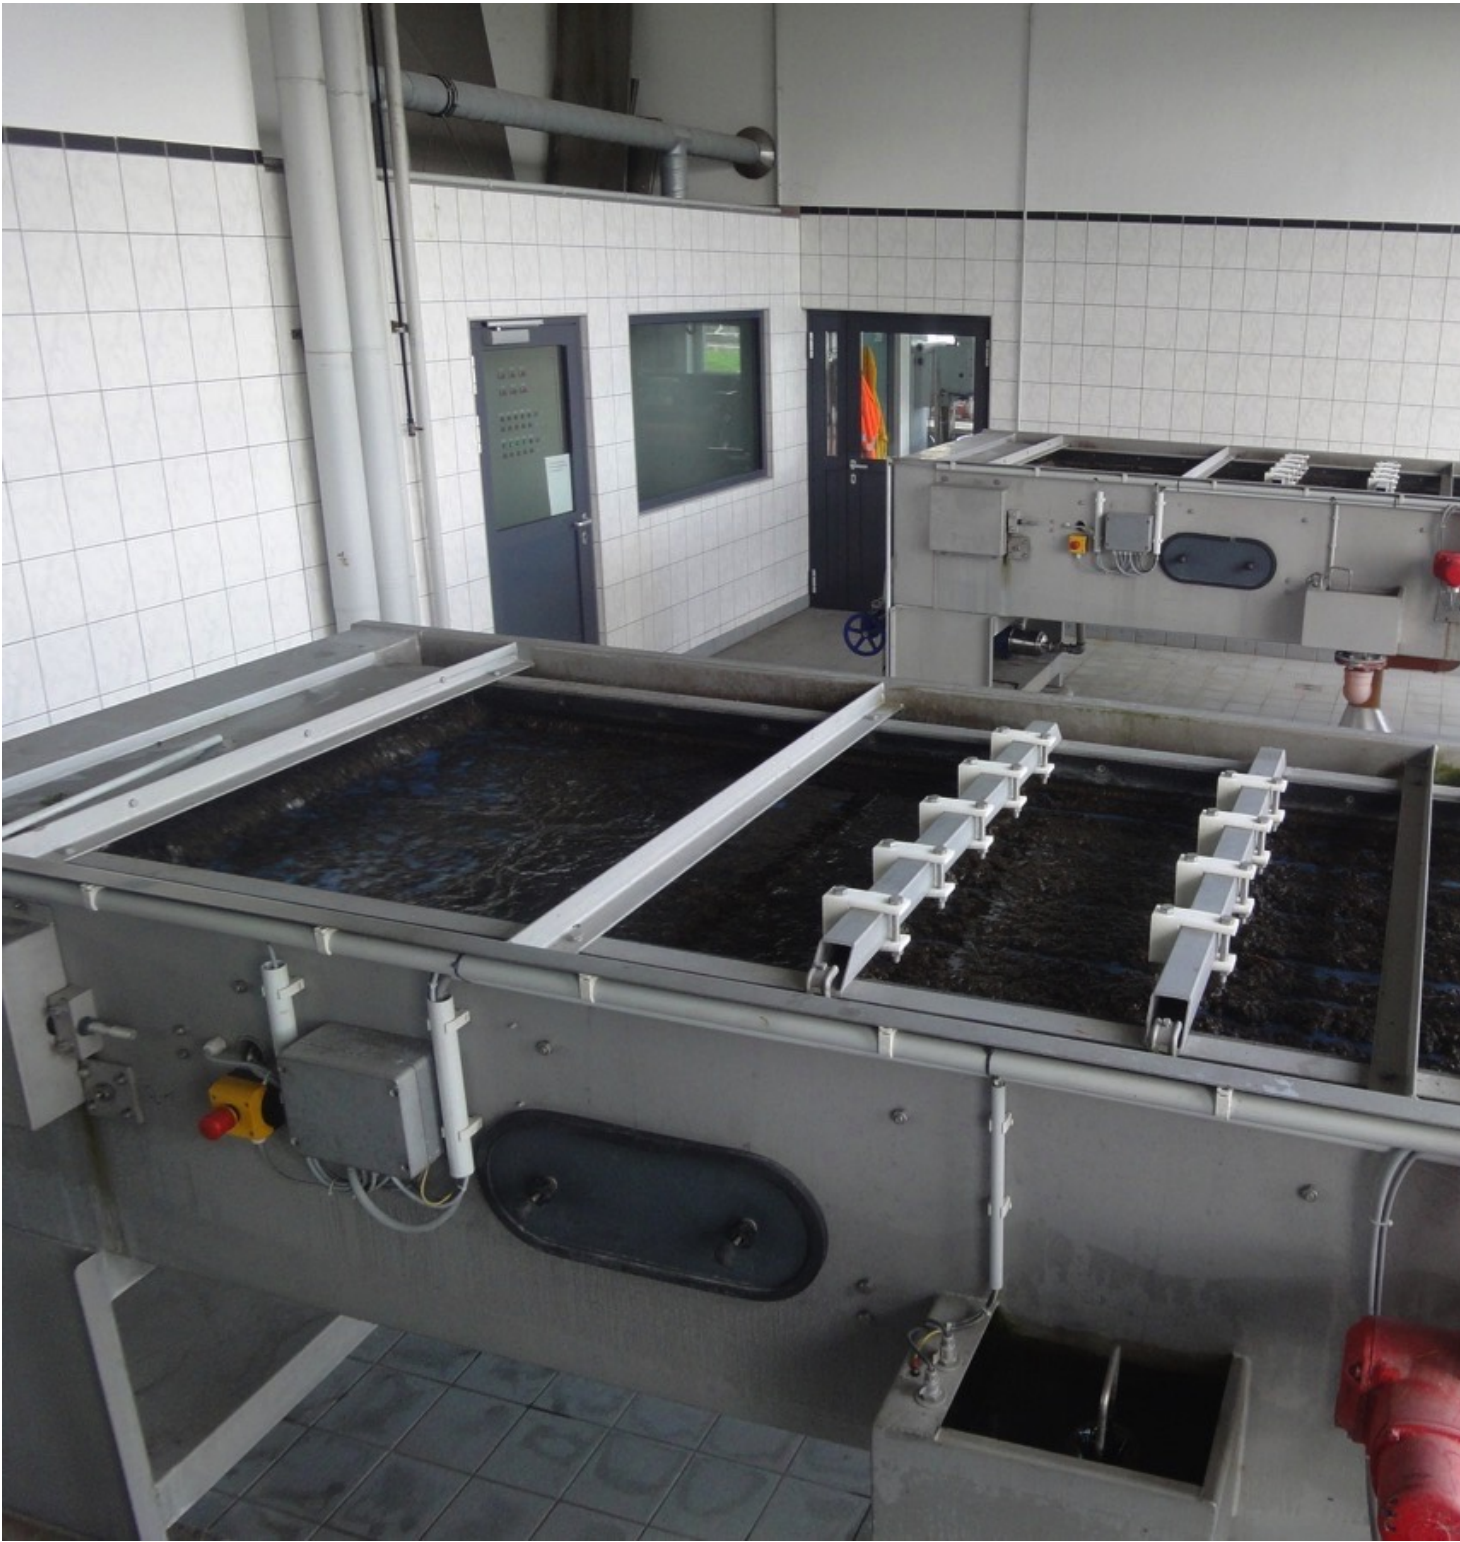
Two belt thickeners with continuously circulating Type 5060 GKD filter belts increase the solids content of the surplus sludge from 0.75% TS to around 5% TS through the addition of flocculant. (Picture: ©GKD)

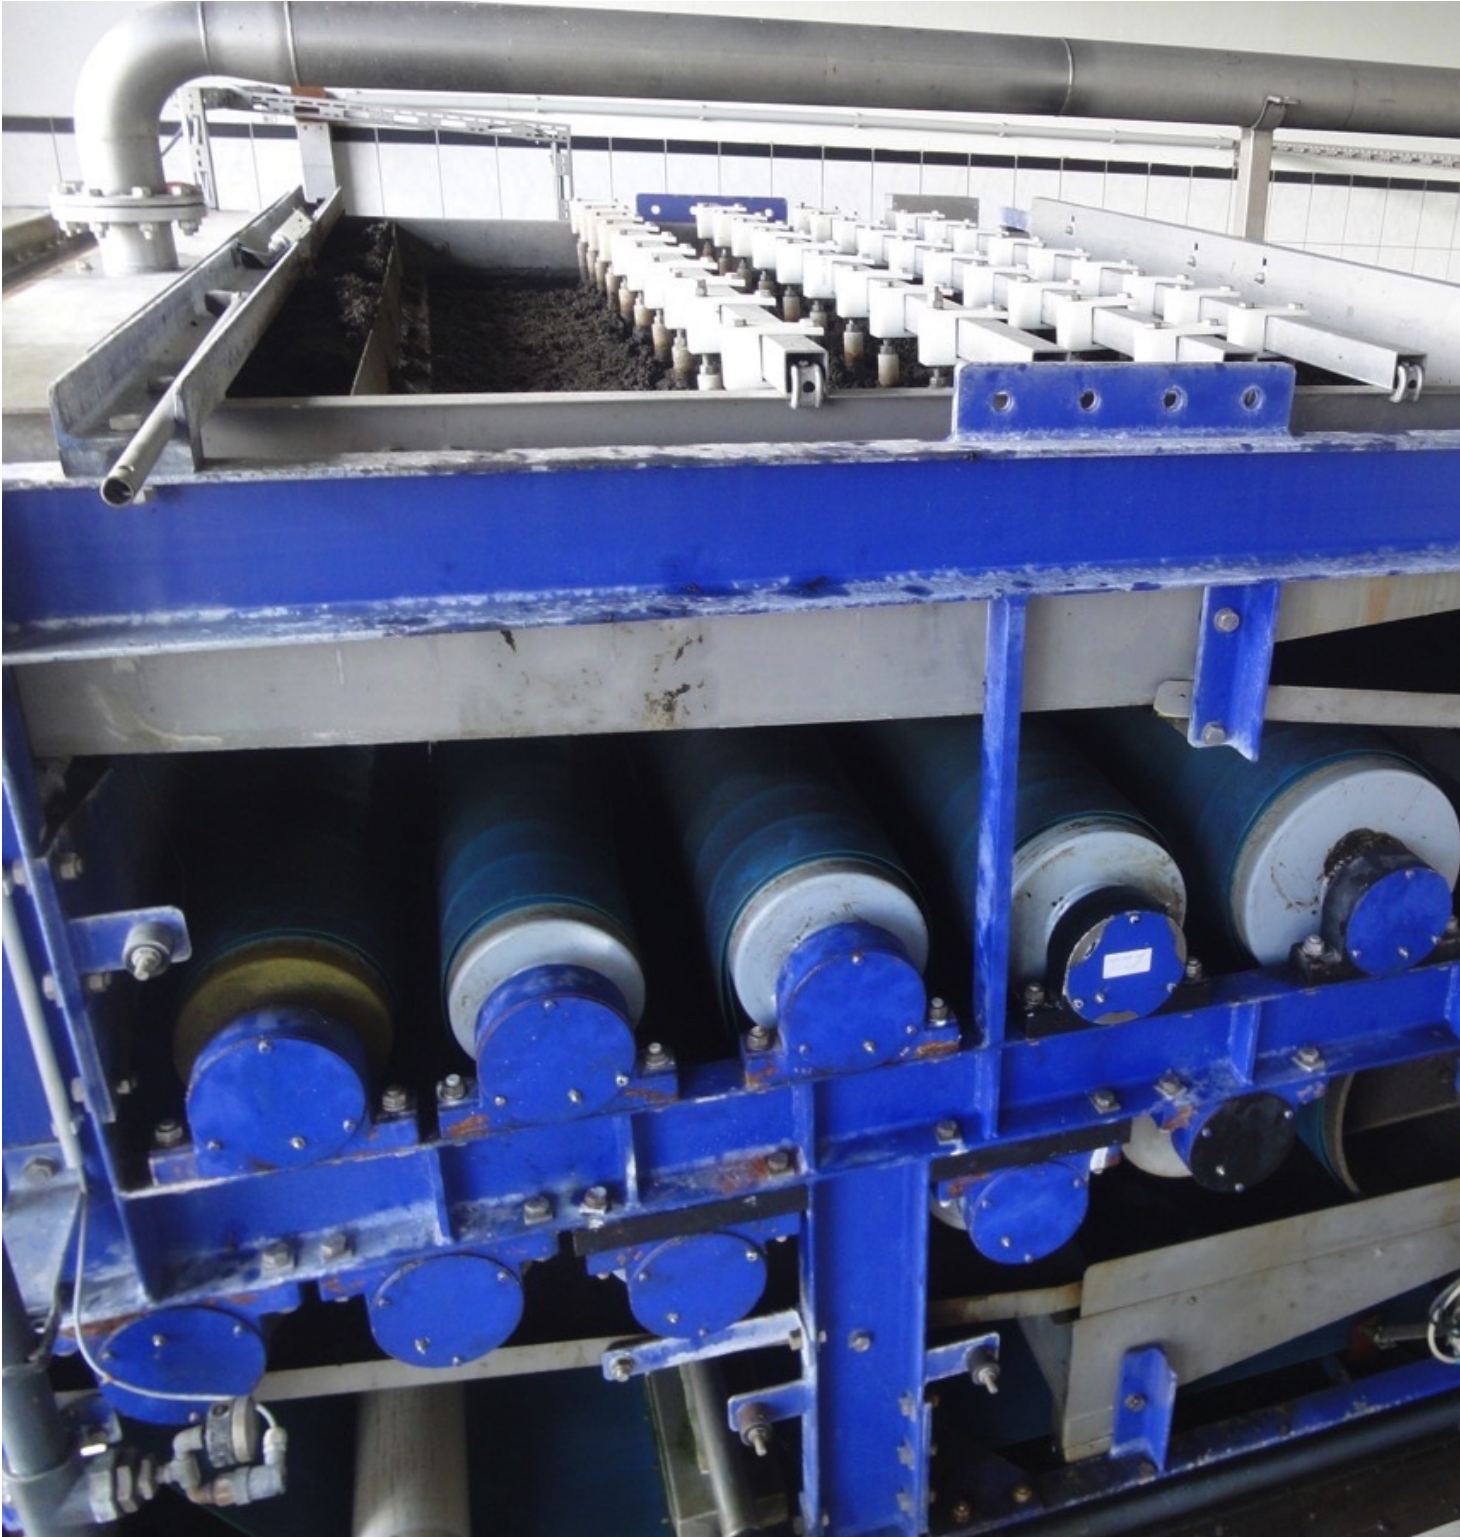
The belt press is fed directly from the thickener, so around 160 cubic meters of sludge is dewatered per day.

The belt press is generally fed directly from the thickener, so around 160 cubic meters of sludge is dewatered per day, whereby the belt speed is based on the grade of the sludge. With easily drainable sludges, approximately twelve cubic meters per hour are fed and then remain in the system for around half an hour.

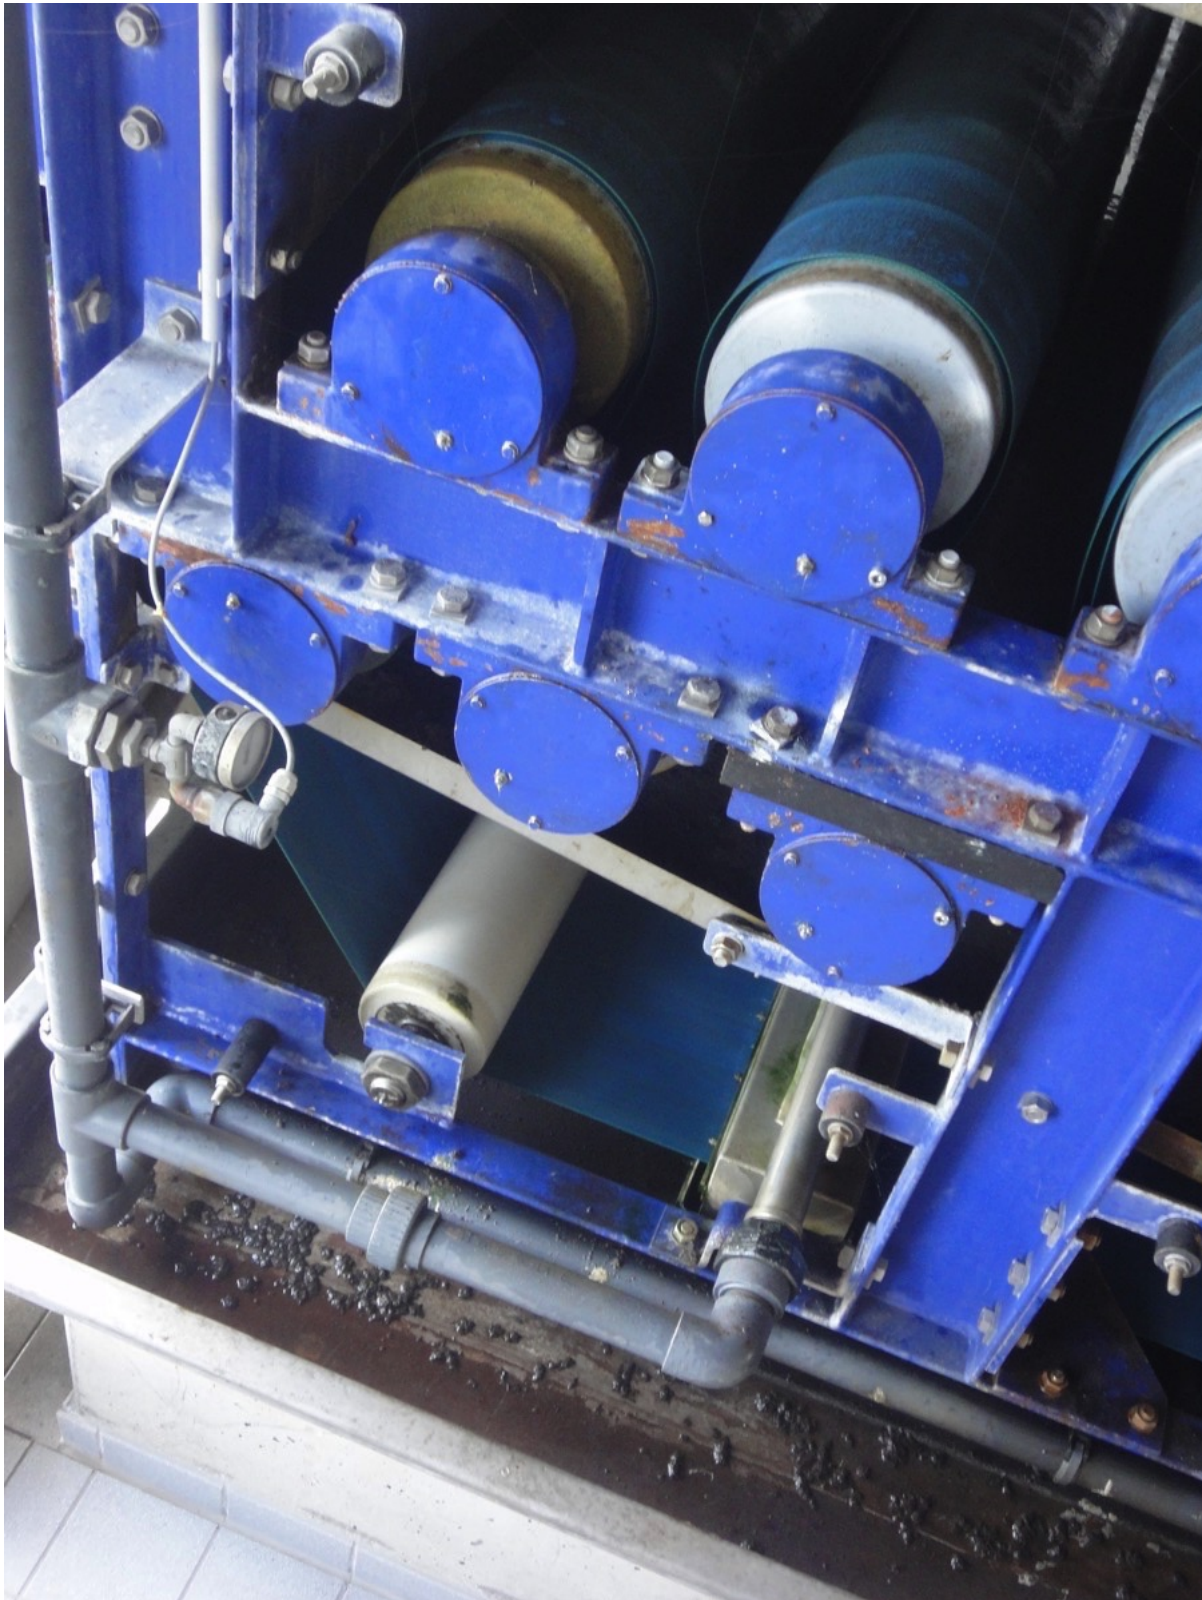
In the pressing area the sludge passes through eleven rollers between the upper and lower belt with belt pressure of 8 bar. (Picture: ©GKD)

After the thickened sludge has been deposited in the belt press infeed area, two scrapers distribute it evenly across the Type 1003 GKD filter belt, which then transports it to the pressing area. Here, the sludge passes through eleven rollers between the upper and lower belt with belt pressure of 8 bar. The belts are subjected to high loads as a result of the forces applied. The woven seams in particular were therefore a much feared weak point in Sonneberg for a long time. This was because the belts previously used at the Sonneberg sewage treatment plant regularly suffered from damaged seams due to the loads they must handle. In fact, these belts were repeatedly torn apart in an uncontrolled way, causing costly downtimes. Plant manager Bernd Hubner remembers: "The most important part of the belt is the seam. With the old belts, sudden failure of these seams led to a great deal of work and costs caused by the sludge that was still in the press. Yet despite the higher personnel costs associated with this work, the significantly longer downtime in comparison with a scheduled belt change was what actually had the greatest negative impact."

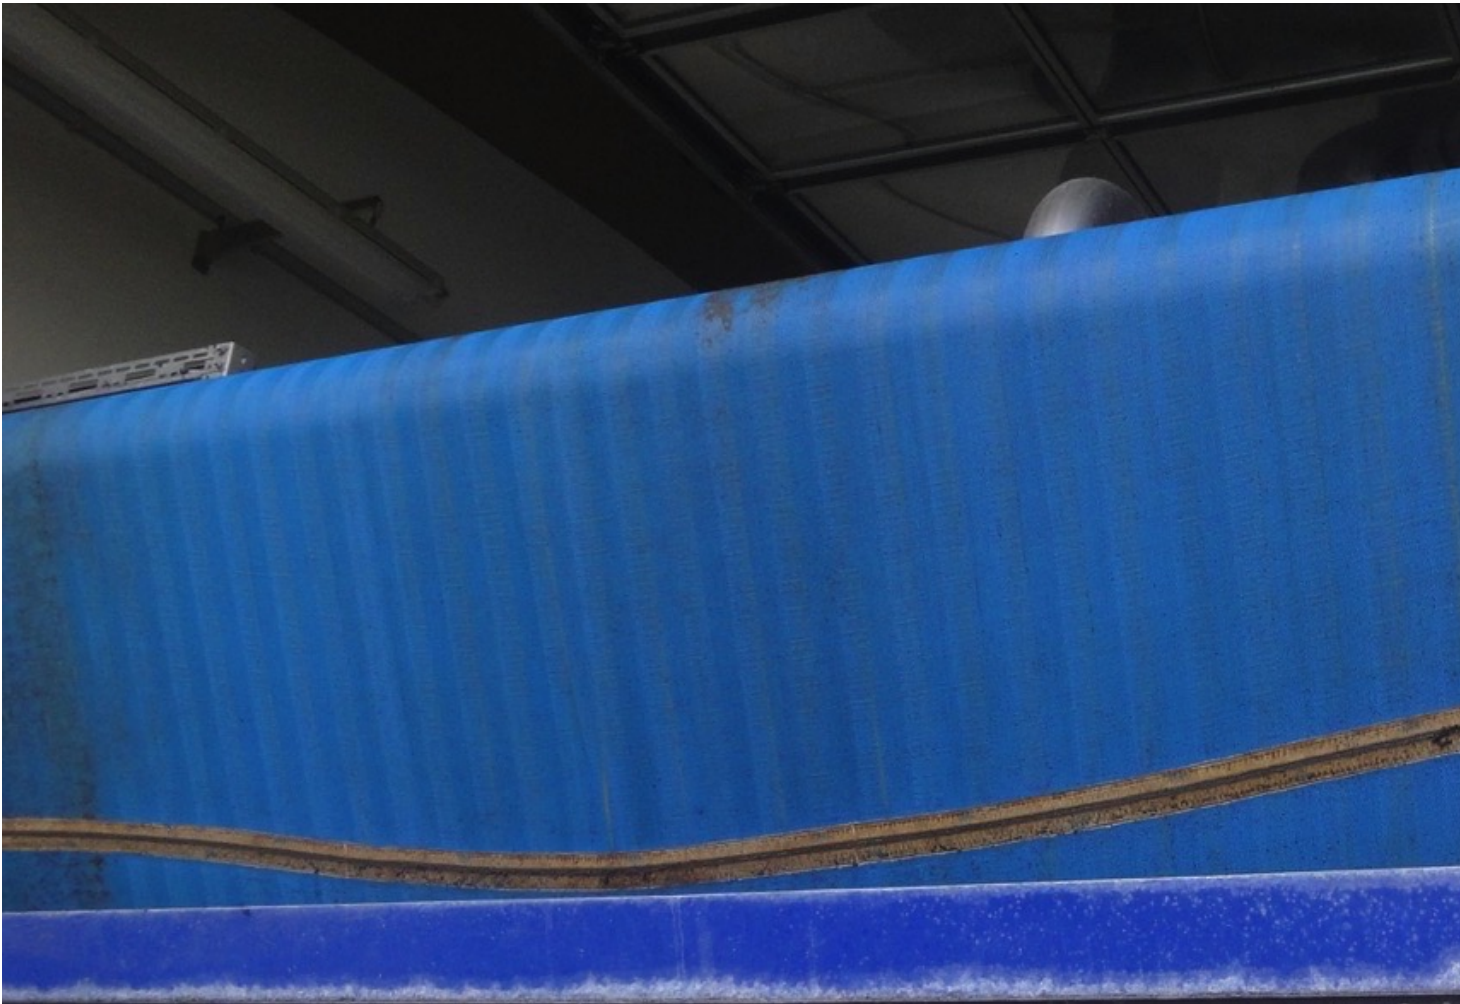
Besides efficient dewatering, the key factor of the GKD-belt Type 1003 with integrated wear indicator is a reliable PAD seam. (Picture: ©GKD)

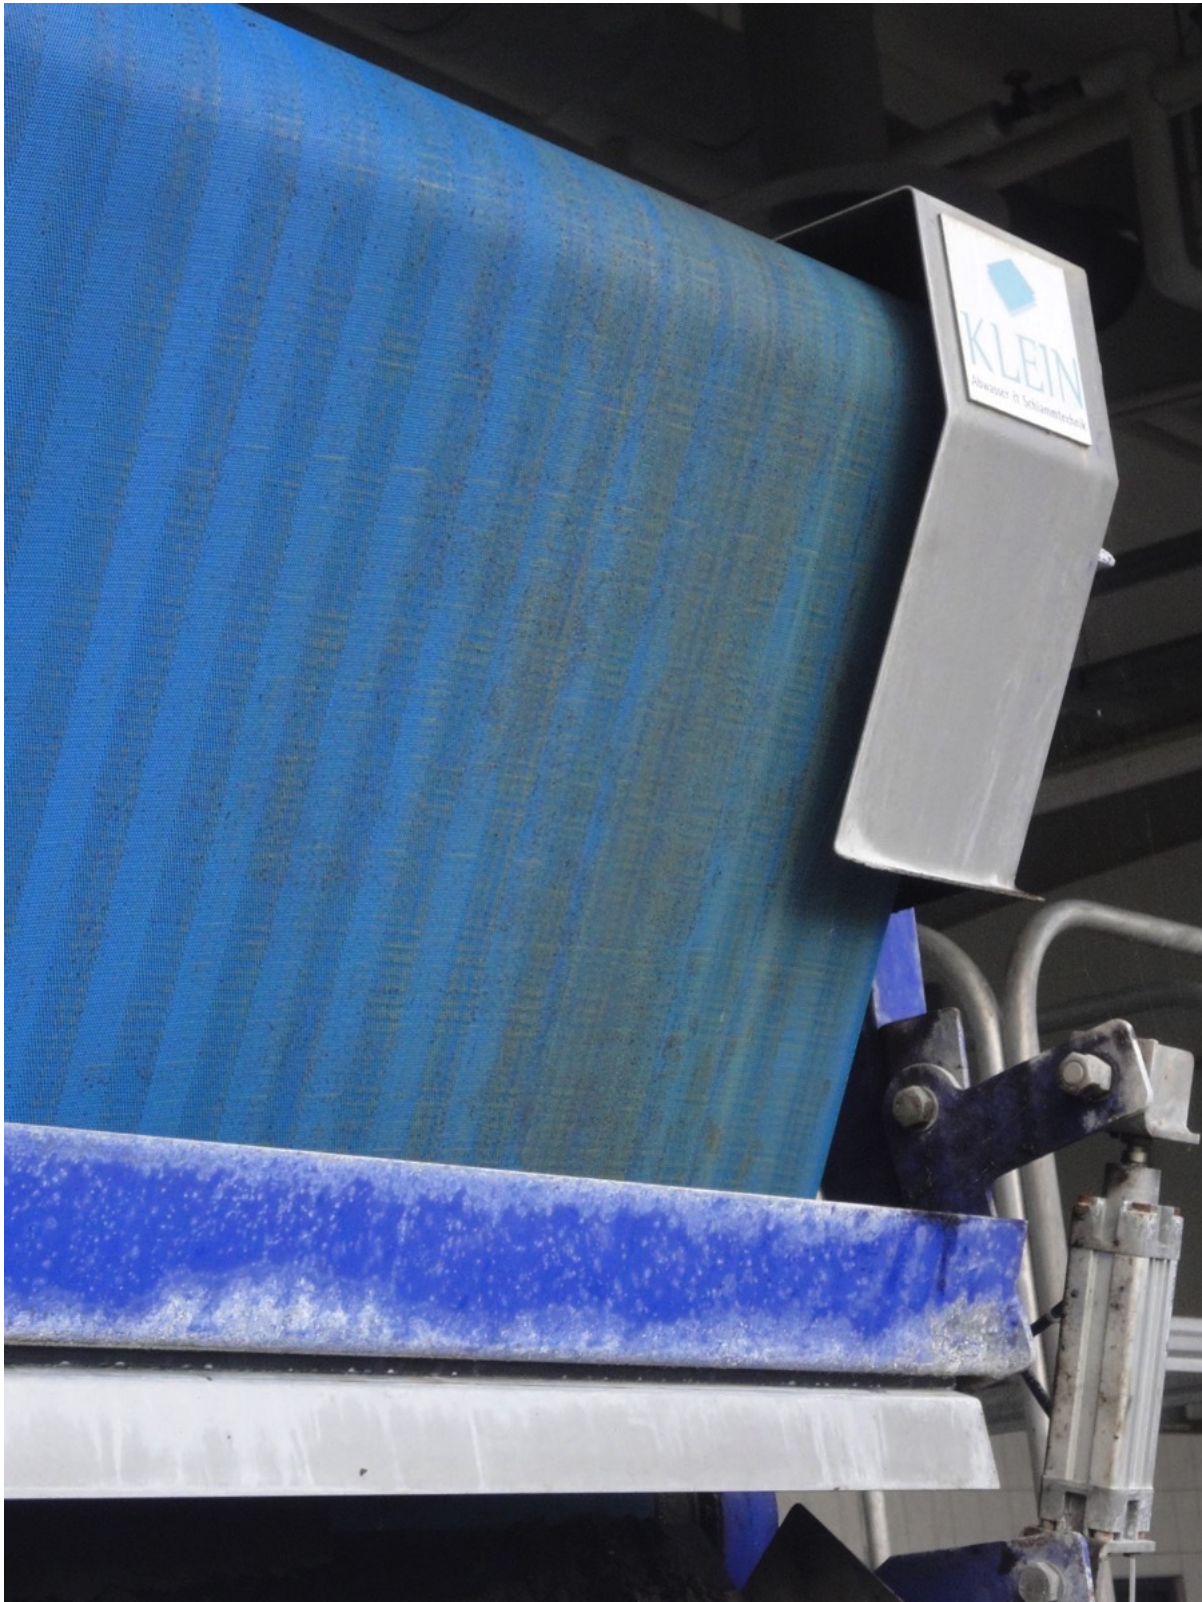
The wear indicator integrated into the GKD-belt Type 1003 allows distinct conclusions regarding the service life to be drawn. (Picture: ©GKD)

The yellow inner core of the 15.25 meter long and 2.50 meter wide GKD polyester belt displays the degree of mechanical wear – similarly to the wear indicators on car tires. This allows damage caused by defective plant components or process-related wear to be detected early on.
