Martin Engineering: Controlling Fugitive Dust at Limestone Conveyor Transfer

Bearbeitet von am 15. Dez. 2017
Neponset (IL), Vereinigte Staaten -

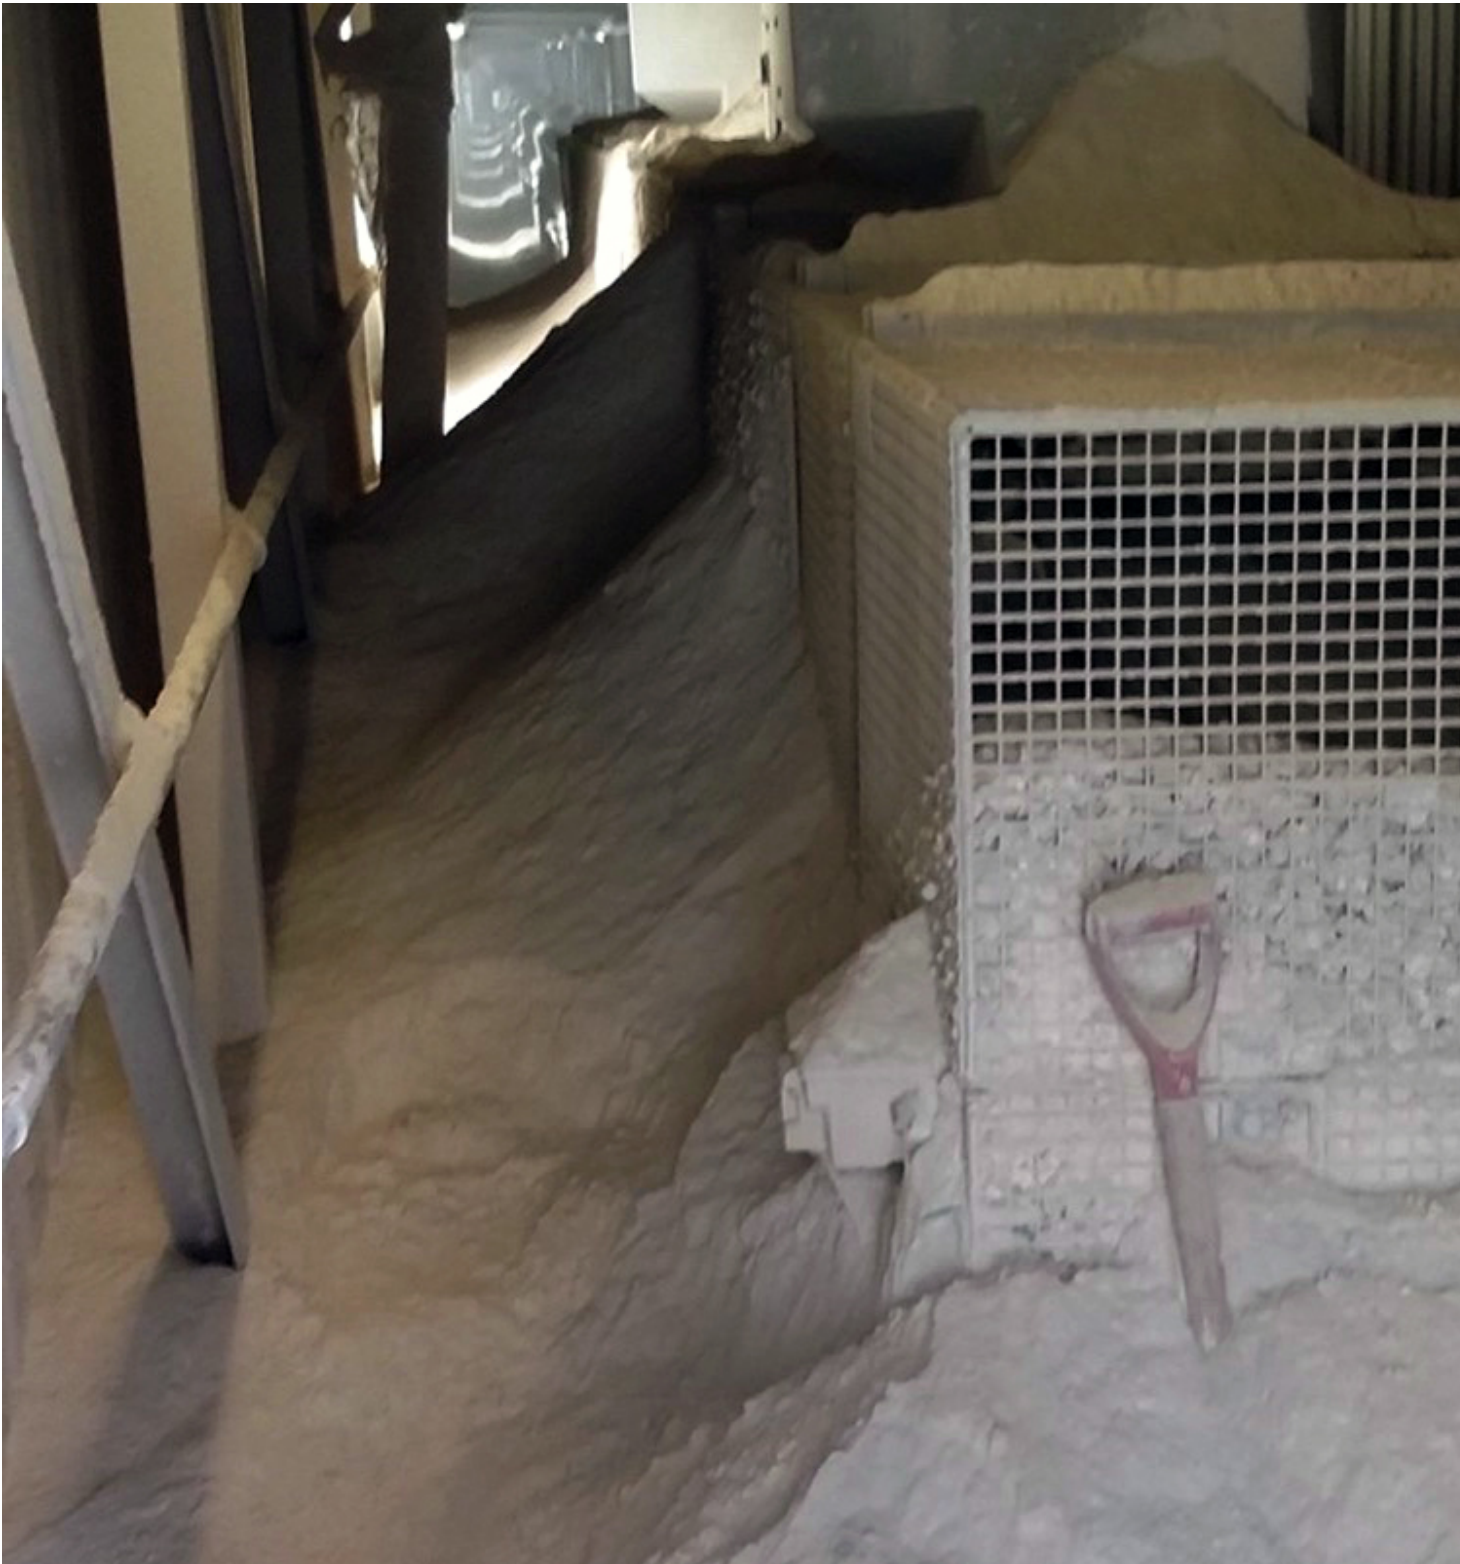
Piled high enough to encapsulate the tail pulley, the dust blocked walkways, posing a potential hazard.

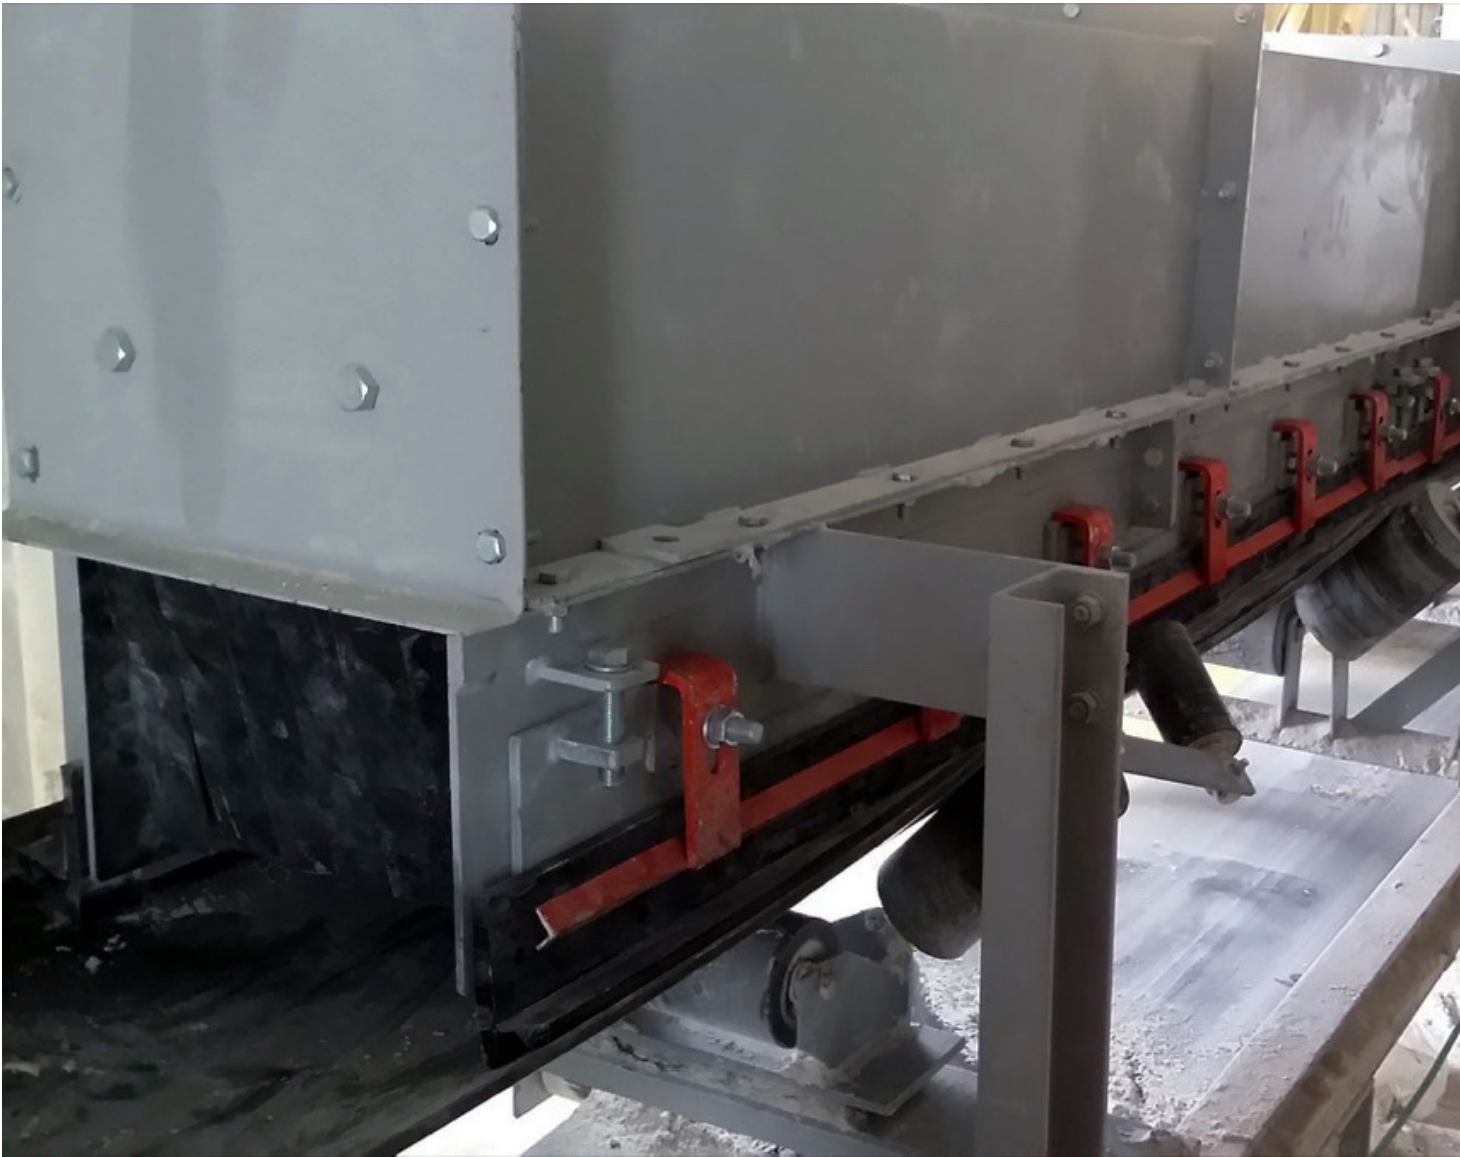
The external wear liner and apron seal help prevent damage to the chute wall.

The new design raised the chute 102 mm (4 in.) from its previous position to accommodate the new wear liner. Mounting brackets with jackscrews provided a secure mount, with precision adjustment of the wear liner to reduce spillage. This system closes the gap between the liner and the sealer, thus eliminating abrasion from trapped material without interfering with existing supports. When accompanied by the skirting and clamps, the system forms a tight belt seal, delivering outstanding fugitive material control. Special mounting tabs allow the liner and skirt seal to be adjusted or replaced from outside the chute, requiring no confined space entry.

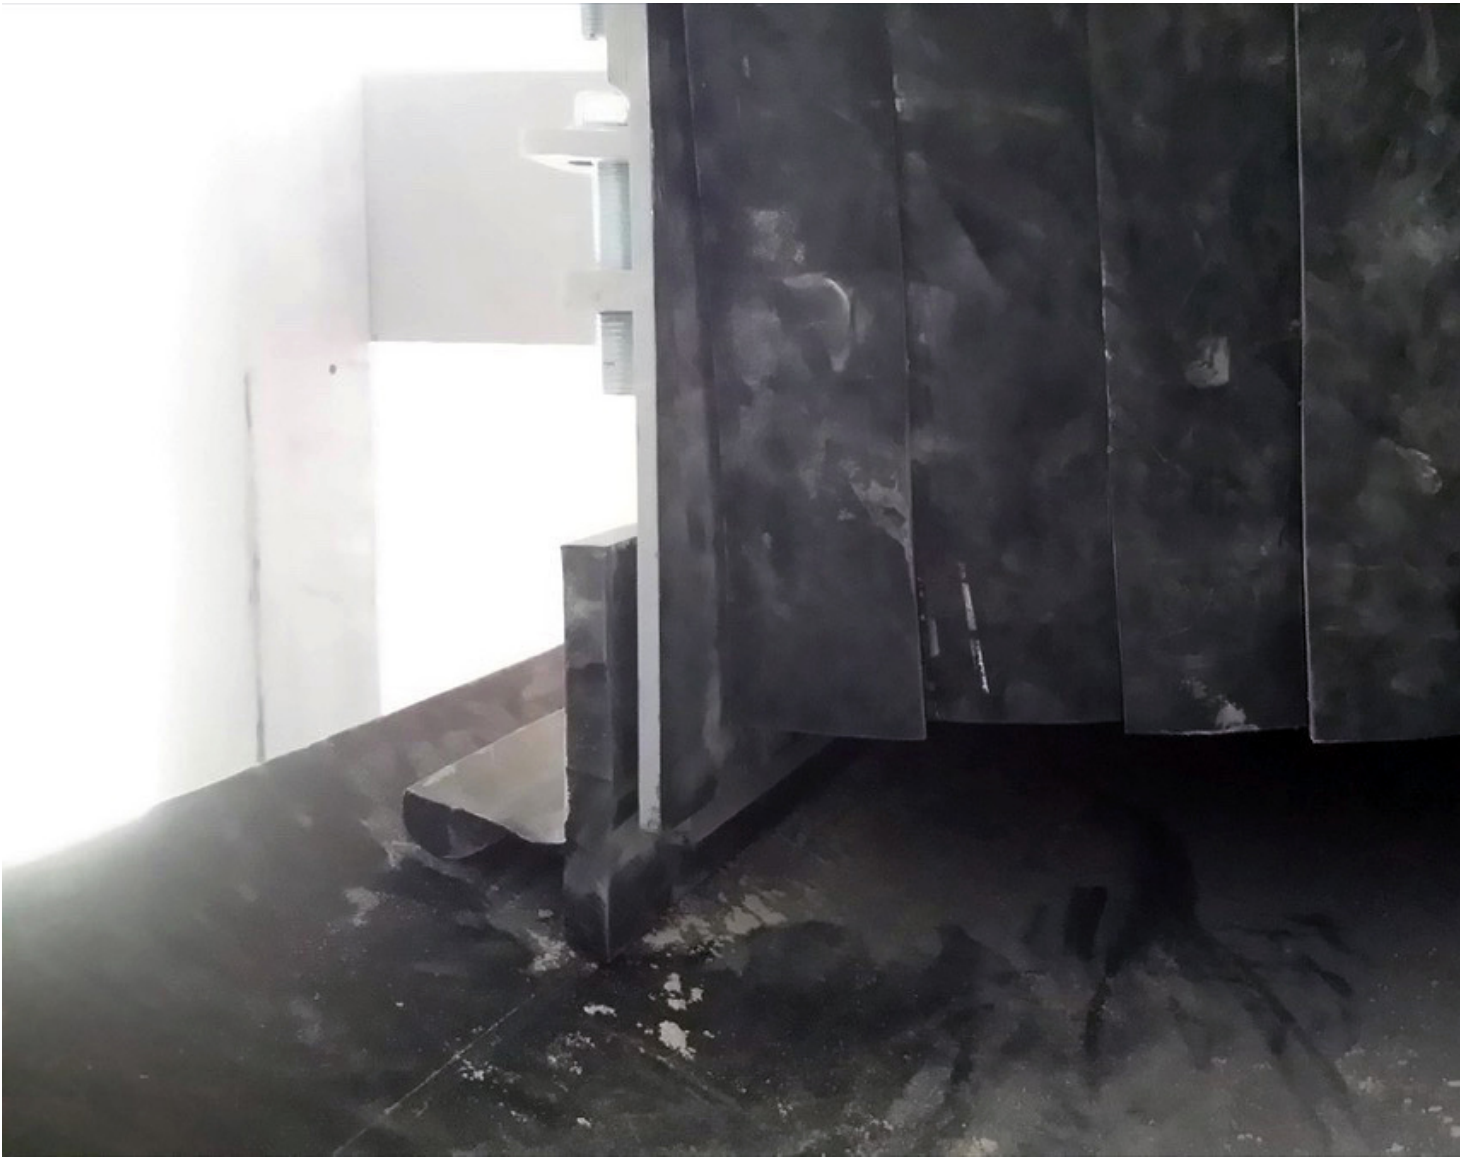
Dust curtains slow down the air flow and reduce fugitive particle emissions.
