## Metal Detectors prevent Plant Damage at Plasmor

Plasmor has installed three Bunting metal detectors to locate tramp metal and prevent damage to processing plant at their building block manufacturing site in Heck, East Yorkshire/UK.

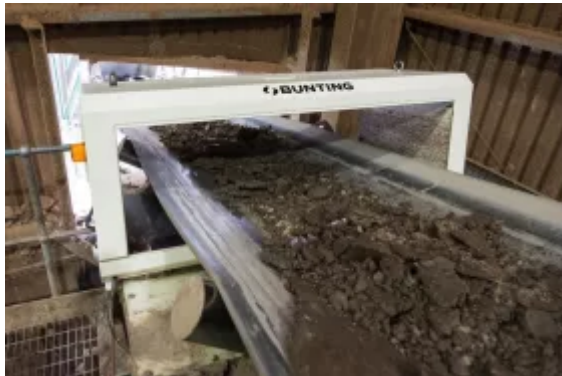
The meTRON Metal Detector on the primary feed conveyor

The divisible tunnel-type meTRON 05D metal detector detects both ferrous and non-ferrous metals present in the conveyed clay. The sensitivity of the metal detector is adjusted to suit the application, focusing on the size and type of tramp metal that could cause damage to processing plant. The 'divisible' design enables simple and quick installation without needing to cut the conveyor belt.

On the primary 1.2 m wide feed conveyor carrying quarried clay into the plant, Plasmor installed a meTRON 05D tunnel metal detector. The clay received into the plant is occasionally contaminated with damaging tramp metal, which if left undetected would damage plant later in the process.

In operation, tramp metal passing through the metal detector triggers a change in the detector's magnetic field, which registers in the control panel. In this installation, the identification of tramp metal results in the stopping of the conveyor and the sounding of an audible and visual alarm. Once detected, the problematic metal is manually removed. The metal detector is then reset and the process restarted.

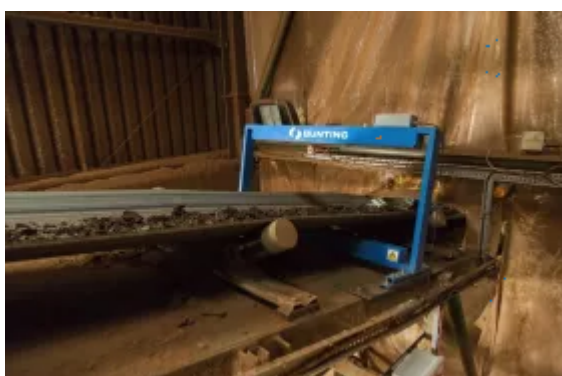
## The second TN77 metal detector

The TN77 metal detectors are both mounted around 0.8-metre-wide conveyors, each handling approximately 15 t/h of clay. These metal detectors are installed to locate any tramp metal contamination, but especially metal parts that had broken away from equipment earlier in the process, such as the tips of the rotating blades that break up the clay as it feeds onto the conveyor.

The TN77 metal detector sensitivity is set specifically to find tramp metal that would damage the extruder. As with the meTRON metal detector, tramp metal passing through the detector stops the conveyor and sets off a visual and audible alarm, allowing the maintenance team to find and remove the metal.
