Case Study

State of the Art Hazard Monitoring for State of the Art Flour Mill

Edited by on 15. Sep. 2021

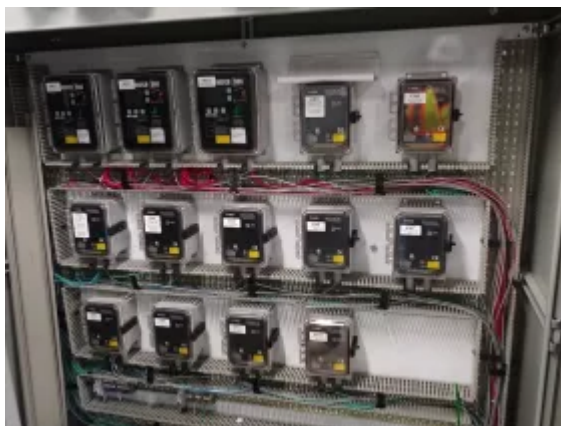
Panel of IE-Nodes

4B's newest hazard monitoring system, the Industrial Ethernet Node (IE-Node) was the perfect fit. It features EtherNet/IP communications that work directly with the customer's Allen Bradley PLC without any gateways while being approved for Class II, Division 1 Group E, F & G hazardous dust environments. It provides inputs for continuous bearing temperature sensors, belt alignment sensors, and speed sensors.

The customer selected the IE-Nodes because they are technologically superior to other options on the market and improve the flexibility of installation all at an attractive price. The IE-Nodes each have 10 inputs and can be expanded to 16 to provide even more flexibility in applications where the site needed additional sensors. All of the sensors can be fully tested with 4B's Speedmaster and ADB Tester and the system has the unique ability to have multiple speed inputs for the PLC to monitor the speed ratio on equipment operating with VFDs.

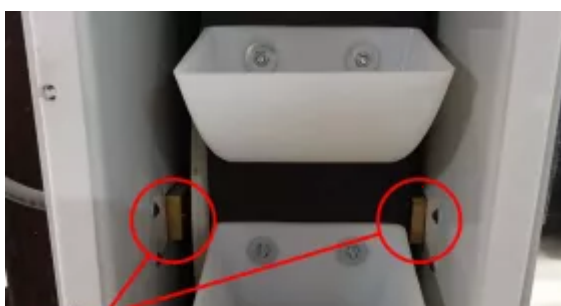
Brass Rub Blocks installed

The customer selected NTC Adjustable Depth Bearing (ADB) temperature sensors, 2" x 4" rectangular brass rub blocks with stainless steel hinged inspection doors for belt misalignment, and whirligigs with 4-20 mA Milli-Speed sensors for monitoring belt slippage. 4B provided training for both the end user and installer to highlight the best practices for wiring and maintaining the system.
