Case Study

Conveyor Transfer Point Upgrade controls Dust at Brazil Port

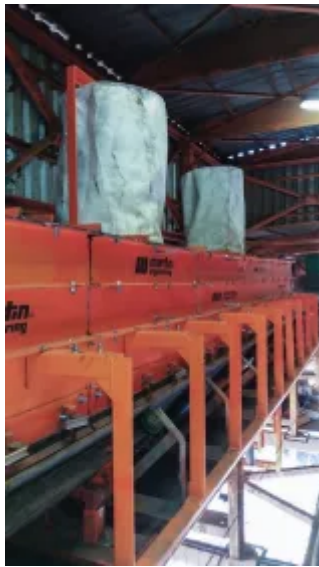
The skirtboard cover is shown with two dust bags.

After constructing a longer sealed enclosure with the ability to control airflow and give dust extra space to settle, technicians added several other critical components. A heavy-duty impact cradle was installed to protect against impact and friction wear on the belt, which reduces maintenance and prolongs operational life. It features a top layer of slick UHMW polymer molded to a base of impact-absorbing SBR rubber, all reinforced with a steel support structure able to withstand as much as 17,000 pounds (53.4 to 75.6 kN) of force.

When the conveyor was activated, operators immediately observed significant results. As material moved through the system, particulates remained within the enclosure and either collected in the dust bags or settled back into the cargo flow. With less carryback on the return side of the belt, dust was drastically reduced in the immediate area around the conveyor system at both the loading and discharge zones.
