## **Dynamic Damage of Rubber-Textile Belts in Pipe Conveyor Application**

[Published in bulk solids handling, Vol. 35 \(2015\) No. 4](#)

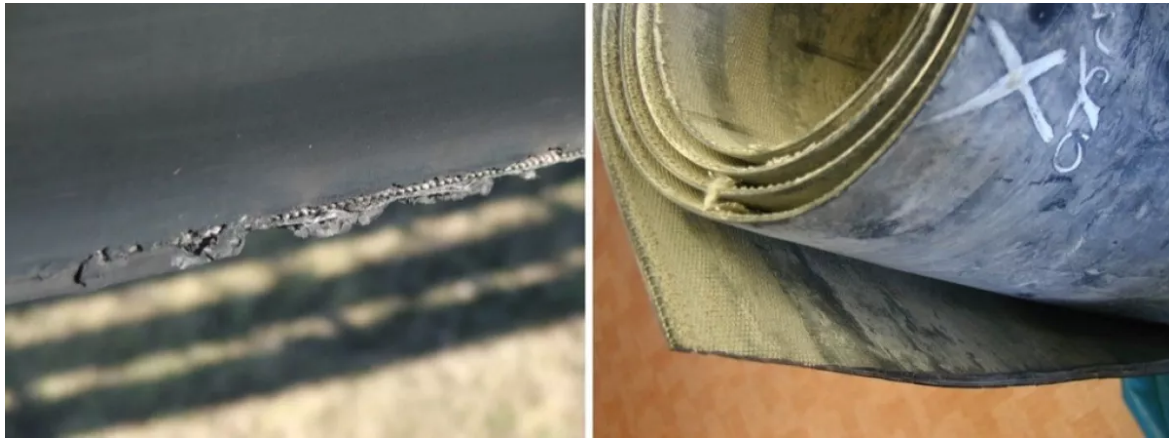
The rubber-textile conveyor belts are used for installation in the pipe conveyors much more than steel-cord conveyor belts. The rubber-textile conveyor belts are suitable for most of the pipe conveyor installations with regard to the strength conditions during the pipe conveyor operation as well as with regard to other circumstances. The conveyor belts installed in pipe conveyors are subjected not only to an influence of the transported material, but they are also exposed to a specific loading, which is caused by a cyclic process of the conveyor belt closing into the piped shape and following opening of it into the flat shape. Important factors are also influences of the operational conditions, quality of maintenance, etc. All these facts are able to cause various damage of the conveyor belt

Fig. 1. Example of damage on edge of the pipe conveyor belt. (Pictures: © Technical University of Košice)

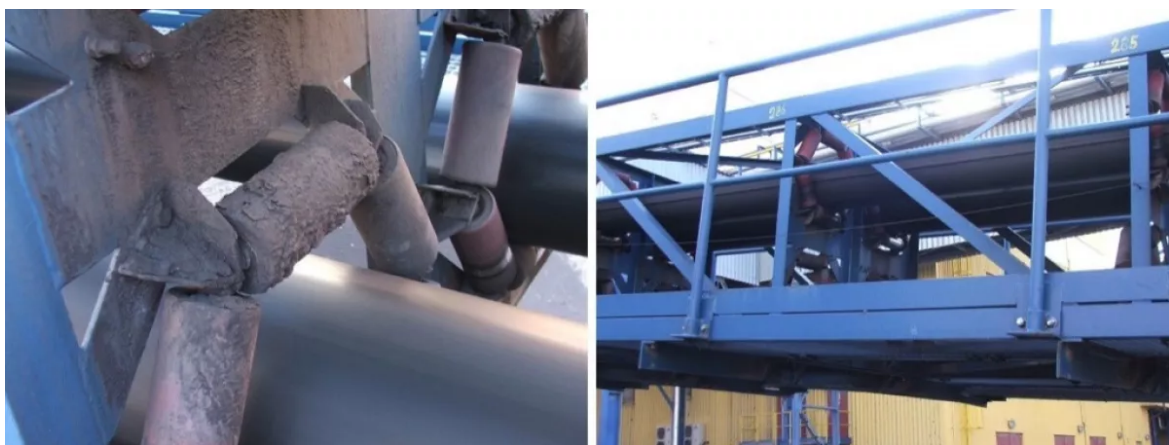
Another possible negative phenomenon, which is occurring within the pipe conveyor operation, is such situation when the rubber-textile conveyor belt does not have a full or stable contact with all six idler rolls situated in the hexagonal idler housing (Fig. 2). This unfavourable situation is occurring in the straight sections of the pipe conveyor trajectory as well as in the sections curved horizontally and vertically. The negative result of this situation is a deformed shape of the conveyor belt cross-section, i.e. the flattened or even flat shape of the belt cross-section what means that the conveyor belt does not have the required dynamic properties and is damaged dynamically. The final result of this undesirable situation is a local increasing of intensity of the conveyor belt wear-out process, which causes a damage of the belt cover layers, higher motional resistances and a possibility of material spillage along the conveying trajectory, as well. All these facts are resulting in undesirable technical and economical consequences for pipe conveyor operator or user.

Fig. 2. Example of situation when the conveyor belt does not have a contact with all idler rolls in the hexagonal idler housing.

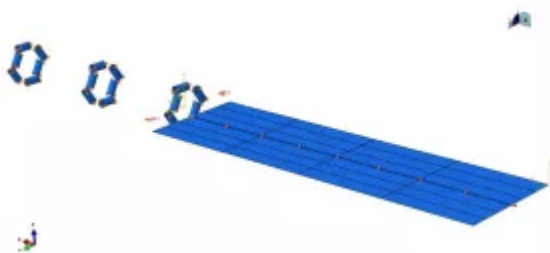
The experimentally obtained results established a database for the development and application of a computational model in order to realise the FEM-analysis. Geometry of this model is visible in Fig. 4. Realisation of this computational model required application of a pre-processor, which is a basic part of the software Abaqus. Three idler housings with an offset arrangement of the guiding idlers were simulated within the framework of the computational model geometry.

Fig. 4. Geometrical model created using the software CAE Abaqus.

Model of the conveyor belt was divided into the six axial parts taking into consideration the results obtained experimentally from the analysed sample. The six-parts division was selected in order the conveyor belt model could contain six zones with various modulus of elasticity values in accordance with the results obtained from the individual experimental measurements specified for modulus of elasticity determination. The given zones are characterised by the same modulus of elasticity values in transversal direction as well as by the equal material density values, while in longitudinal direction the individual modulus of elasticity values are different in each of zones.

The boundary conditions are defined in such a way that each of the guiding rolls has removed all degrees of freedom. The conveyor belt has removed three degrees of freedom in the middle in all directions except of longitudinal direction. This arrangement enables to do the required shift of the conveyor belt into the correct position in the idler housing within the framework of the calculation process.

Margins of the conveyor belt are bound by means of two referential points and there are situated the auxiliary torques in these referential points in order to form the piped shape of the conveyor belt. Another loading of the conveyor belt represented the gravity force and tensional force. The finite element mesh was assembled using the finite elements of the type Shell with the global contact function defined between the individual contact pairs.

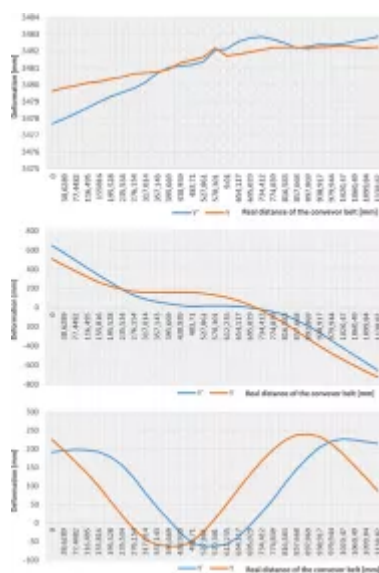
Fig. 7. Graphs of conveyor belt deformations for the belt with the dynamic damage  $Y$  and without dynamic damage  $Y'$  in direction of the axes  $X, Y, Z$ .

The graphs in Fig. 7 describe the partial values of deformations in the case of pipe-shaped belt in direction of the axes  $x, y, z$ . The graphs are recording the values obtained from both computational examples. The graphs show significant differences in the calculated results between the model of conveyor belt, which is damaged dynamically and the model of undamaged conveyor belt. It is possible to say according to the obtained results that if the belt is damaged dynamically, it is formed in the idler housing otherwise than it should be, in comparison with the undamaged belt. The contact points between the belt and forming idlers in the hexagonal idler housing are also different for both types of the conveyor belts.
