# Whipped into Shape - Concrete Mixing Plant Relieves Pressures with Silo Cleaning Service

Published in bulk solids handling, Vol. 34 (2014) No. 2

When their silo walls bulged due to increased internal stresses, which resulted from material build-up within the silo, a North American Ready Mix Concrete plant looked for a possibility to empty the silos without the need to enter them.

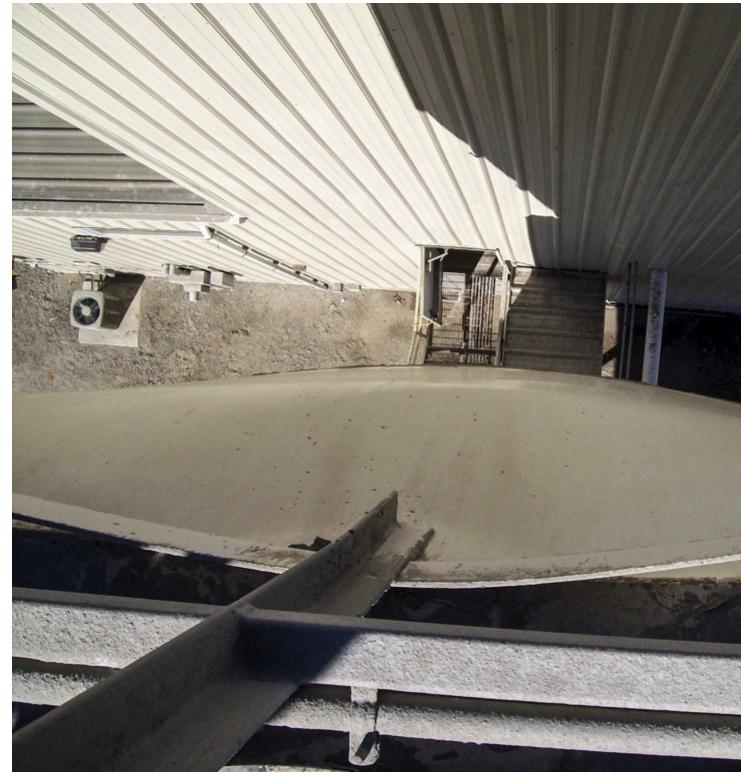
Silo walls bulged, due to increased internal pressures. (Pictures: ©Martin Engineering)

Commercial Acres features a Treyco RMC Plant that's capable of producing more than 200 cubic yards per hour. The complex includes three 125-ton storage silos measuring 30'x30'x57' (9.144m x 9.144m x 17.374m), two used for cement storage and one for fly ash / pozzolan storage. Cementitious material is hauled to the plant in pneumatic tankers and blown into the silos through 3-inch lines."Over time, material dust in the three pneumatically-loaded silos gradually built up, first on walls and ridges and eventually clinging to all the interior surfaces," explained Concrete Production Manager Jeff Jackson. "As a result, the air flow became constricted, raising the pressure within the silos and exerting greater force on the structure, connections and piping."The compacted build-up continued to collect particles, effectively shrinking the internal space as the pneumatic blower forced more material through the silos. The severity of the problem became apparent to system operators when they noticed the walls of the silos actually starting to bulge outward. During a shutdown and inspection, the staff could observe interior damage and decided that over-pressurization had compromised the structural integrity of the three storage vessels. The need for repairs was clear and immediate, but the material build-up presented a serious obstacle. Remembering a recent article on silo cleaning authored by Martin Engineering that he had seen in a trade publication, Jackson contacted the company about the problem. Already familiar with Martin from using its conveyor belt cleaners and other components, he briefly explained the problem and the urgency of a resolution. Stark received a phone response the same day, and a Martin Engineering Field Supervisor scheduled a site visit for Saturday, during which he visually assessed the situation.

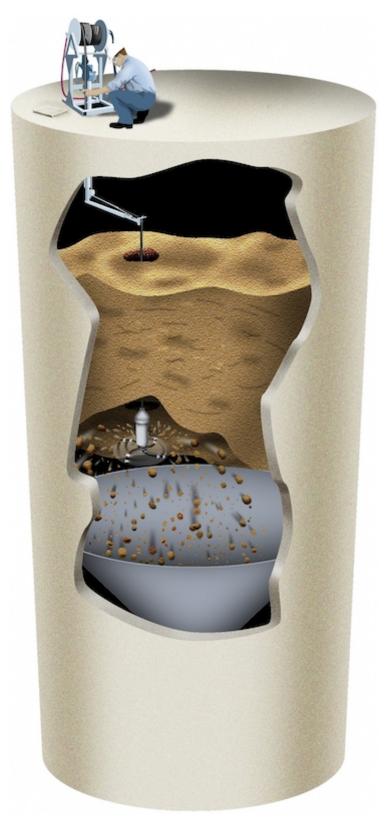
Utilisation of the heavy duty whip in a clogged silo avoids the need for personnel to enter the silo.

The Martin heavy duty whip is a portable, remote-controlled tool that can be lowered into storage containers through a manhole opening. Powered by compressed air, the patented motor can use a variety of different flails and cutting edges to knock down accumulated material without damaging storage vessels. Abrasion-resistant steel chain is best suited for most applications, with non-sparking brass chain for combustible materials. Urethane flails can also be employed to protect lined vessels that could be susceptible to damage from metal tools.Martin's top-access cleaning technology eliminates the need to send a man inside a storage vessel and risk potential injury. The equipment is set up outside the silo, and it's portable enough to maneuver around various bin sizes and shapes.The modular boom of the Whip extends up to 28 feet (8.5 meters) and can clean vessels up to 60 feet across (18 meters) from a central opening of just 18 inches (450 mm) in diameter. The air hose is protected with double wire braid, and the pneumatic motor delivers powerful cleaning action from the rotating head to remove buildup.

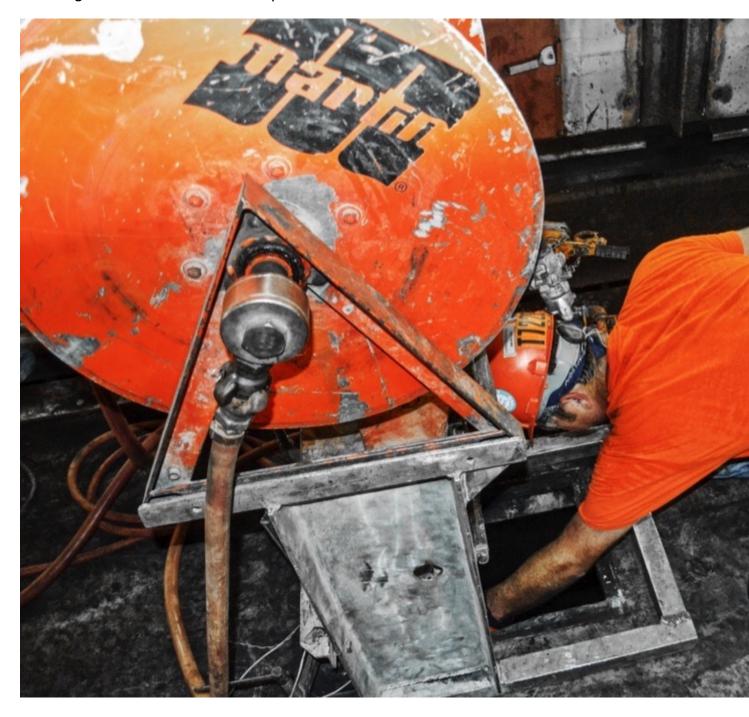
The drive of the whip is installed on top of the silo. It works through a 450 mm diameter hole.

The technicians secured the equipment over an access hatch at the top of each vessel at Commercial Acres. Though all Martin silo cleaning crews are OSHA and MSHA certified for confined space entry, they instead used remote control from outside the bin to safely guide the cleaning head. The 2-man crew lowered the whip through an opening in the blockage, starting at the bottom and undercutting the material as they worked their way up. In most cases, the technique allows material to be recaptured and returned to the material stream, and Stark was able to salvage the entire 40 tons of cementitious product removed from the silos. The entire process required just a one-day outage for the service. The silo restoration will include removing all internal horizontal supports, pulling all sidewalls back to their original flat position, then replacing the horizontal bracing and adding further dimensional support. Exit feedback from Stark management was a clear indication of the company's satisfaction with Martin Silo Services, which helped the facility quickly resolve a difficult issue and prepare for the required repairs as soon as possible. The report showed work was completed in a safe and timely manner, precisely on the predicted schedule.
