## **Bag House Operation Problems: Failure Patterns, Problem Identification and Solutions**

[Published in bulk solids handling, Vol. 34 \(2014\) No. 2](#)

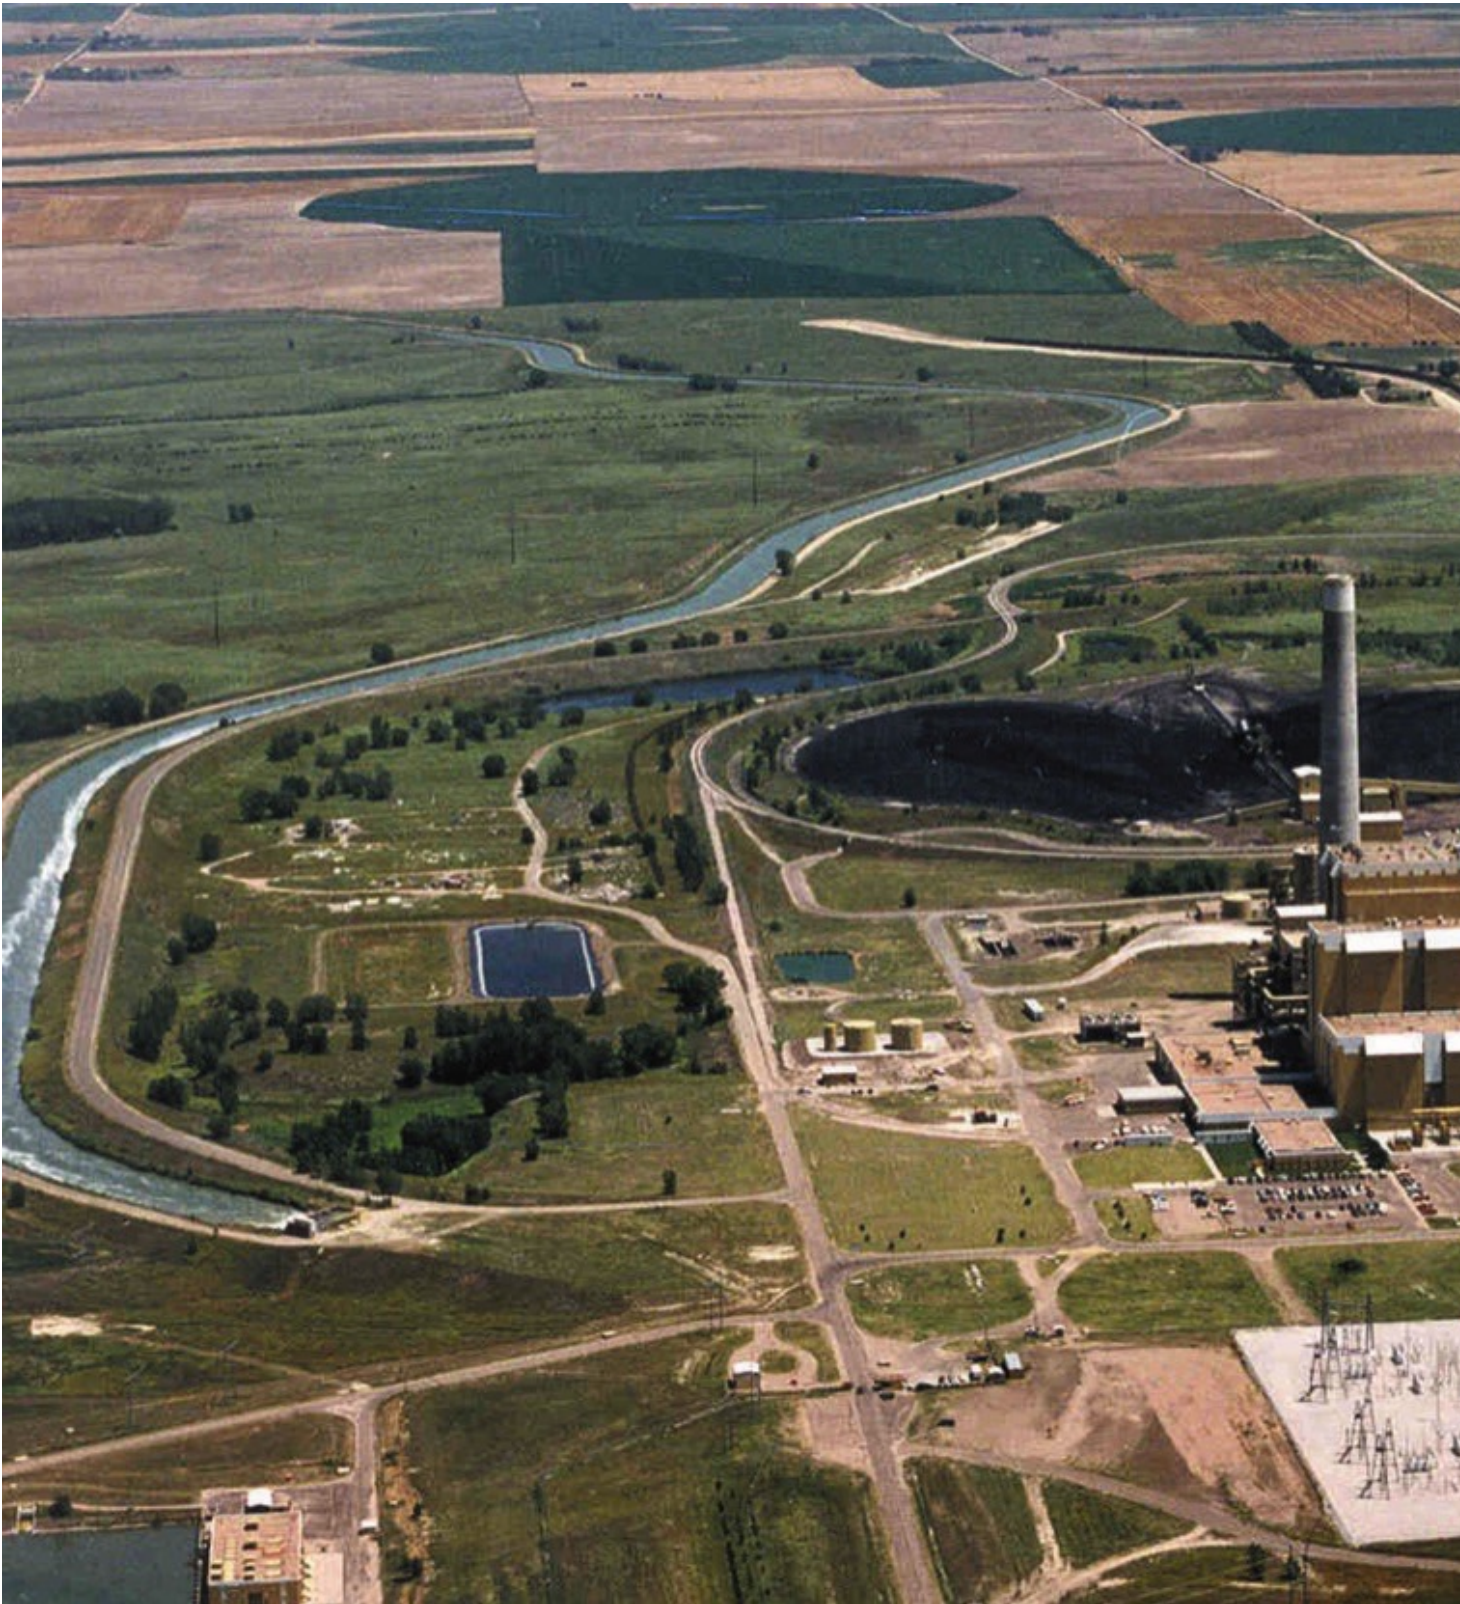
Fig. 1: Today, bag filters find increasing attention also for the filtration of solid fuel power stations. (Pictures: ©Evonik Fibre GmbH)

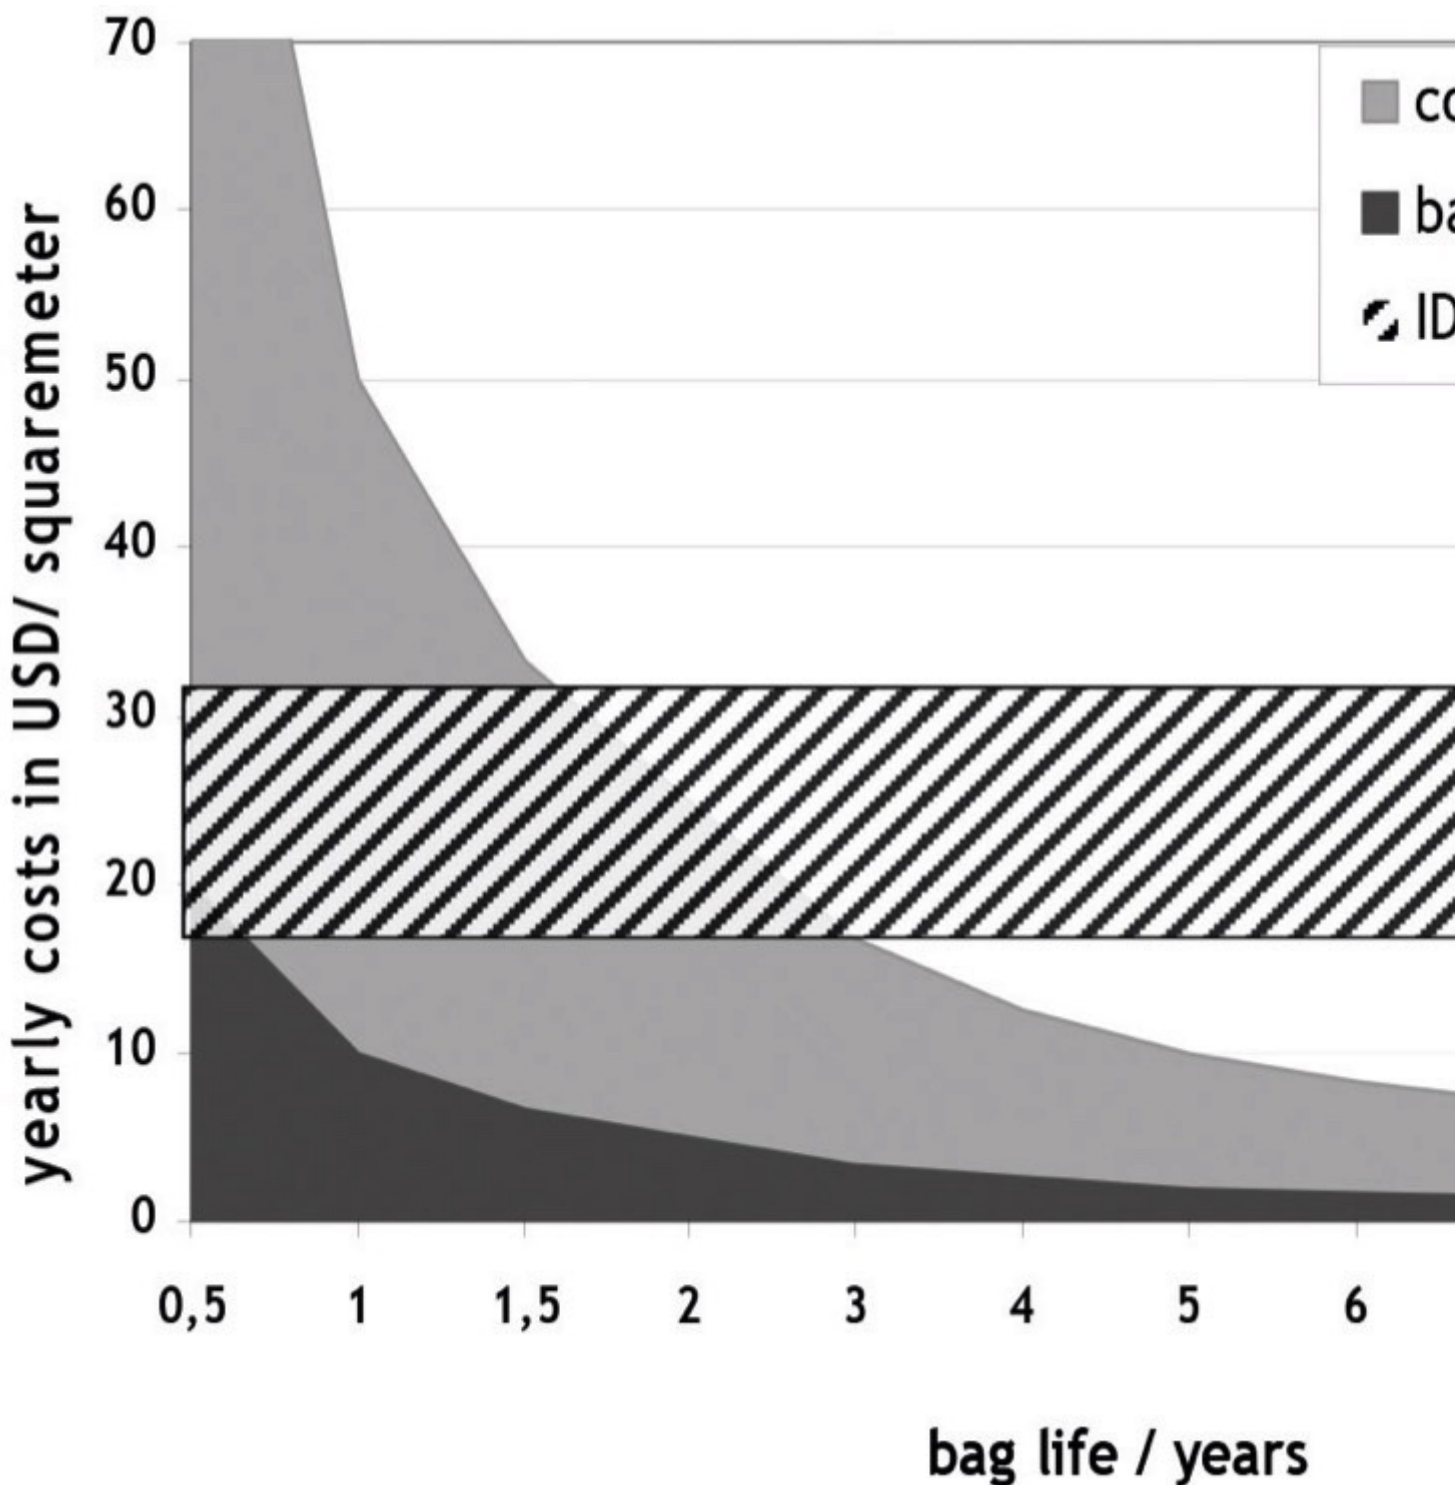
Fig 2: Major bag house operating/maintenance costs.

The operation of a bag house results in expenses for fan power, pressurised air and bag material as well as cost for manpower and the loss of production during maintenance. Bag costs are typically the most obvious and therefore best evaluated cost factor as it is a big investment at the start-up and at the time of complete replacement. In fact it is typically just number 2 after the fan power. With its effect on all other operating costs the choice of bags has to be made properly, including the evaluation of its effect on other costs. In Fig. 2 the operating costs for a bag house are displayed, split in cost for new bags, bag change and disposal and ID fan power. Major differences and therefore a wide range of each single cost factor has to be considered for different applications and bag house layout.

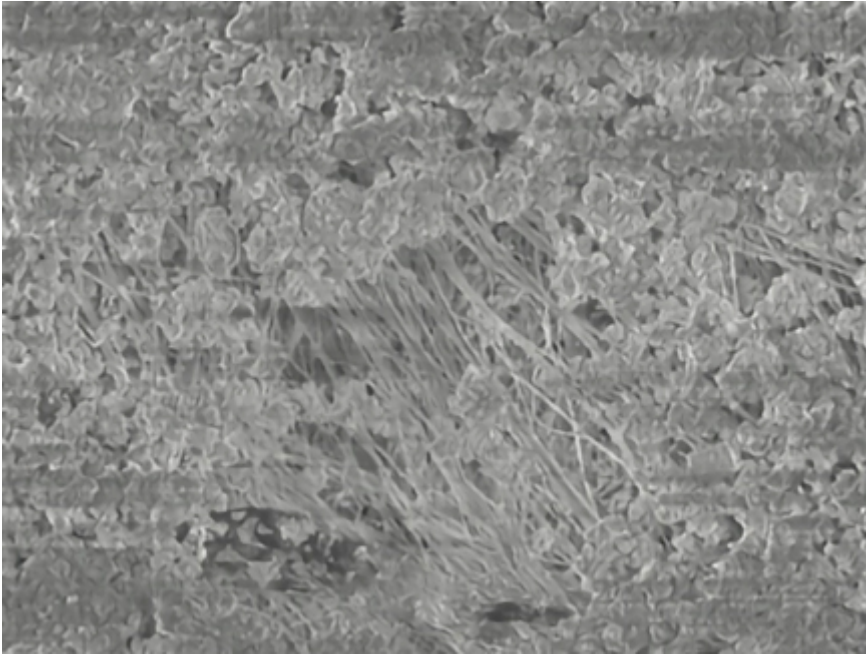
Fig. 3: SEM-picture of a dense dust cake (ammonia salts) on a membrane.

Some dust components may result in a dense blocking layer. One example is ammonium sulphate. The particular problem is that salts decompose at temperatures around 300°C and crystallisation takes place on the filter media. This results in much stronger bonding between dust and filter material than from inert dust. Membranes appear to have a more pronounced susceptibility in this regards, leading to immediate and permanent problems with increased pressure drop. **Operating conditions** Excessive humidity, (if condensation takes place) can cause sticky behaviour of dust. Condensation in capillary, like between particulate, takes place above the dew point, hygroscopic dust properties further increase the critical temperature. Below a certain humidity the pressure drop will also increase (just slightly, typically without reasonable problems) as binding forces between particles are reduced without contribution of monomolecular water layers on the surface.

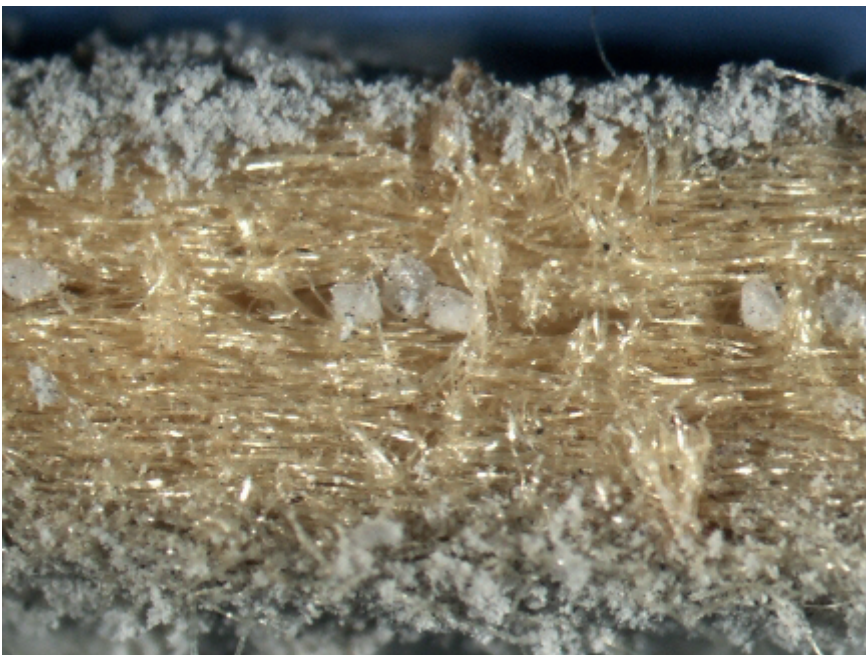
Fig. 4: Contamination from the clean gas side.

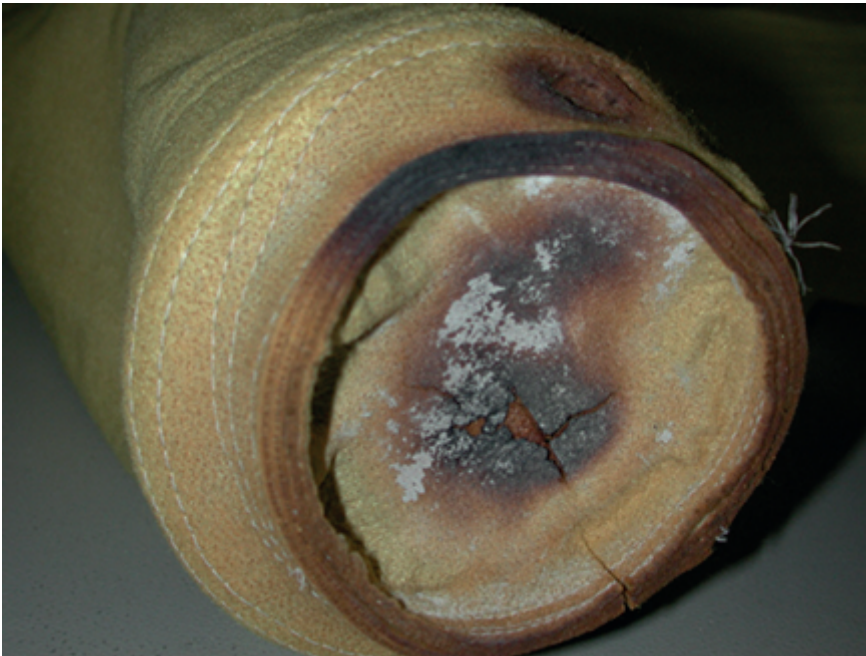
Fig. 5: Shrunk bag bottom as a result of high hopper dust levels.

**Shrinkage or elongation - excessive temperature:** Short time temperature peaks do not cause a high degree of chemical damage to fibre material but rather influence its dimensional stability. Depending on fibre material and load during operation shrinkage or elongation is typically experienced. A locally pronounced failure can be observed if high hopper levels result in locally high temperatures at the bag bottoms. Elongation due to peak temperatures above the material limit can result in folds and mechanical wear as shown later on.

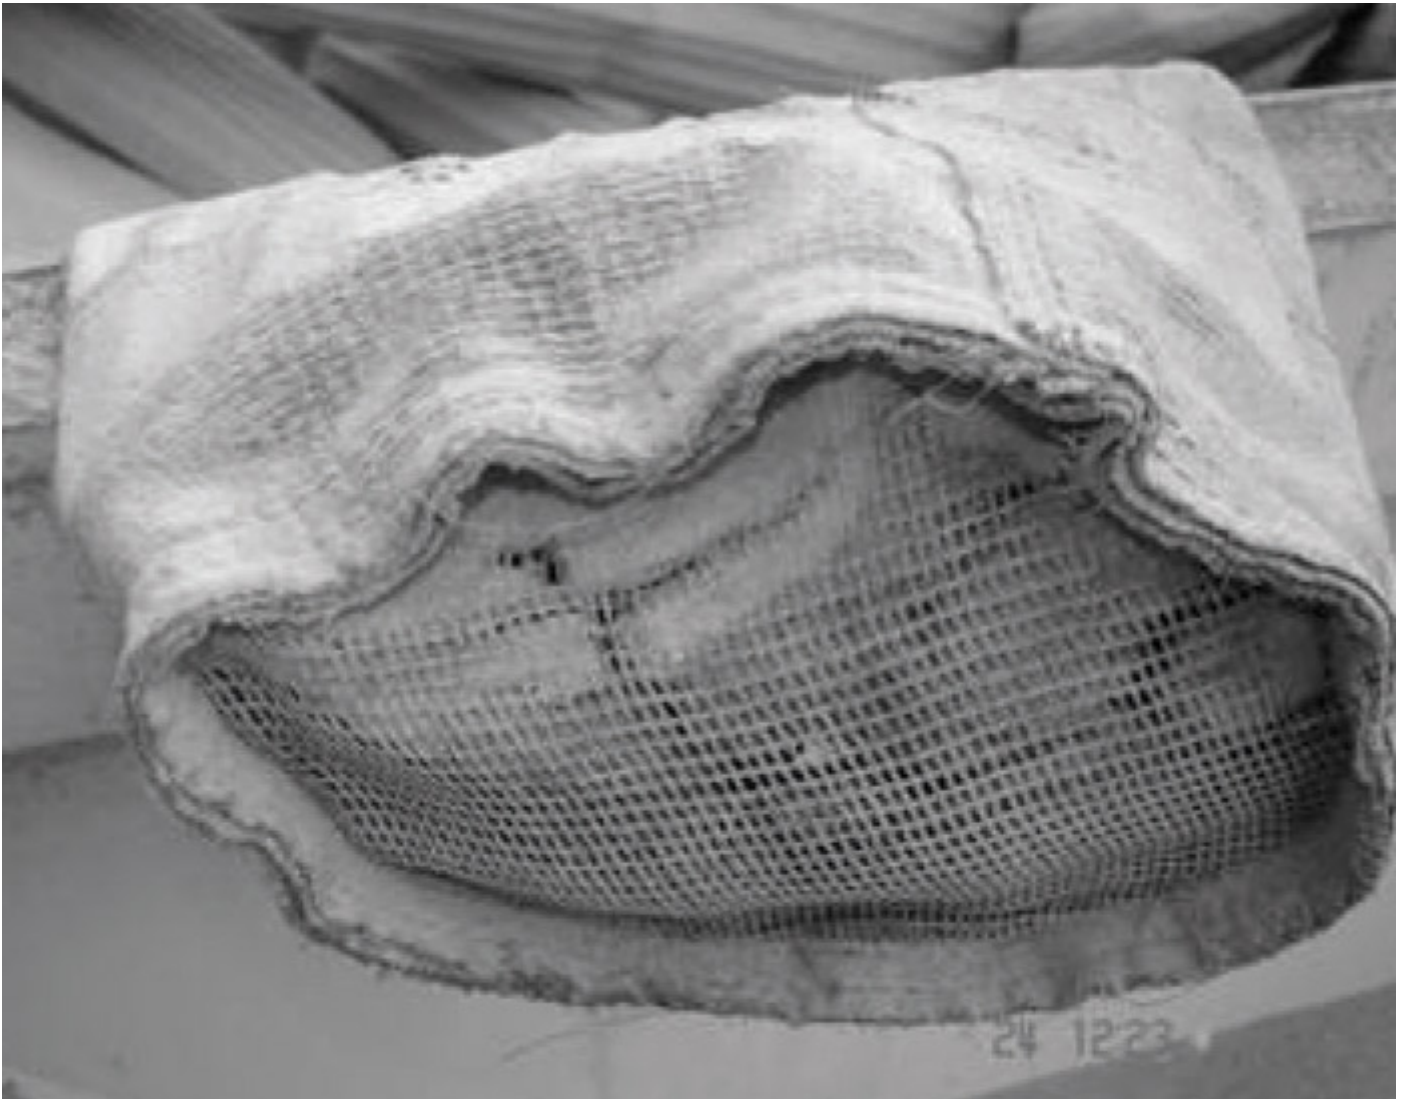
Fig. 6: Abrasion of the entire felt from the supporting scrim due to high local gas velocity.

**(Excessive) mechanical wear:** This may be due to abrasion from locally high gas velocities. Locally high gas velocity and re-entrainment of dust from the hopper is resulting in abrasion of the bag material. Even some bag materials show lower susceptibility against abrasion adaptations of the flow distribution are the only way for stable operation of the filter in this case. Abrasion from pulsing is often observed as secondary failure pattern when dust from the clean gas plenum is blown into the bags during pulsing. Abrasion starting from inside close to the bag top end is indication.

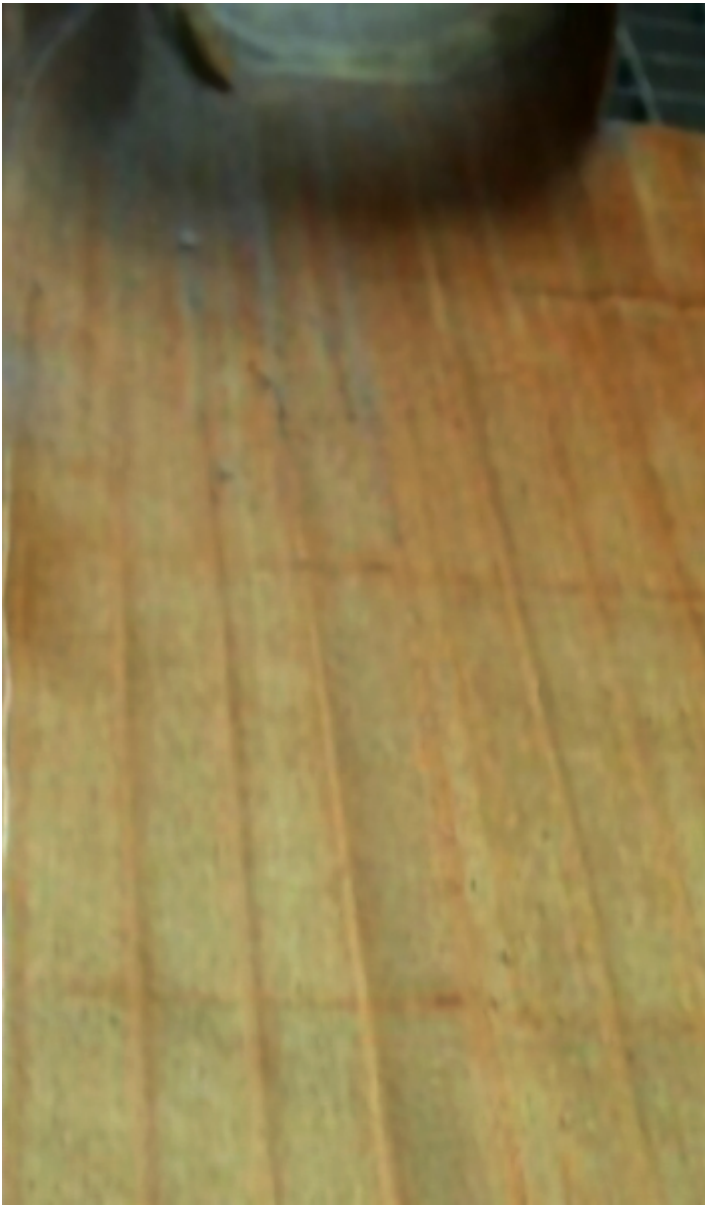
Fig. 7: Rust in the top section of a bag (left) and in a cross section through the felt (right).

Pronounced asymmetric appearance may indicate wrong adjusted cleaning valves/venturis. Red-brownish discolouration of the bag top section from rust is an indication for corrosion (e.g. as a result of condensation) as cause for abrasion from rust. Condensation may be the result of a cool-down below the (acid) dew point during pulsing, leakage due to improper sealing or insufficient insulation (Fig. 7) **Abrasion along cage wires:** Damage along cage wires is typically experienced when the cages are damaged or corroded, or after bag-to-bag or bag-to-wall contact due to misalignment of cages (Fig. 8). **Mechanical wear along folds:** Holes may also result from increased mechanical burden close to a longitudinal fold (e.g. oversized bag). Elongation in cross direction during operation has also to be considered for a misfit of bags on cages. (Fig. 9)

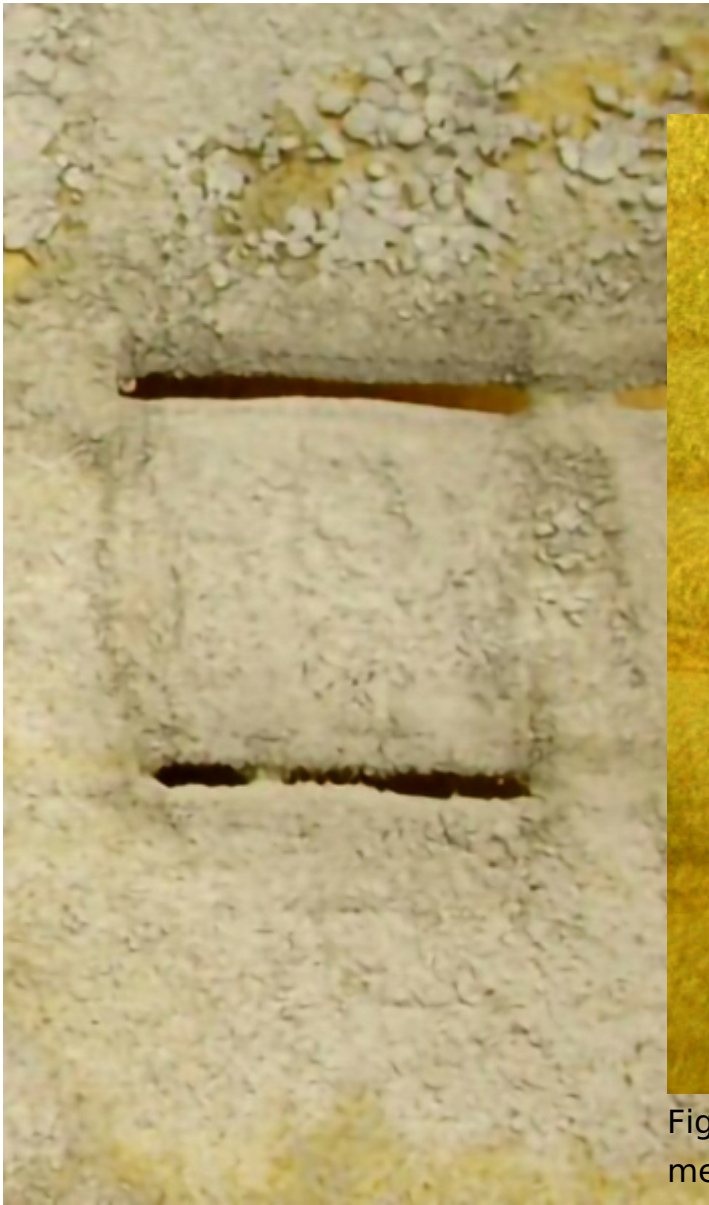
Fig. 8: Hole along cage wire uncleaned (left) and cleaned (right).

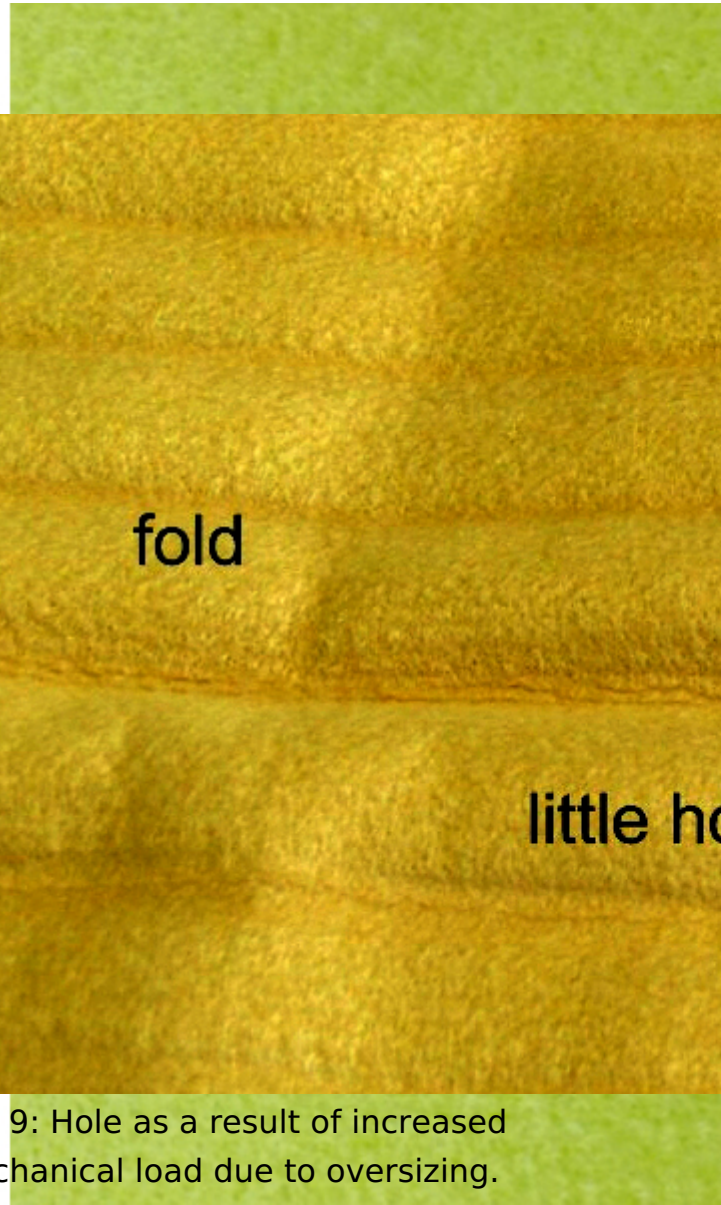
Fig. 9: Hole as a result of increased mechanical load due to oversizing.

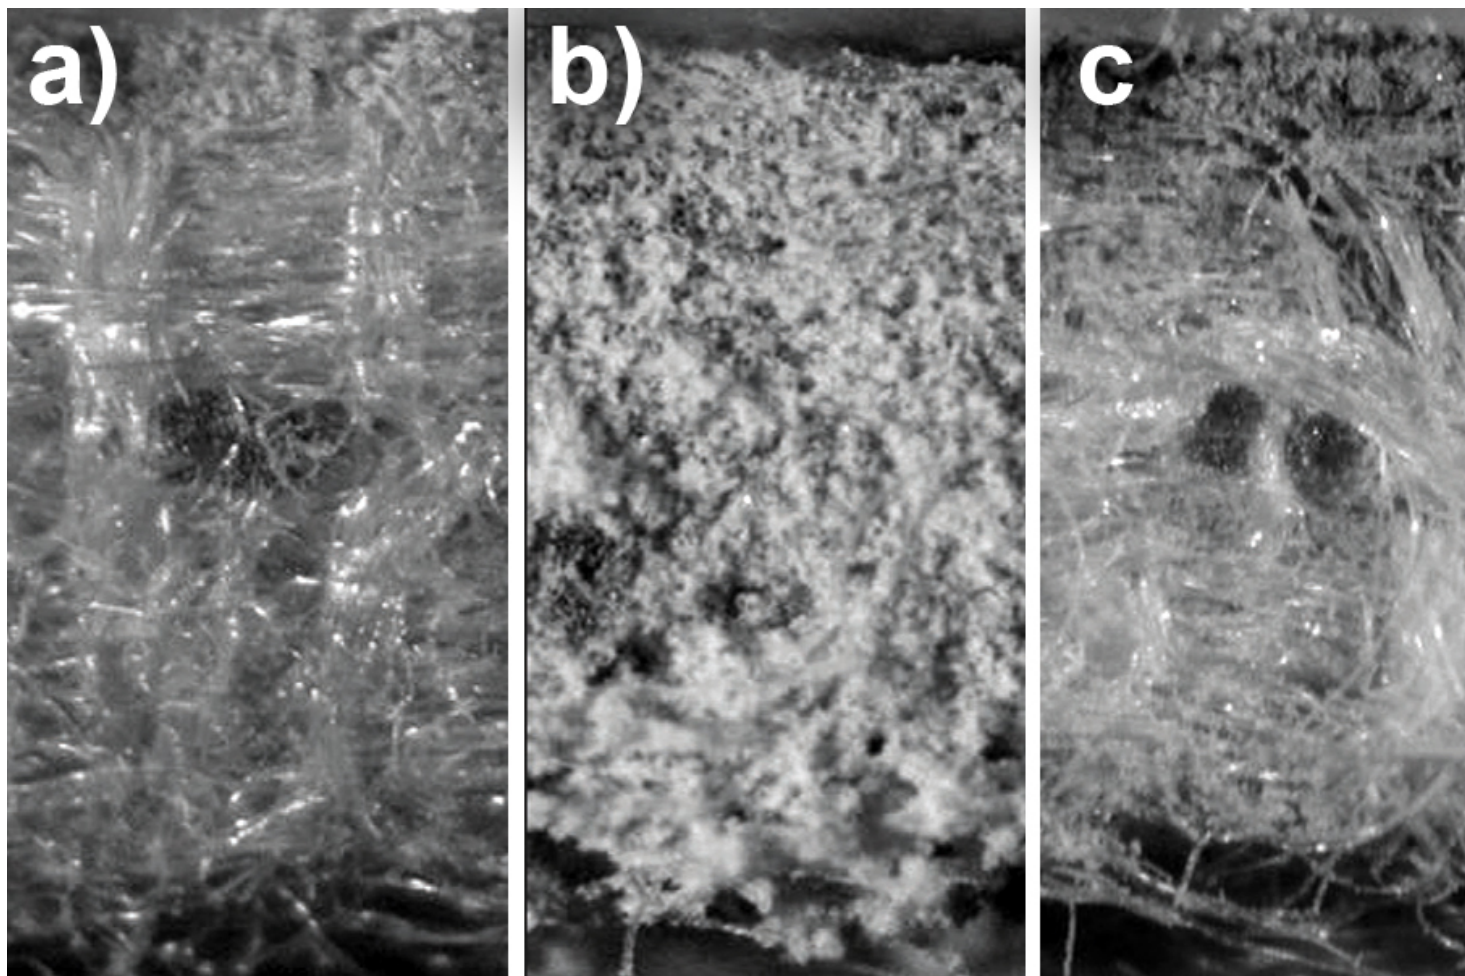
**Typical Failure Pictures (Fig. 11)**

Fig. 11: Comparison of different filter material constructions and examples for their failure: a) needle felt with good surface filtration, b) needle felt with dust penetration, c) membrane on needle felt, d) membrane on glass fabric.

**Needle felt:** Penetration of dust into the felt is typically resulting in increased pressure drop. Totally penetrated felts like displayed in the right picture show increased emissions. Needle felts which are constructed to meet the demands of a particular application can ensure high filtration efficiency on a long term. The bag life is typically limited by mechanical and chemical ageing of the fibre material.

**Membrane on needle felt:** After membrane damage dust accumulates behind the membrane, resulting in increased pressure drop. Increased cleaning pressure to release the membrane is a way to overcome acute problems with blocking, the needle felt has to overtake filtration afterwards.

**Membrane on glass fabric:** The open scrim does not favour clogging after membrane damage but rather penetration as it does not offer sufficient filtration efficiency for pulse jet applications.

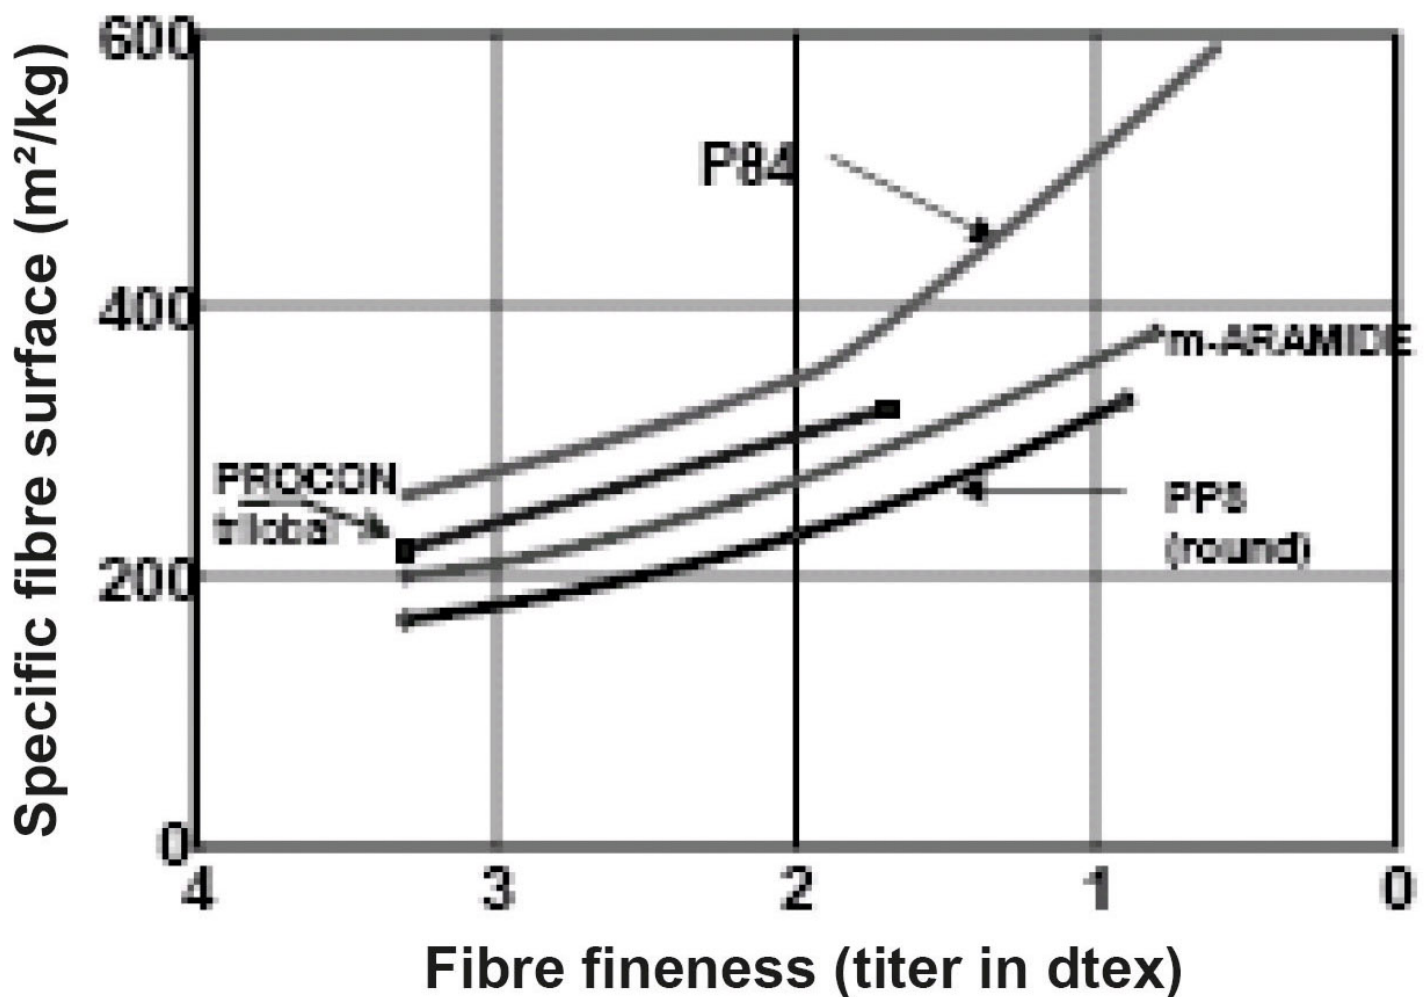
Fig. 12: Specific surface of different fibre materials.

One of the main challenges in today's filter construction is to improve the efficiency of the filter materials. Ways There are different solutions to fulfill this task and to prevent dust from penetration into the felt. The implementation of fine fibres increases the fibre surface and decreases pore size. Blends of different fibre titres on the one hand make it possible to use finer fibres than processible on their own (during felt production) and on the other hand result in derived, narrow pore size distribution. The use of structured fibre cross section: trilobal and multilobal fibres increase the fibre surface (when the felt weight is kept constant). Fig. 12 displays the specific surface of different fibre materials depending on the fibre titer. In addition low velocity areas exist between the lobes of the fibres where dust can be accumulated without an increase of the differential pressure drop.
