White Paper

## **Why new Splices fail - Splice Failures resulting from Rubber Compound Incompatibility**

[Published in bulk solids handling, Vol. 37 \(2017\) No. 4](#)

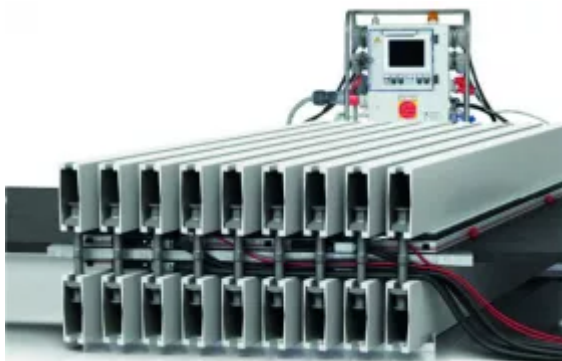
Fig. 1: Hot vulcanising press

Vulcanising presses have become more efficient and advanced, offering better control over the splicing process. Heating and cooling times have been greatly reduced.

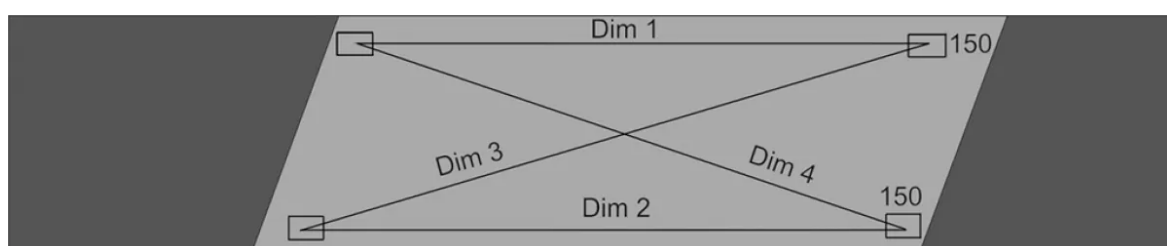
Fig. 2: Splice measurement matrix as per SANS

1. Permanently embossed marks shall be placed on the inside four corners of the splice on the bottom cover according to Fig. 2.
2. The sum of the dimensions shall not change by more than 1 %. The base line initial measurements shall be made on the low tension return side of the conveyor when the belt is under tension at a recorded datum point and always re-measured at the same datum point and under the same tensioning conditions.
3. Initial measurement to be done by splicing constructor.
4. Should the tensioning conditions change, a new set of base line dimensions shall be established.

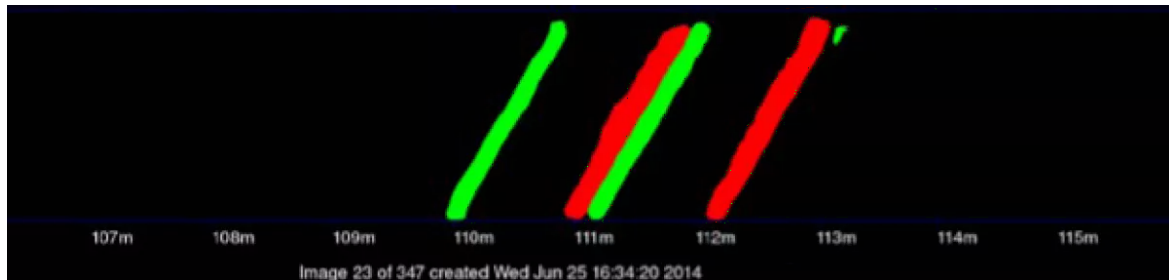
Fig. 3: Typical representation of a splice on a steel cord reinforced belt, by means of magnetic flux leakage scan

In the magnetic flux leakage scan image, the cords are magnetized and any leakage in the magnetic flux is detected by sensors mounted in a sensor array.

The image in Fig. 3 is of a two-stage splice showing no deformation in the splice alignment or stray and damaged cords in the splice area (Fig. 4).

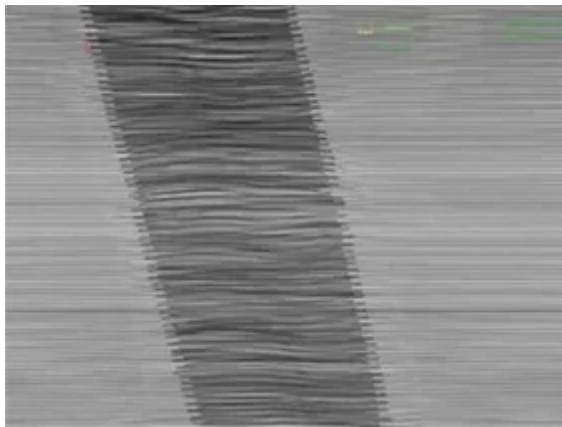
Fig. 4: Typical representation of a splice on a steel cord reinforced belt, by means of a X-ray scan

X-ray scanning is however, not cost effective and does have some safety concerns linked to it. With the recent advances in the accuracy of magnetic flux leakage scanning it is possible to obtain a very accurate representation of the splice and it is possible to determine small deviations within the splice. The systems can also be permanently installed on the structure with the added benefit of offering a full belt scan to determine the condition of all the cords within the belt.

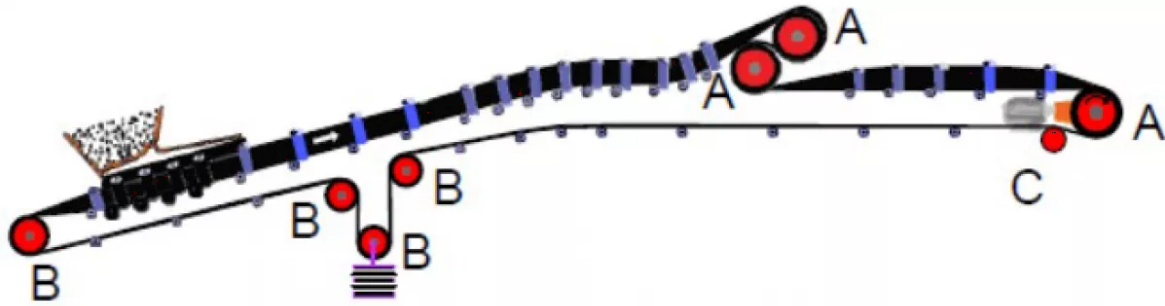
Fig. 5: Conveyor system indicating positive and negative bends in short succession at pulleys A-C and at A-A

Further research is required on the effect of positive and negative bending of splices, different types of splices, including the effect of the frequency of bends on a splice, for instance at the head and snub pulley, or from a high tension snub pulley into a drive pulley. The specifying of a minimum relaxation distance between two bends in opposite directions should be investigated and documented (Figs. 5 and 6).

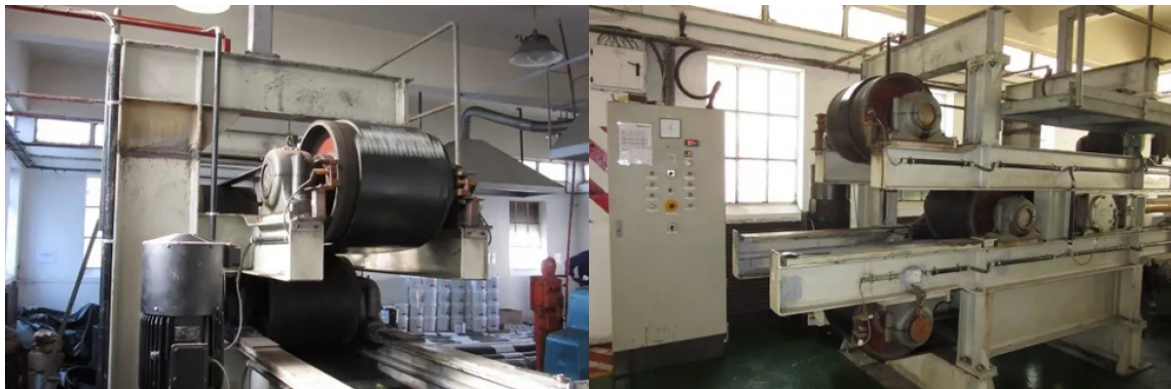
Fig. 6: DIN dynamic splice testing equipment

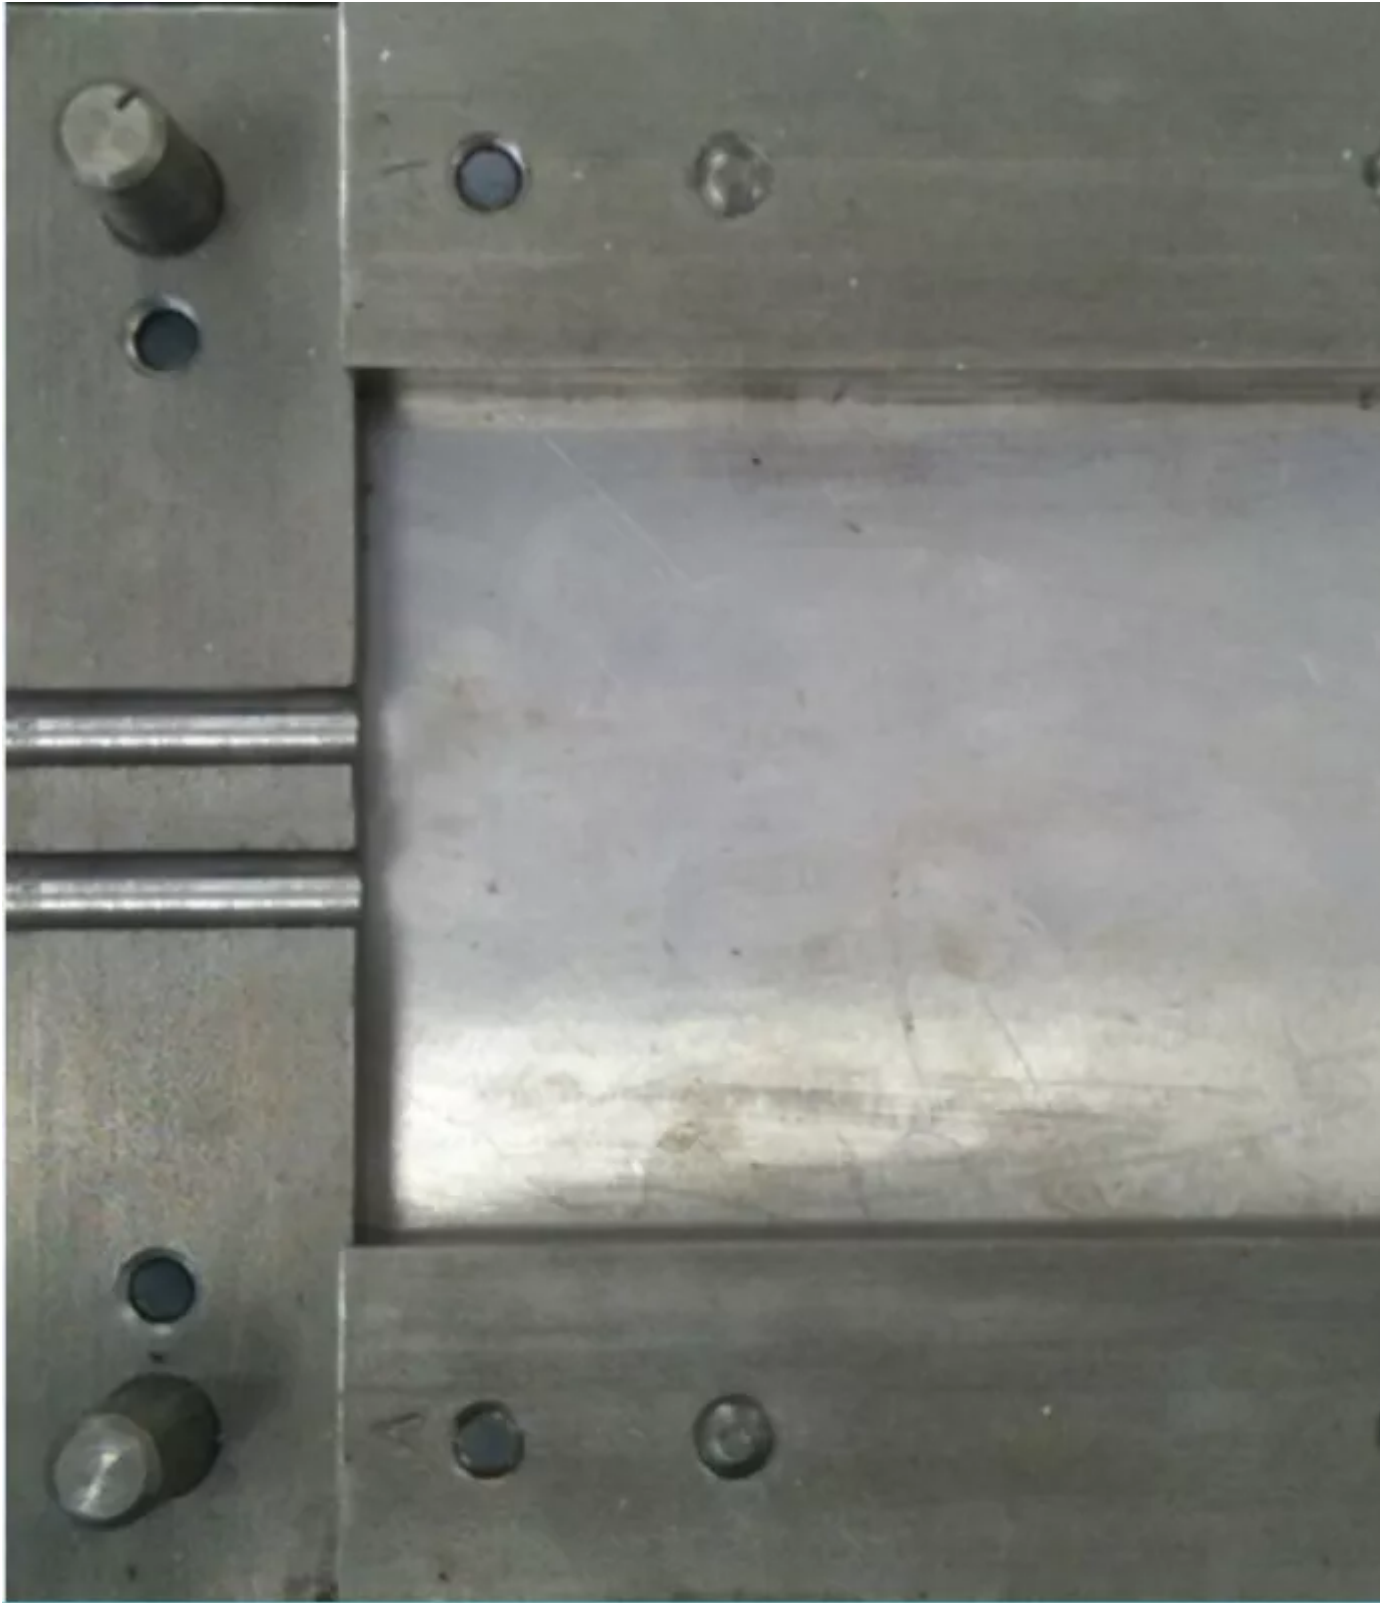
Fig. 7: H-block mould

Compatibility of splicing material and belt is assessed by testing the adhesion of the splicing material to the aged belt cords. For this purpose the preparation of an H-block test piece is required (Figs. 7 to 11).

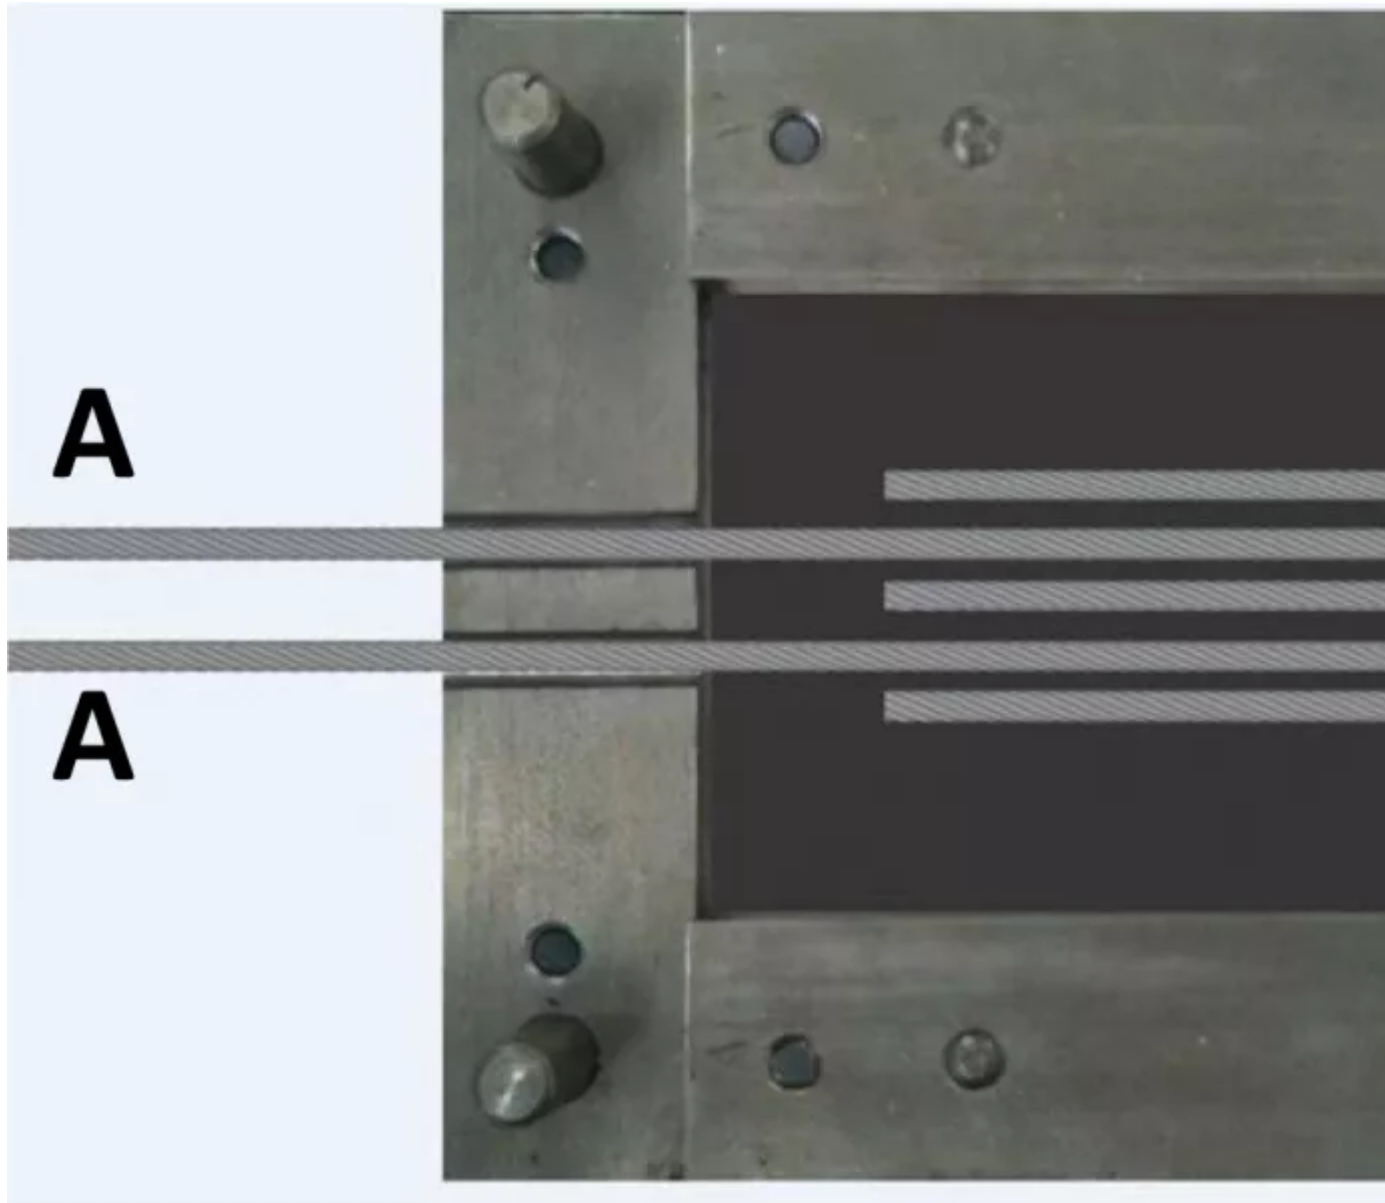
Fig. 9: H-block assembly

Two H-blocks are constructed by using cords from belt A either side of a cord from belt B. (A,B,A,B,A) and two H-blocks constructed by using cords from belt B on either side of cord from belt A (B,A,B,A,B).

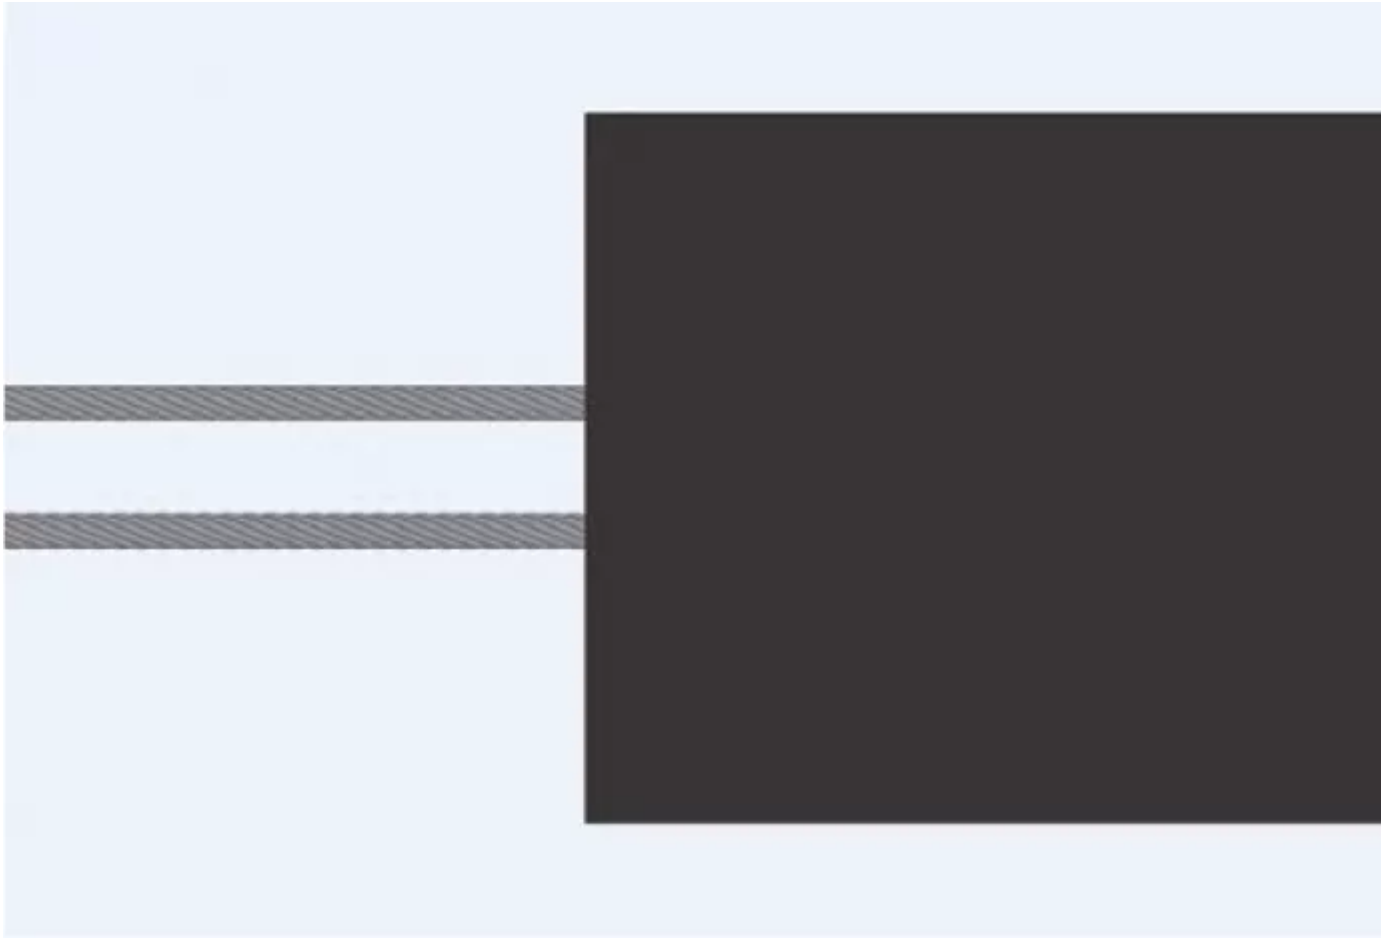
Fig. 11: Completed H-block

The H-block consists of three cords vulcanised in a splicing material rubber matrix. A minimum of four H-blocks are required for testing.
