Case Study

## **GKD: Sewage Treatment Plant enjoys greater Planning Reliability for its Belt Press**

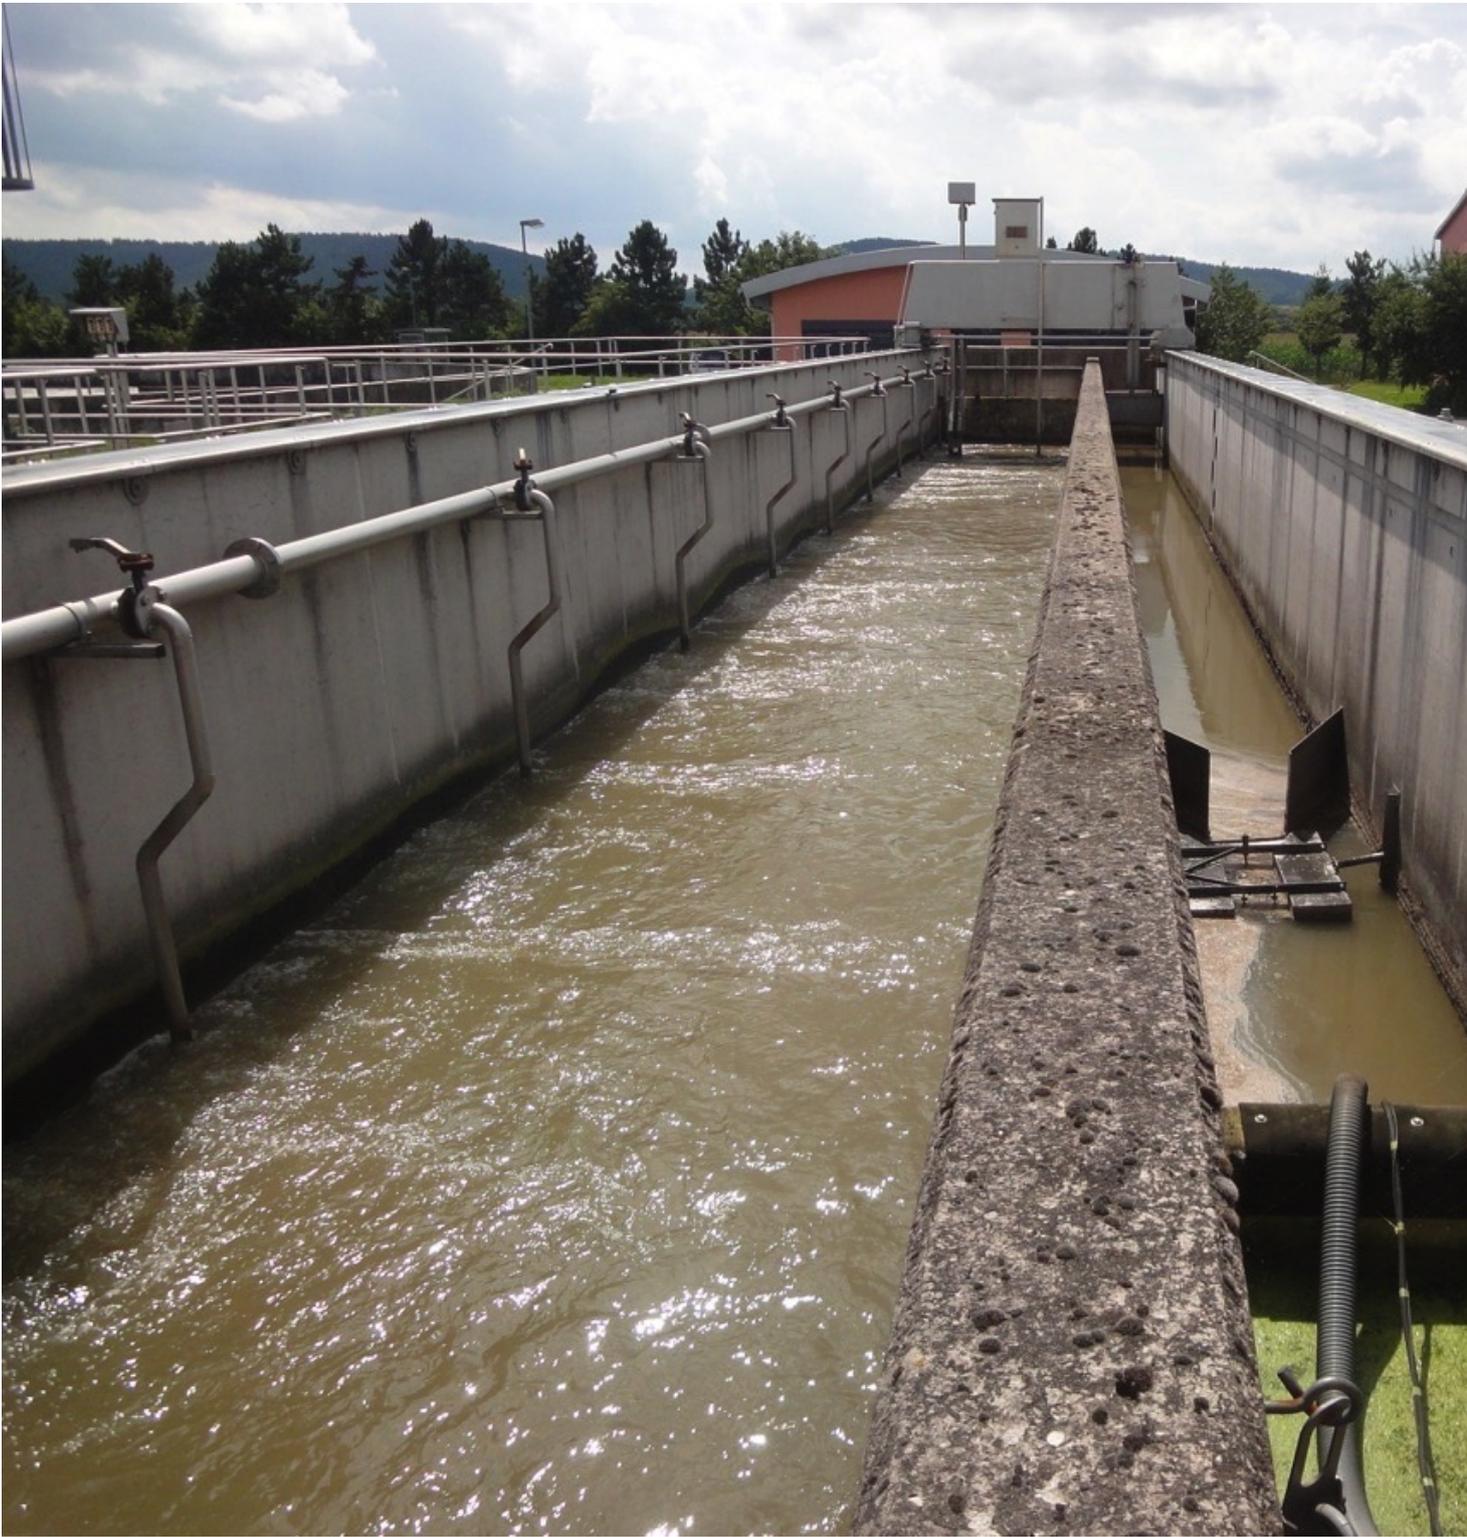
In the sand trap any sand in the material is released, washed and dewatered, allowing it to be used as backfill material in ditch and trench digging operations. (Picture: ©GKD)

At the four plants, mechanical cleaning is initially performed using a rake system with screw compactor for dewatering the raked material. In the ventilated sand trap with sand washer, any sand in the material is released, washed and dewatered, allowing it to be used as backfill material in ditch and trench digging operations. At the same time, light substances such as oils and greases are removed here.

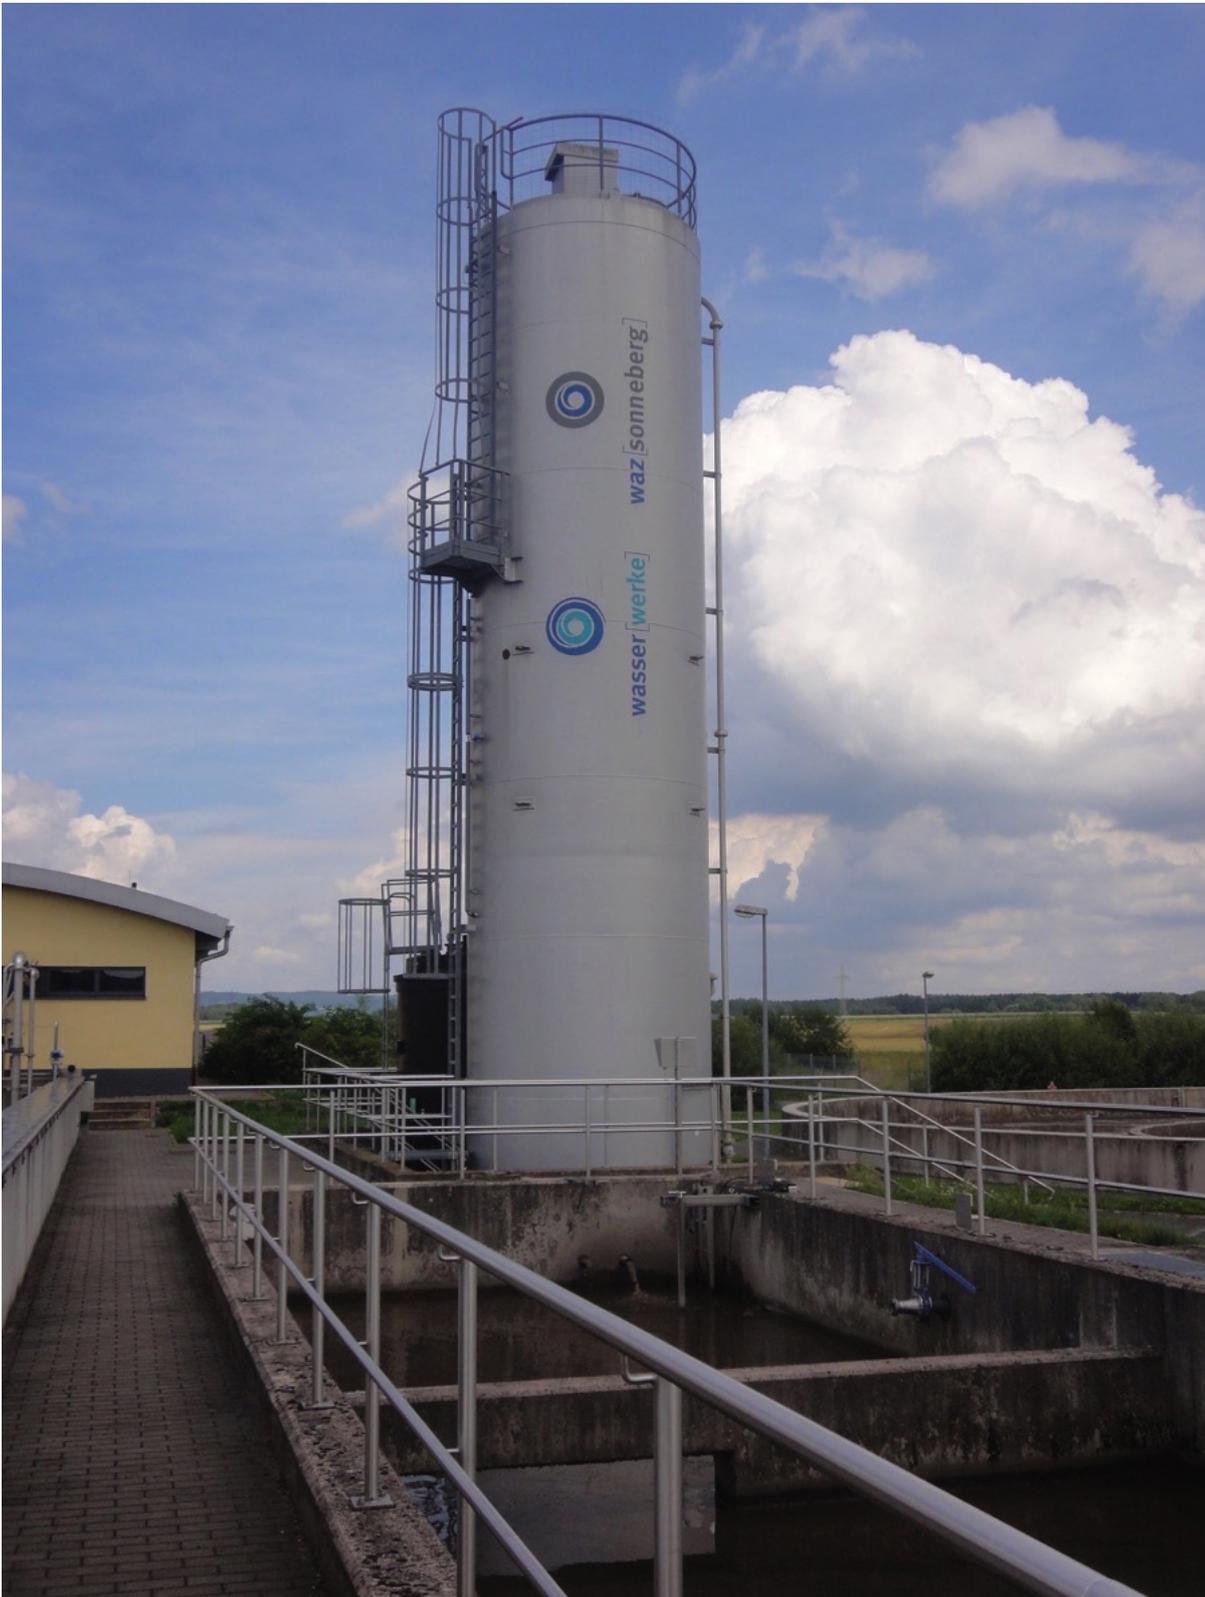
Lime hydrate must be added to the wastewater due to the very soft nature of the water in Sonneberg. (Picture: ©GKD)

bacteria and associated formation of bulking sludge stimulated by the large volume of fecal sludge. In two aeration tanks, designed as circulation basins measuring 95 meters in length and boasting an effective volume of 13,540 cubic meters, the nitrogen contained in the waste water is removed and the sludge aerobically stabilized. A blower station with five rotary piston blowers guarantees pressure ventilation of the basin. Two blowers supply each basin, while the fifth serves as a reserve unit and is also used to cover peak loads. The blowers are operated intermittently. The organic carbon is removed and the nitrogen nitrified during the ventilation phases. Denitrification is performed in the non-ventilated phases. To stabilize it, lime hydrate must be added to the wastewater in the second phase of the selector basin due to the very soft nature of the water in Sonneberg. It is metered from a 70 cubic meter lime silo that is heated in winter.

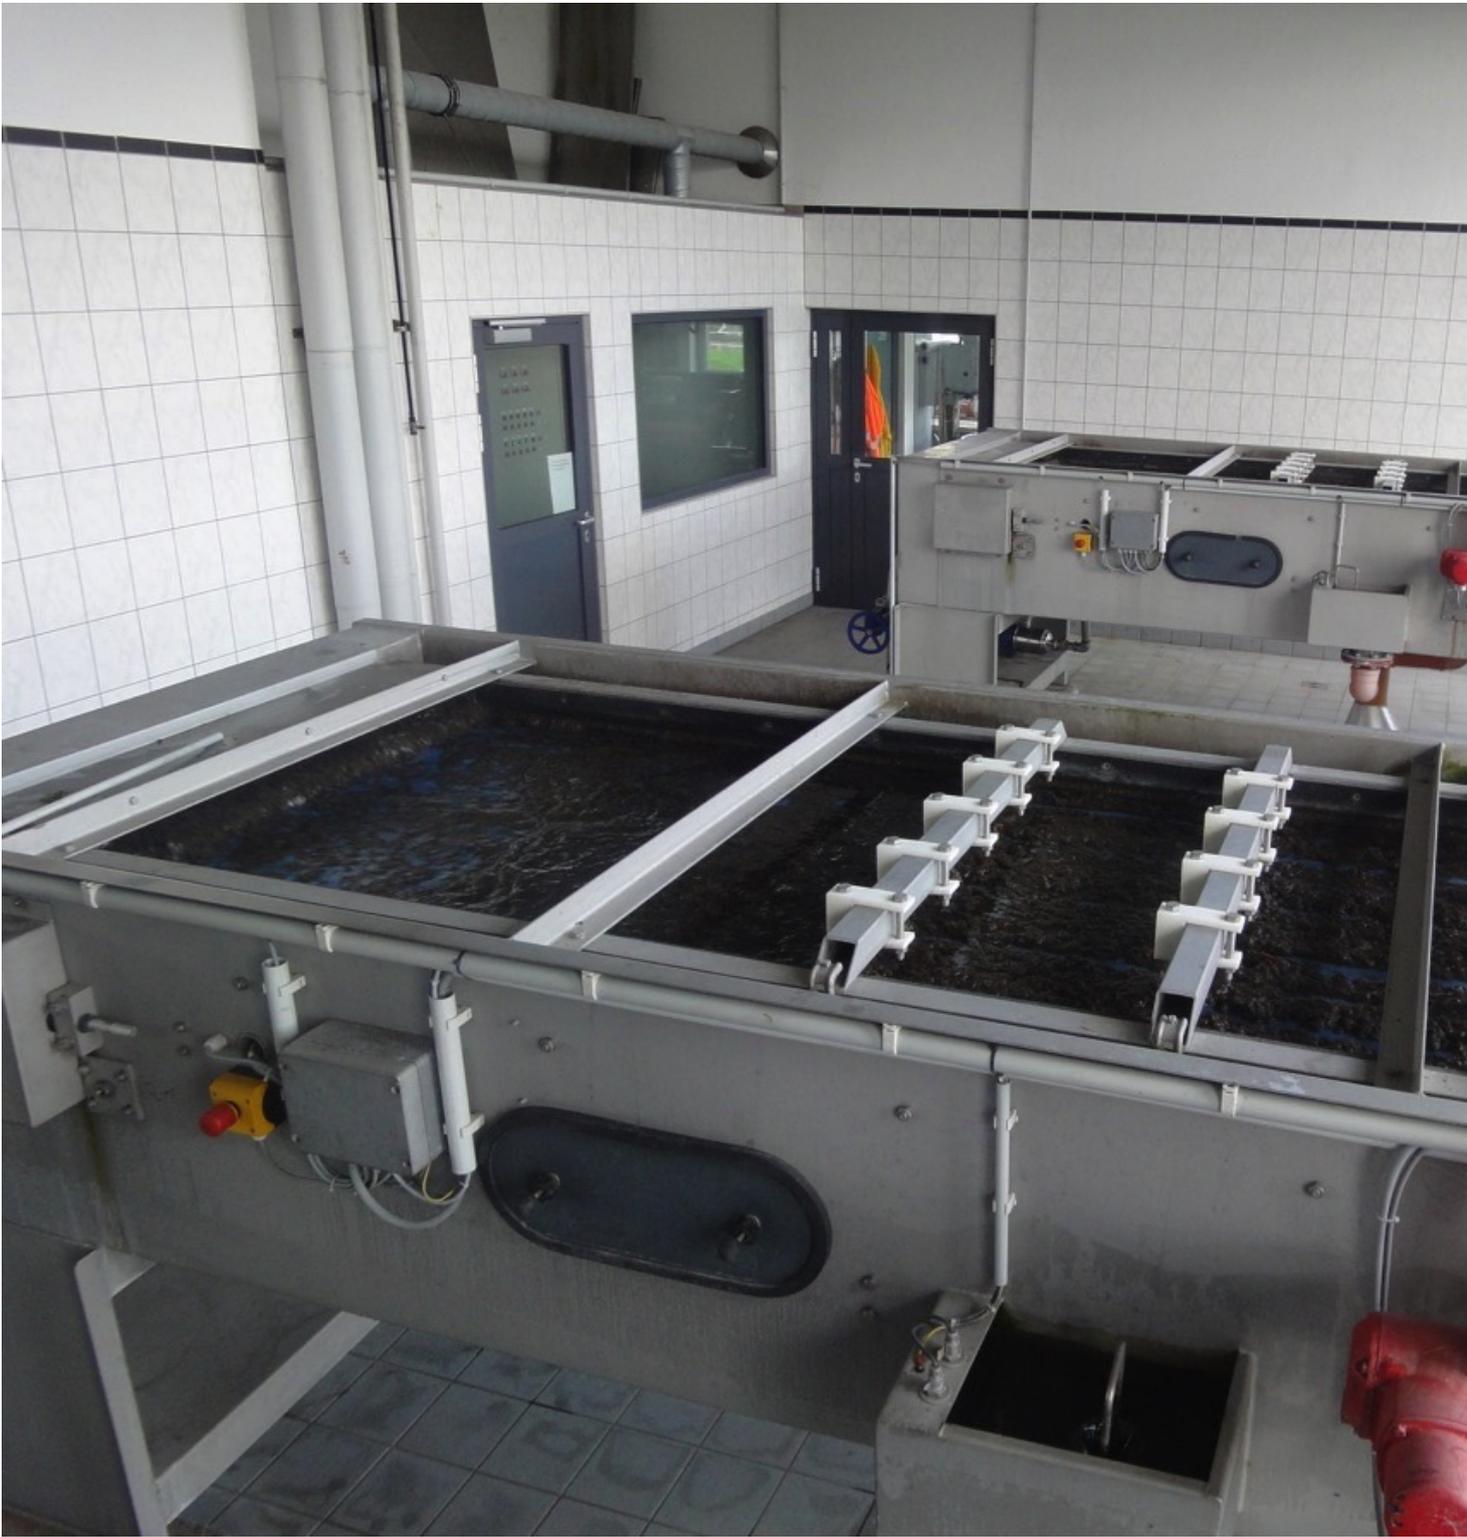
Two belt thickeners with continuously circulating Type 5060 GKD filter belts increase the solids content of the surplus sludge from 0.75% TS to around 5% TS through the addition of flocculant. (Picture: ©GKD)

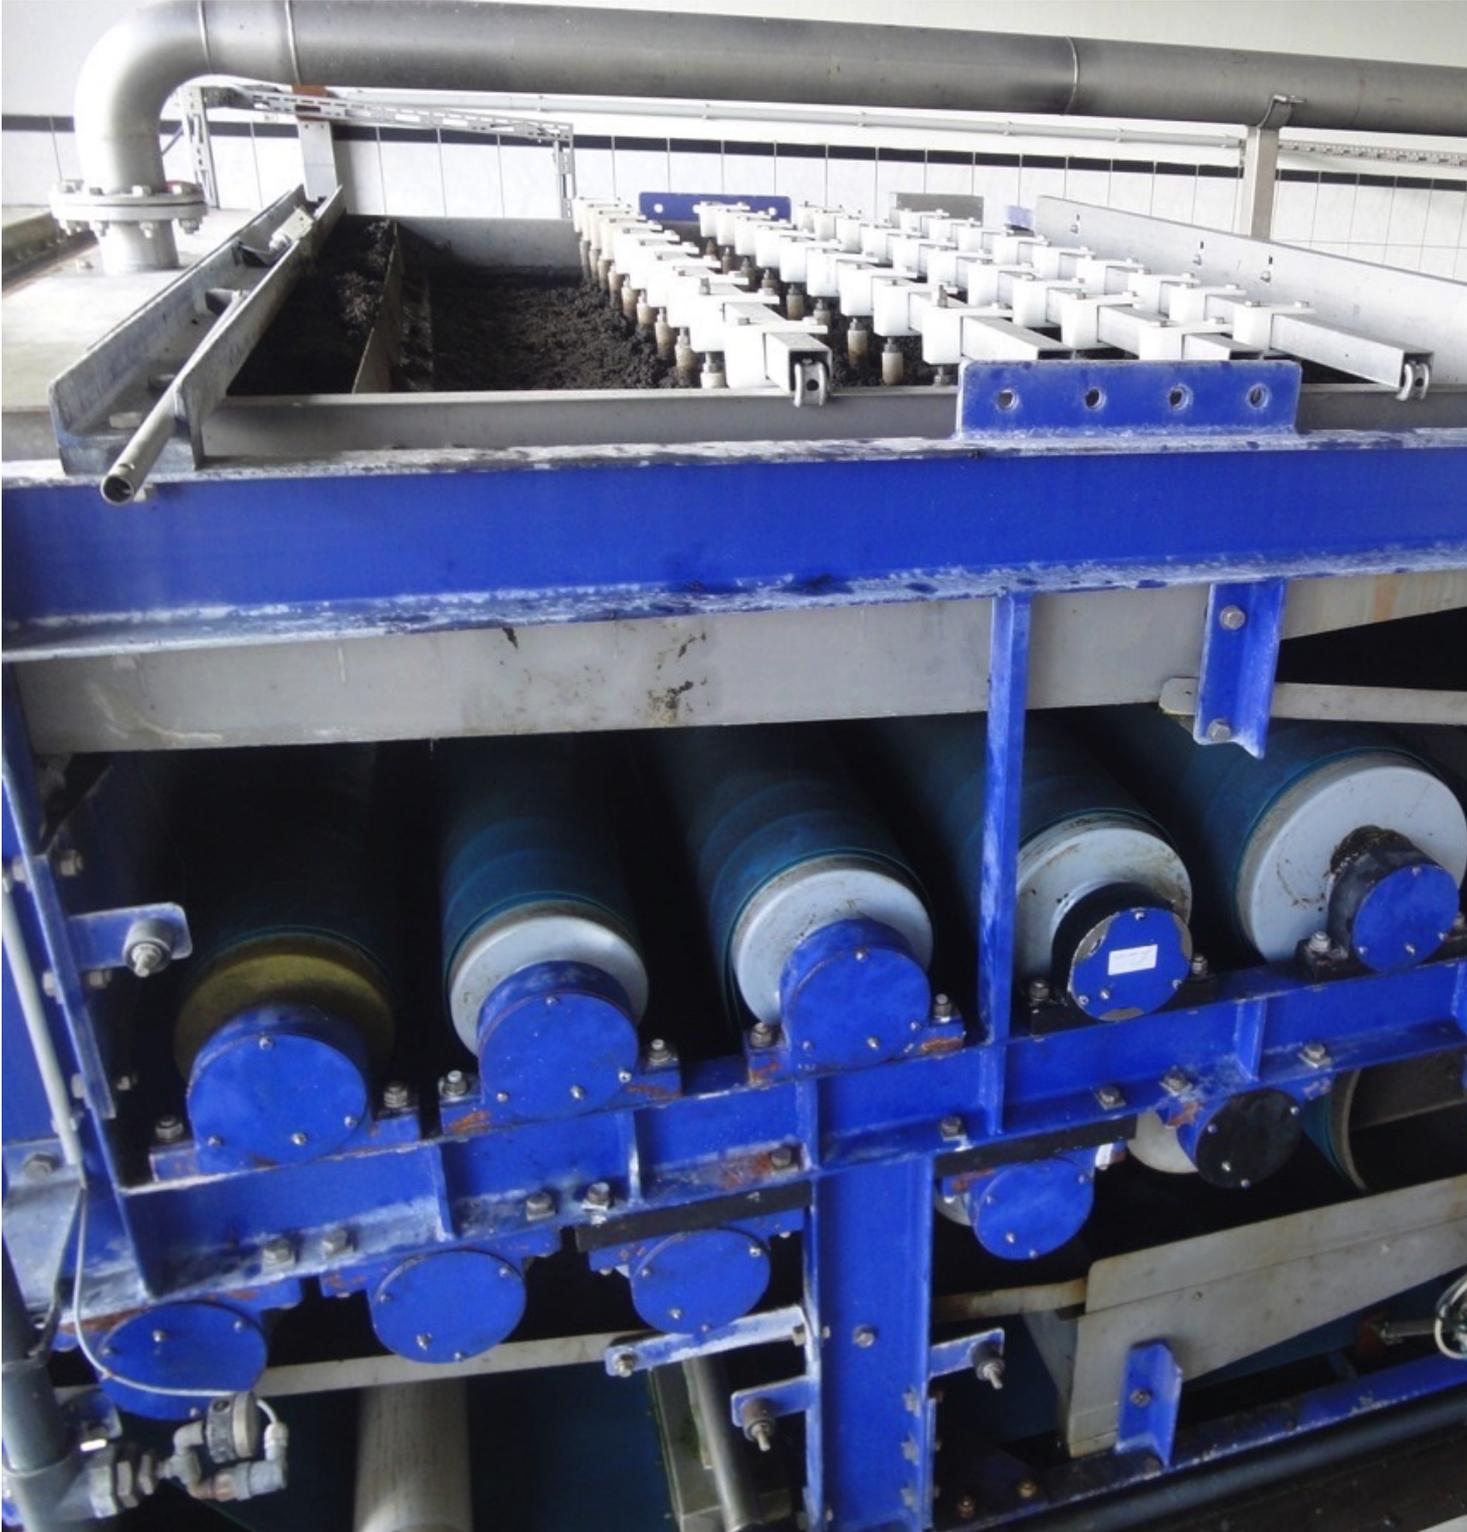
The belt press is fed directly from the thickener, so around 160 cubic meters of sludge is dewatered per day.

The belt press is generally fed directly from the thickener, so around 160 cubic meters of sludge is dewatered per day, whereby the belt speed is based on the grade of the sludge. With easily drainable sludges, approximately twelve cubic meters per hour are fed and then remain in the system for around half an hour.

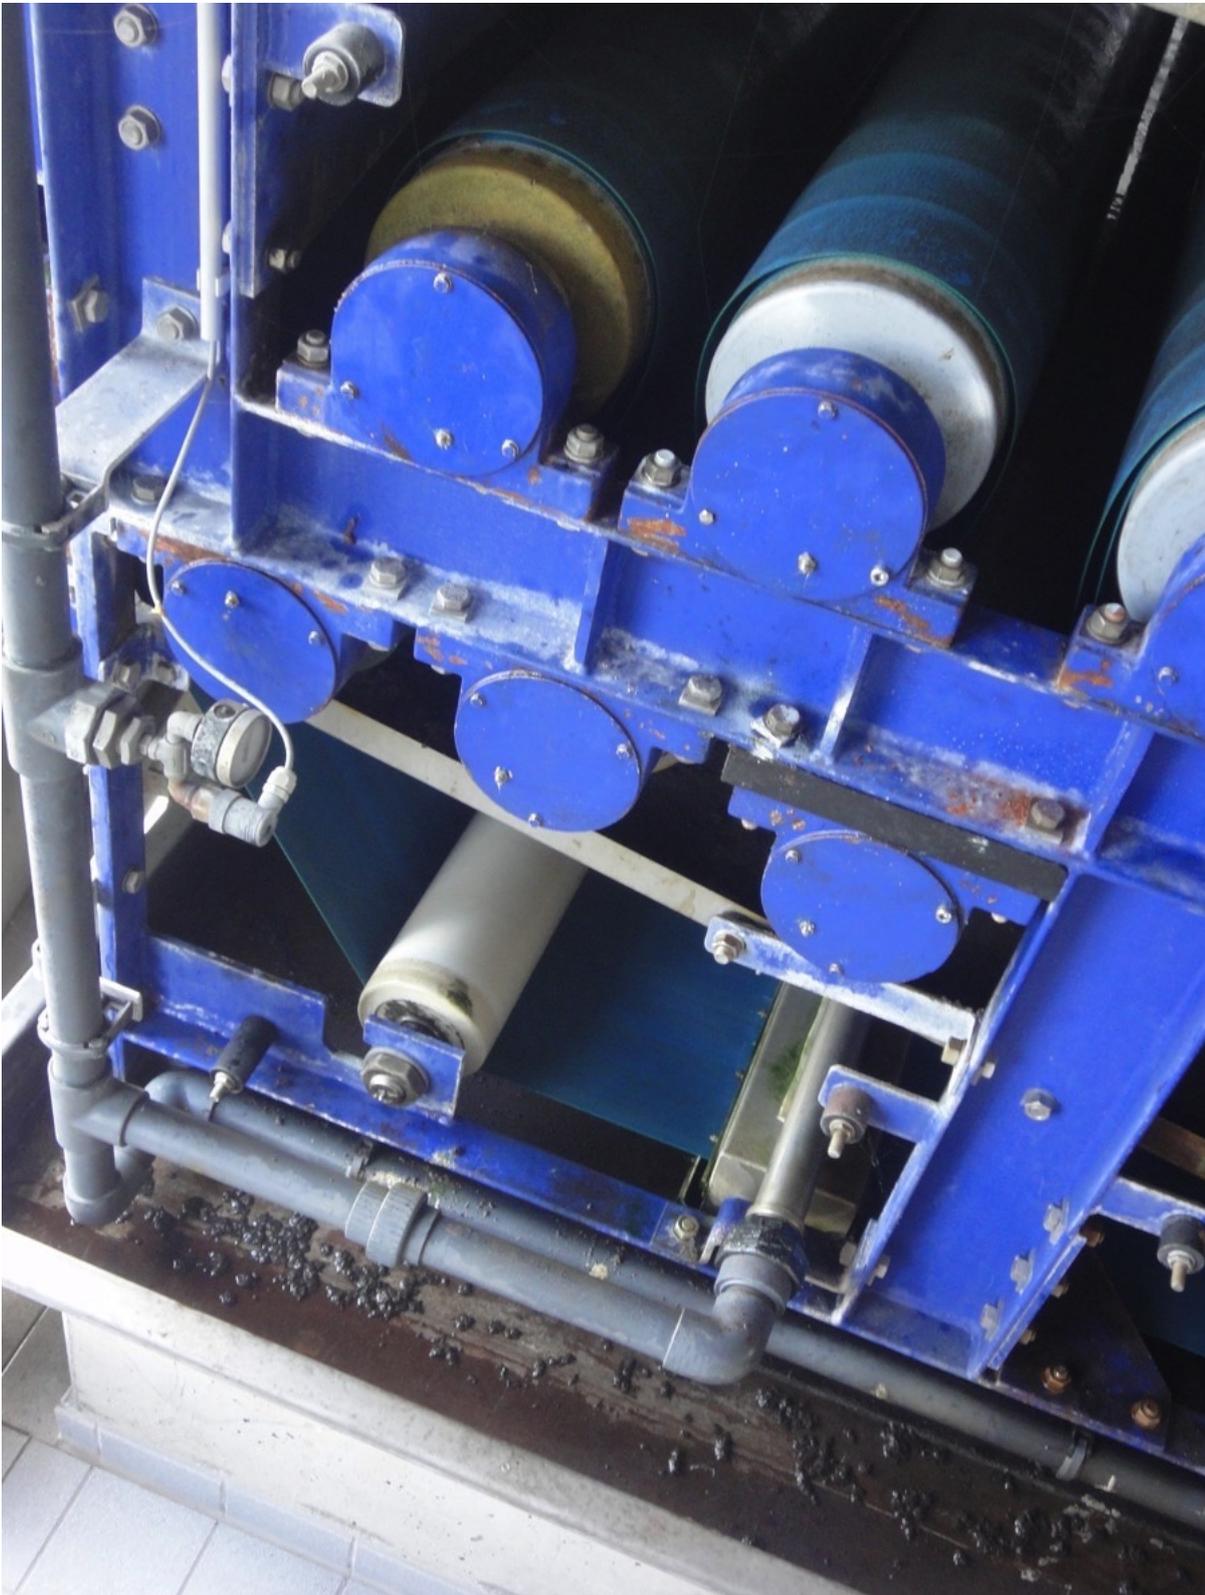
In the pressing area the sludge passes through eleven rollers between the upper and lower belt with belt pressure of 8 bar. (Picture: ©GKD)

After the thickened sludge has been deposited in the belt press infeed area, two scrapers distribute it evenly across the Type 1003 GKD filter belt, which then transports it to the pressing area. Here, the sludge passes through eleven rollers between the upper and lower belt with belt pressure of 8 bar. The belts are subjected to high loads as a result of the forces applied. The woven seams in particular were therefore a much feared weak point in Sonneberg for a long time. This was because the belts previously used at the Sonneberg sewage treatment plant regularly suffered from damaged seams due to the loads they must handle. In fact, these belts were repeatedly torn apart in an uncontrolled way, causing costly downtimes. Plant manager Bernd Hubner remembers: "The most important part of the belt is the seam. With the old belts, sudden failure of these seams led to a great deal of work and costs caused by the sludge that was still in the press. Yet despite the higher personnel costs associated with this work, the significantly longer downtime in comparison with a scheduled belt change was what actually had the greatest negative impact."

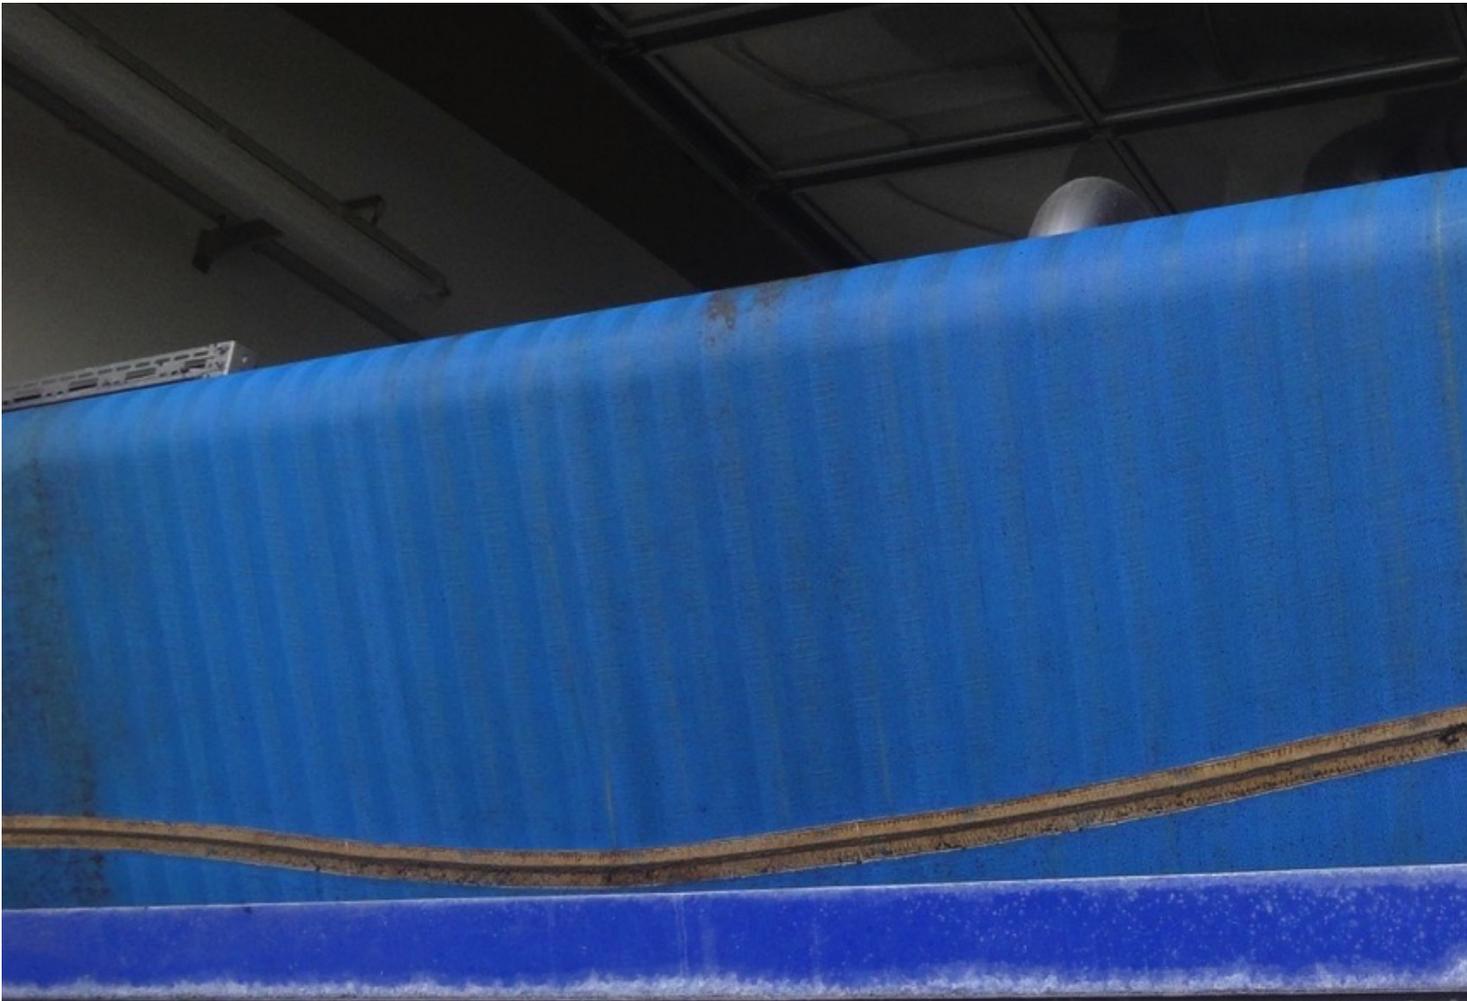
Besides efficient dewatering, the key factor of the GKD-belt Type 1003 with integrated wear indicator is a reliable PAD seam. (Picture: ©GKD)

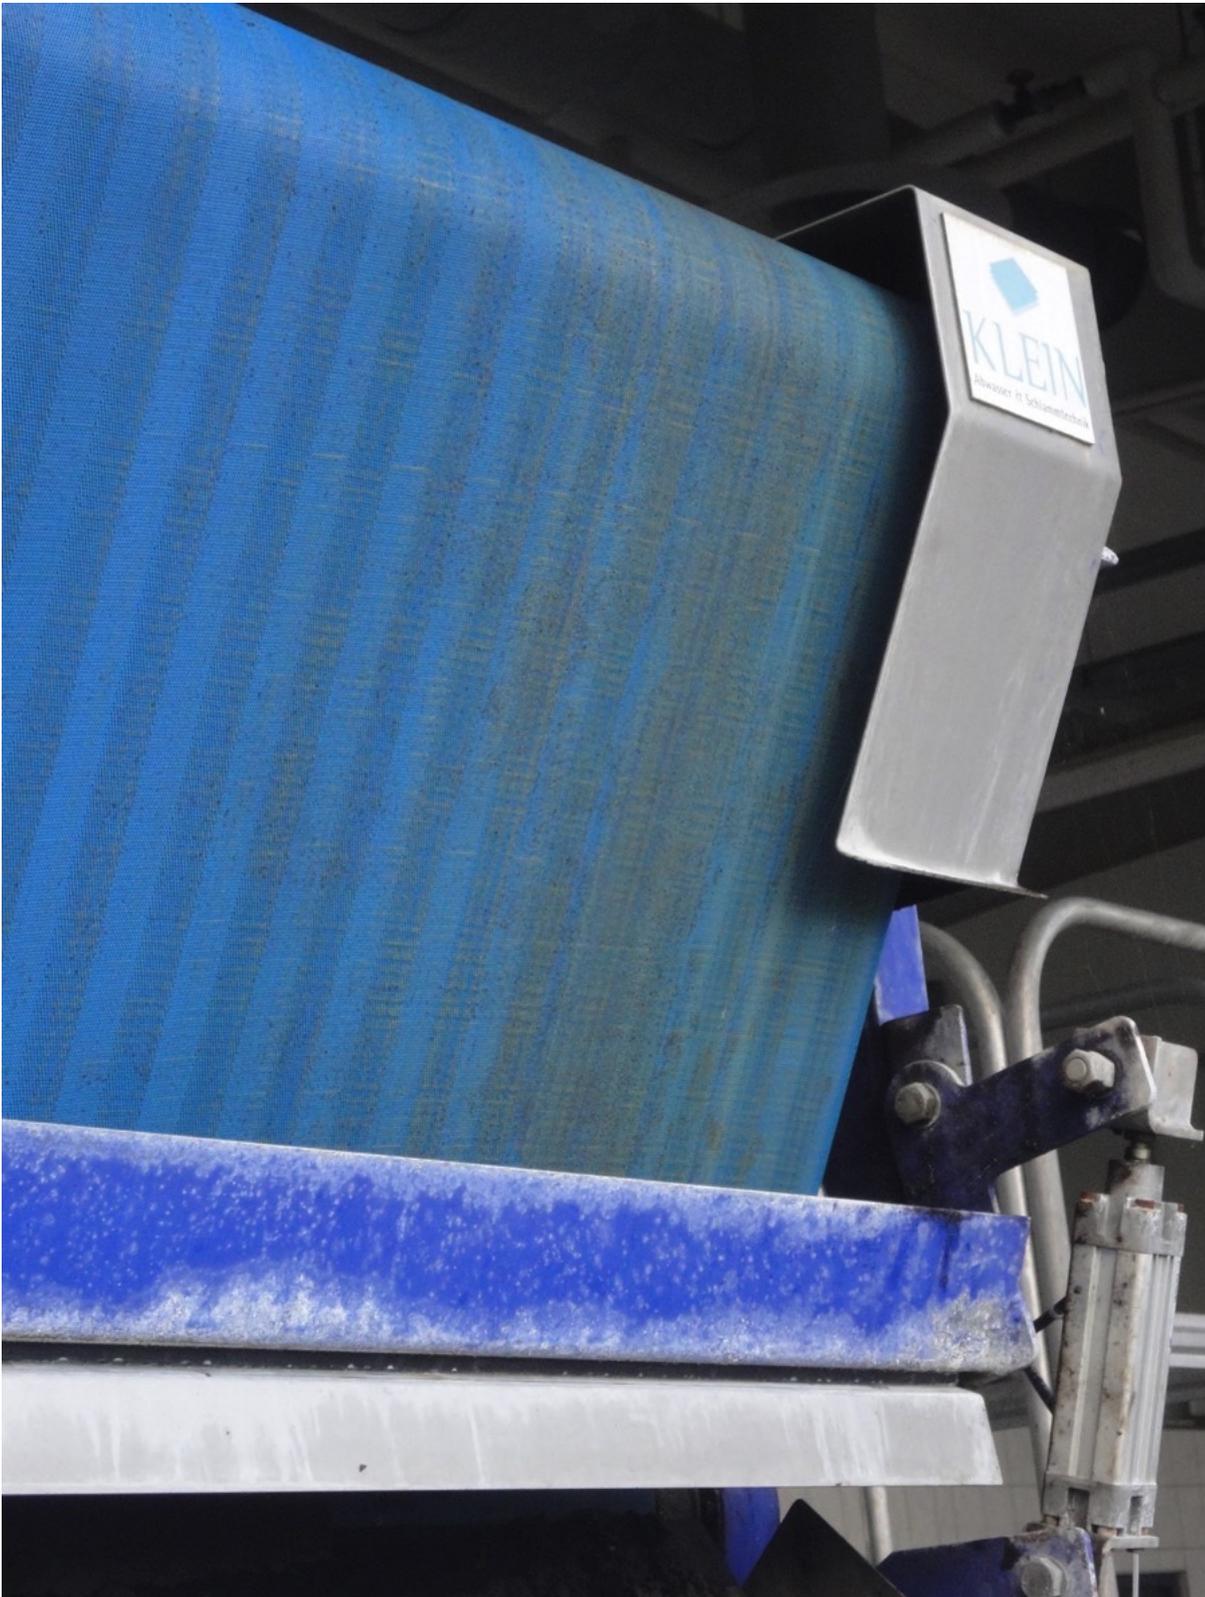
The wear indicator integrated into the GKD-belt Type 1003 allows distinct conclusions regarding the service life to be drawn. (Picture: ©GKD)

The yellow inner core of the 15.25 meter long and 2.50 meter wide GKD polyester belt displays the degree of mechanical wear – similarly to the wear indicators on car tires. This allows damage caused by defective plant components or process-related wear to be detected early on.
