Product News

Martin Engineering: Controlling Fugitive Dust at Limestone Conveyor Transfer

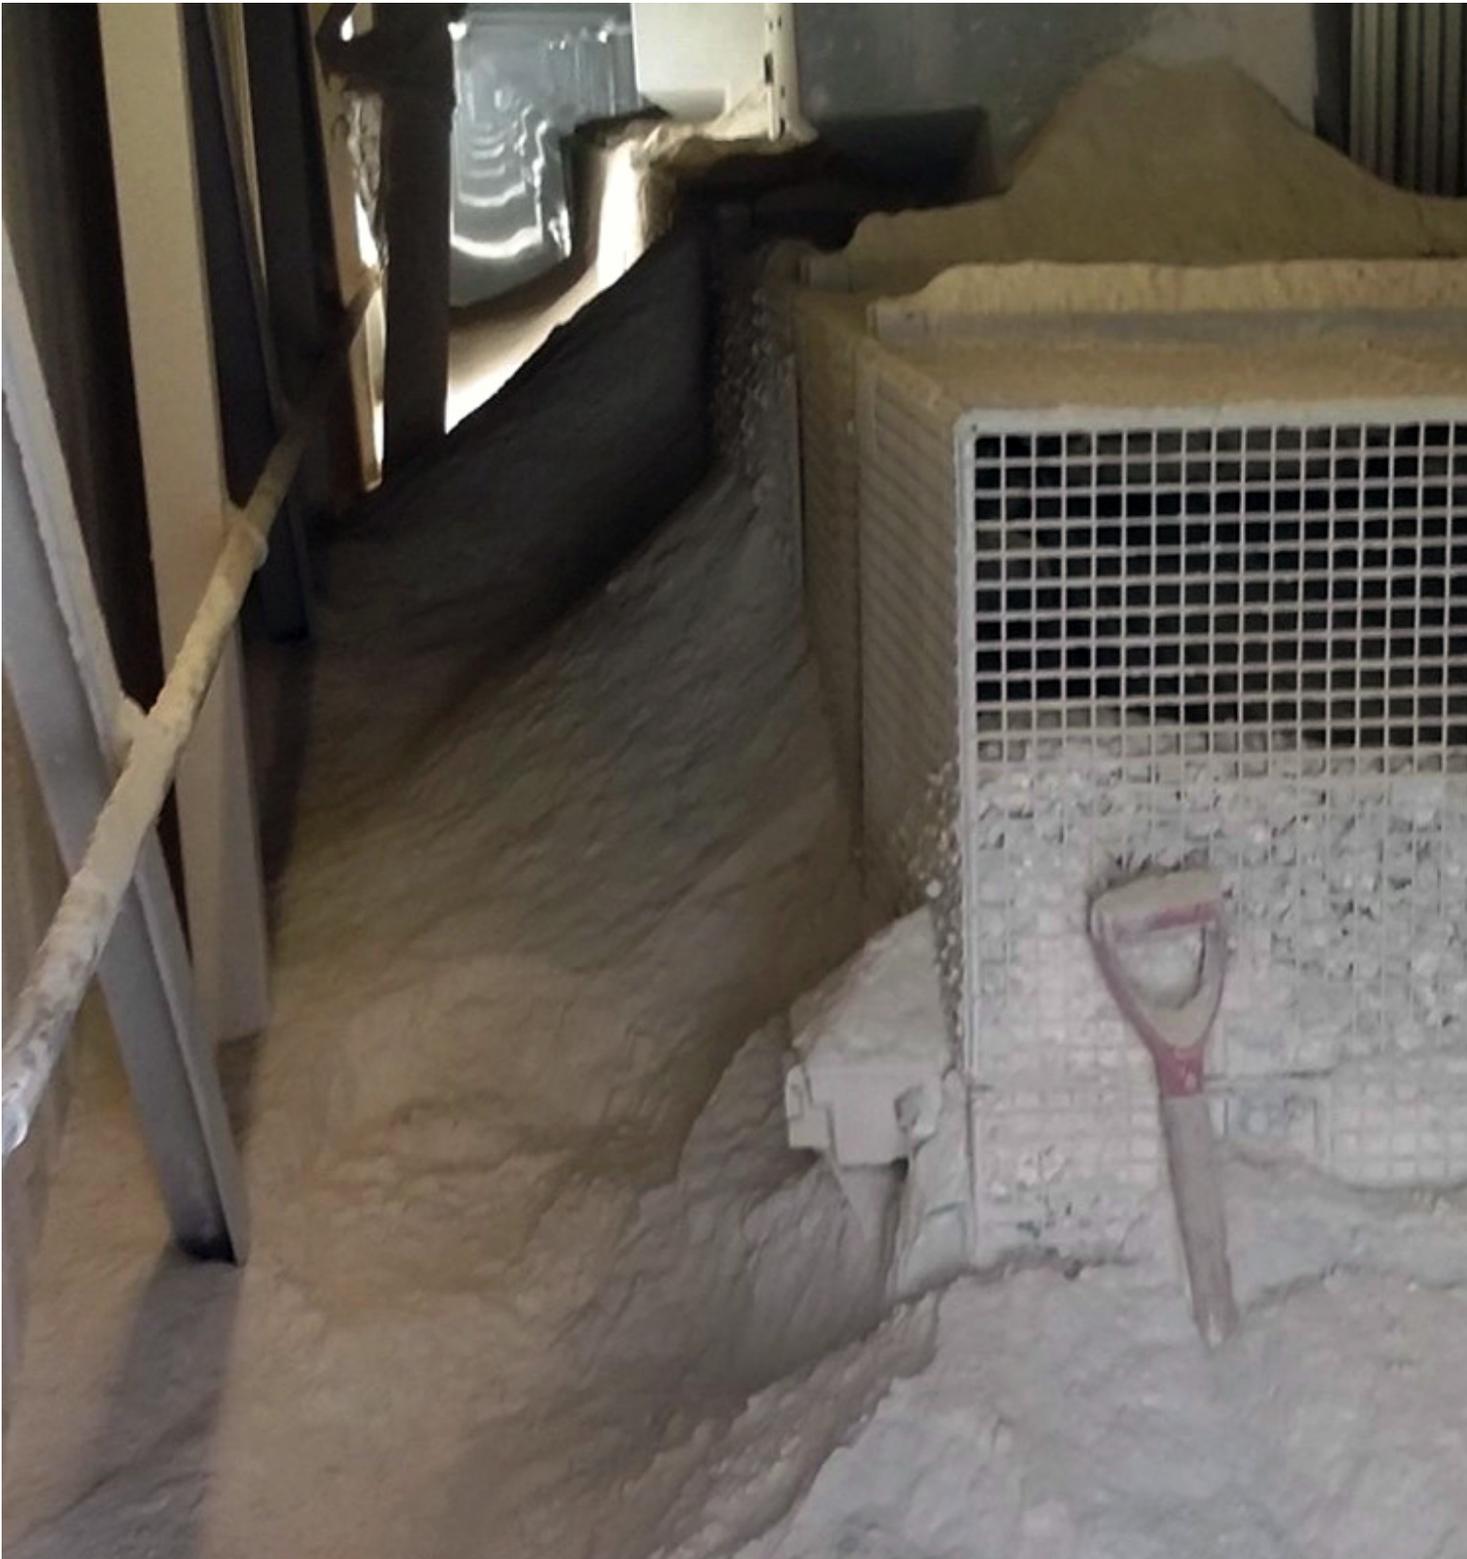
Piled high enough to encapsulate the tail pulley, the dust blocked walkways, posing a potential hazard.

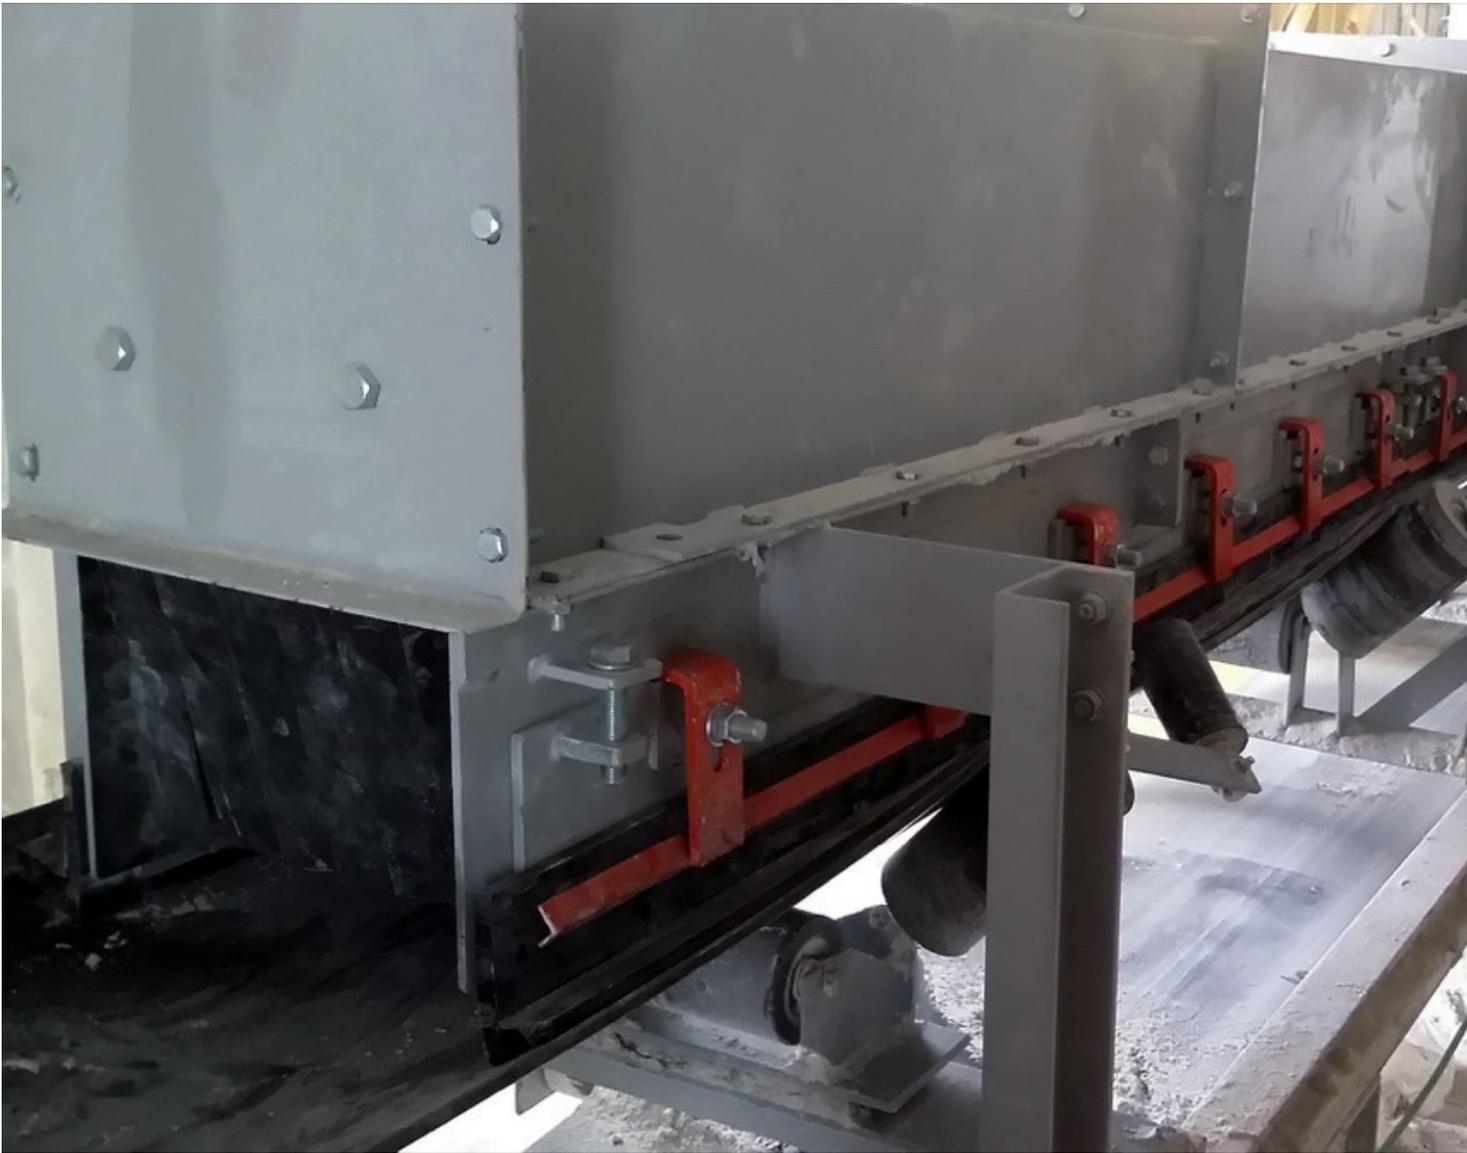
The external wear liner and apron seal help prevent damage to the chute wall.

The new design raised the chute 102 mm (4 in.) from its previous position to accommodate the new wear liner. Mounting brackets with jackscrews provided a secure mount, with precision adjustment of the wear liner to reduce spillage. This system closes the gap between the liner and the sealer, thus eliminating abrasion from trapped material without interfering with existing supports. When accompanied by the skirting and clamps, the system forms a tight belt seal, delivering outstanding fugitive material control. Special mounting tabs allow the liner and skirt seal to be adjusted or replaced from outside the chute, requiring no confined space entry.

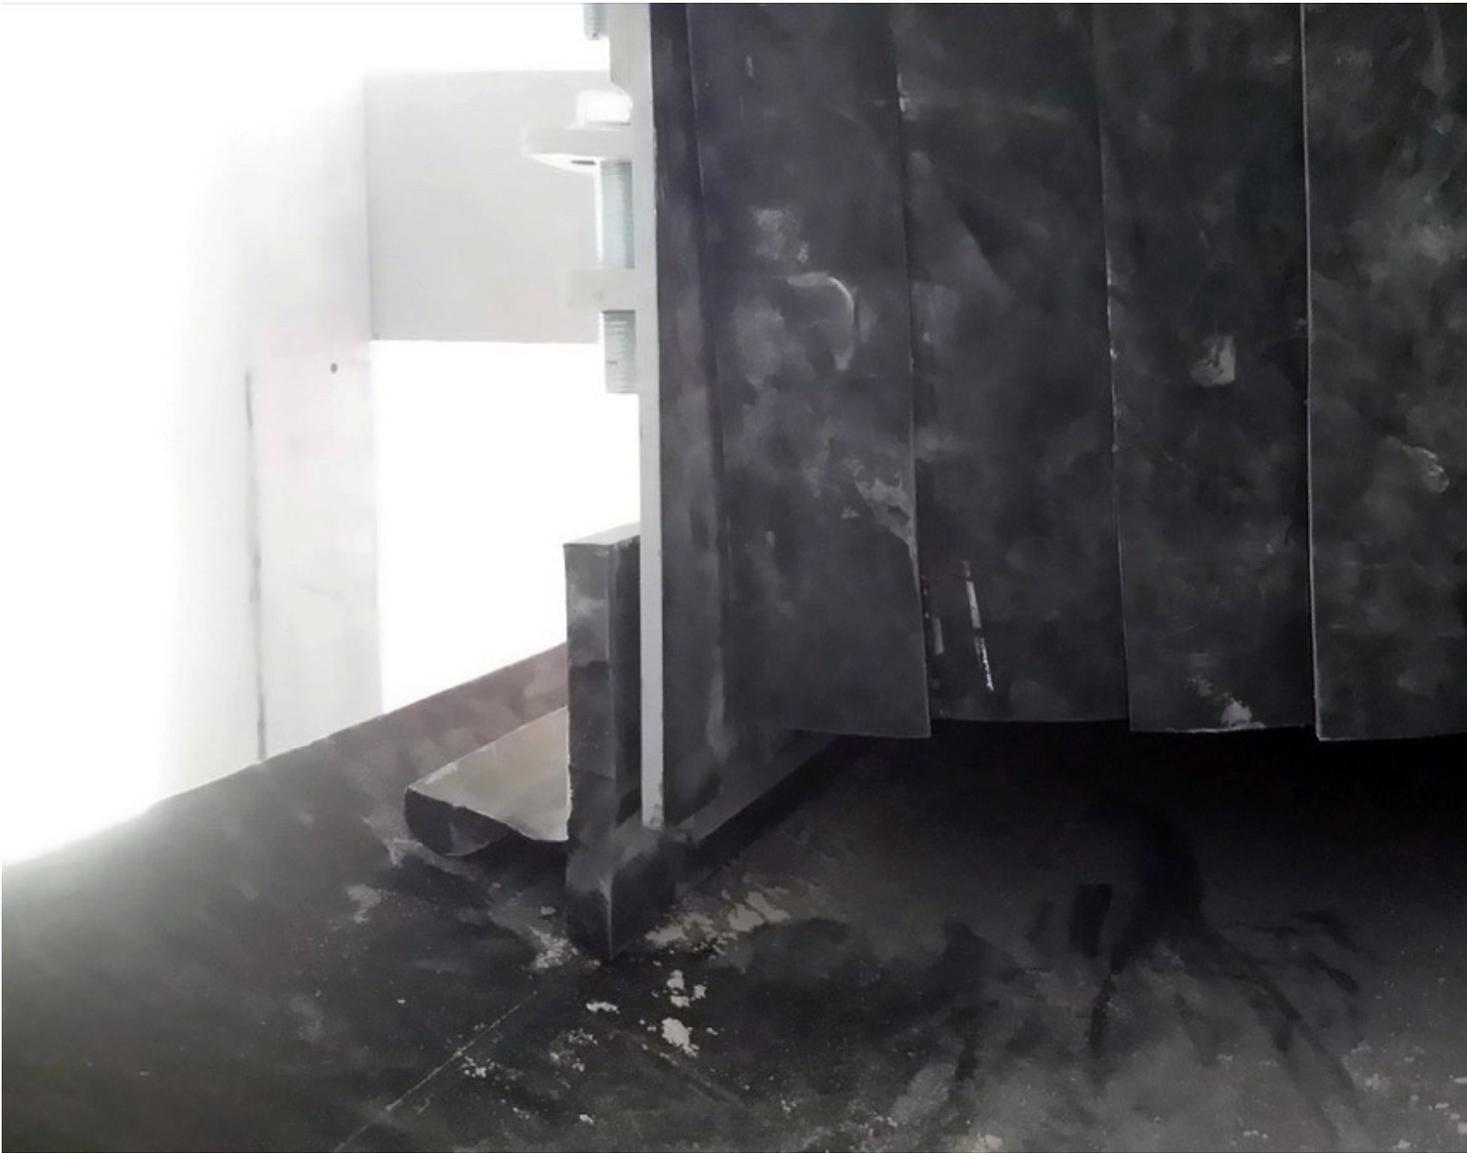
Dust curtains slow down the air flow and reduce fugitive particle emissions.
