A New Conveyor Belt Wear Test Stand

Heribert Ballhaus, Germany

2. Description of Test Wear Stand

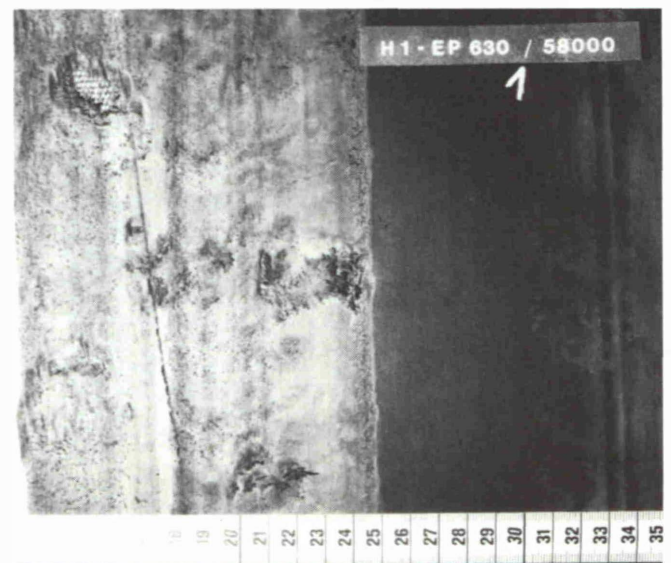
Fig. 3: Wear occurring in a steelcord belt ST630 after 31,225 rotations on the test stand

The steelcord belt was removed after a longitudinal crack several meters long had appeared, this was not caused by additional application of force or impact. The textile belt was removed after initial damage occurred to the upper insert layer of the tension member, spread over the whole length of the belt (Figs. 3 and 4).
