# Bulk Grain Silo Developments in Southern Africa

**G. E. J. Henny and P. H. H. Stamm, South Africa**

## Summary

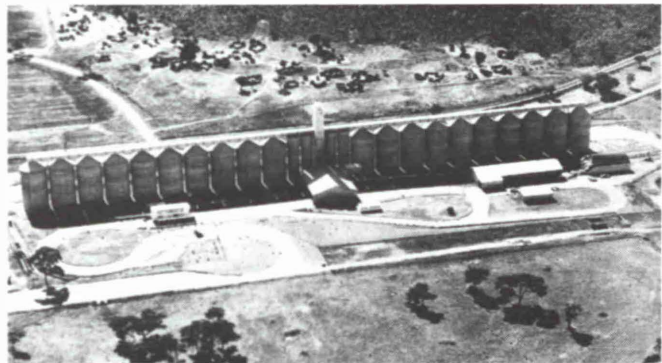
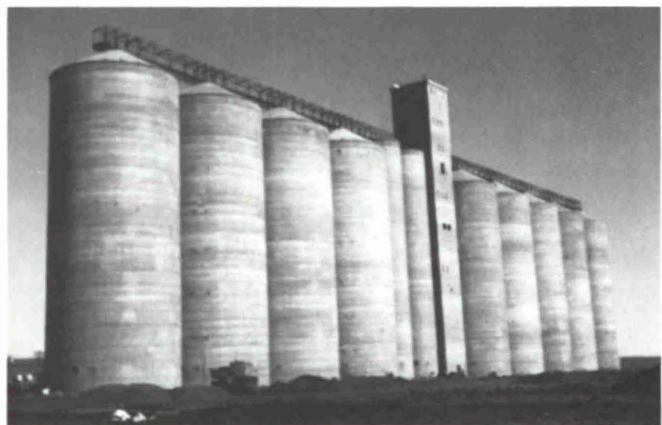
Fig. 1 shows typical rural silos consisting of a number of large diameter free-standing bins.
