# OMEGASLATE SUPERSEAL SYSTEMS LIMITED

## ROTARY VALVE UPGRADE CASE HISTORY QUARRY APPLICATION No.9

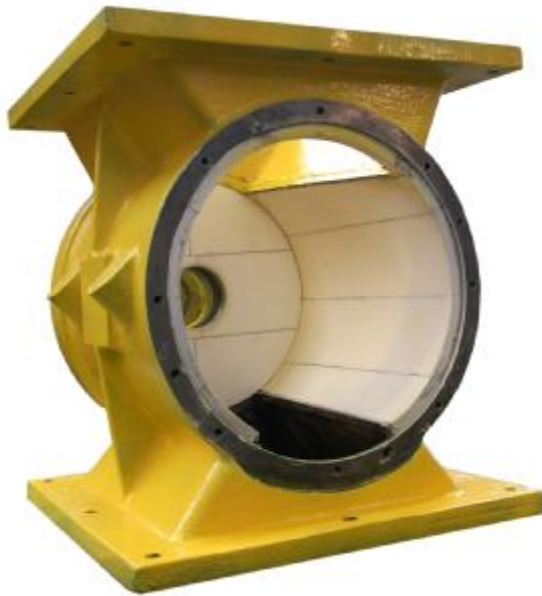
Figure 1

1. To use an existing proprietary cast iron valve body and fit new 10 mm thick, diamond ground, 99.7% alumina ceramic lining system (see figure1).

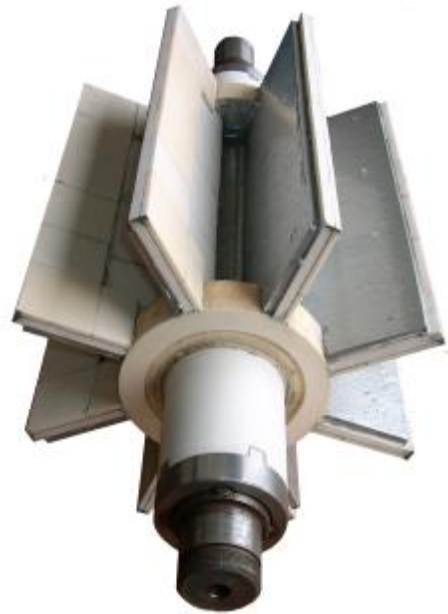
Figure 2

2. To use a heavy duty rotor with a minimum 50 mm diameter steel shaft and 75 mm alumina ceramic shaft protection through stuffing boxes (**almost a 75% increase in steel shaft sectional area and 66% increase in shaft sealing area**). The ceramic shaft protection is to be bonded to the rotor shaft and mechanically locked in position with castellated steel rings welded to the rotor shaft. Ceramic blades will be as used on the previous ceramic lined valve (see figures 2 & 3).

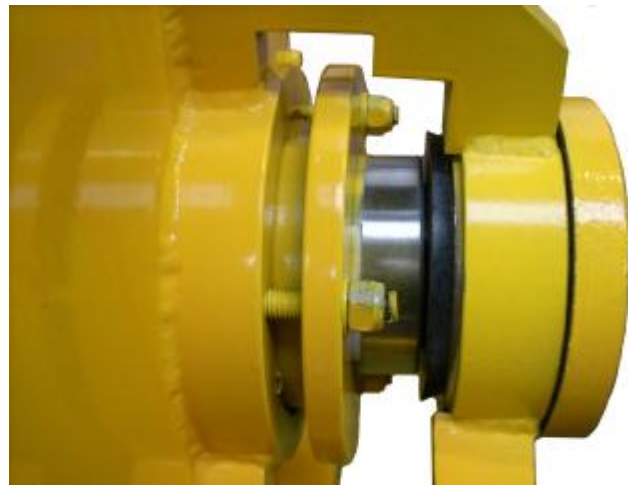
Figure 4

3. To manufacture new fabricated and machined steel endplates with larger stuffing boxes to house 12 mm square PTFE square section packing (**a 125% increase in sectional area, over the previous 8 mm square section packing**) and heavy duty circular, 3 bolt, steel packing compression clamping rings (see figures 4, 5 & 6).

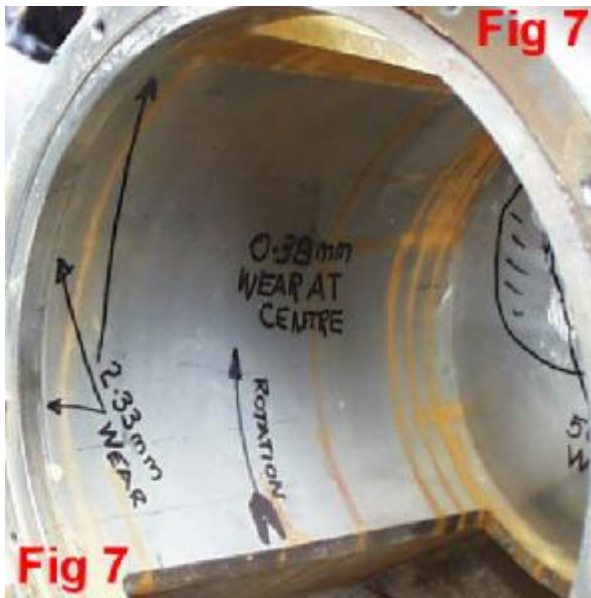
The Ni-hard valve failed because all the Ni-hard components had completely worn out within 8 weeks of operation. The ceramic lined valve failed because the ceramic shaft protection failed. If it had not been for the ceramic shaft protection failure, the ceramic lined rotary valve would have been operational for significantly longer than 96 weeks. However, the reason for the ceramic shaft protection failure was over tightening of the steel stuffing box compression rings, which caused the adhesive joints, between the 38 mm rotor shafts and the 50 mm outside diameter ceramic shaft liners, to shear. The 38 mm diameter rotor shafts, running through the stuffing boxes, were deemed too weak for this application as they were prone to bending and flexing.

**Fig 7**  
NI-HARD LINED BORE

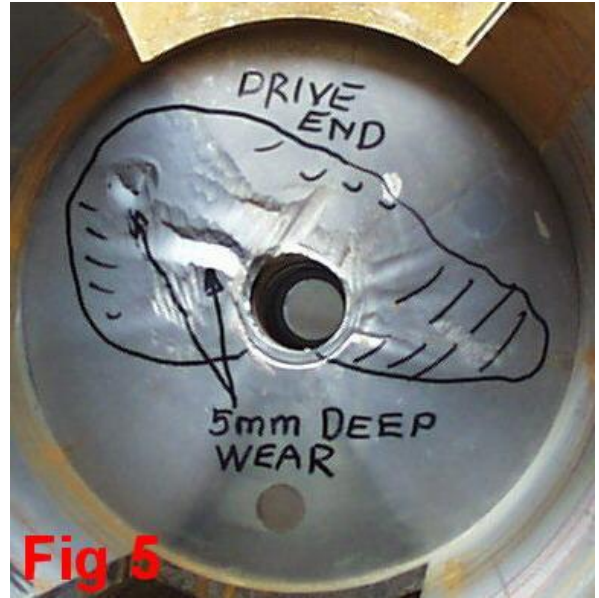
**Fig 5**  
NI-HARD LINED DRIVE ENDPLATE

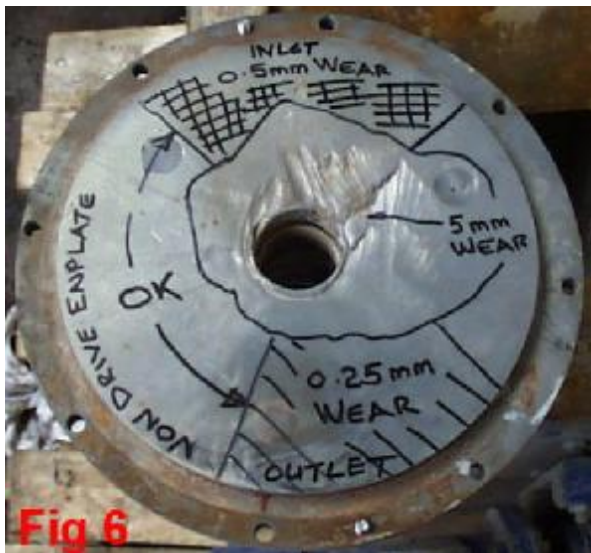
**Fig 6**  
NI-HARD LINED NON-DRIVE  
ENDPLATE

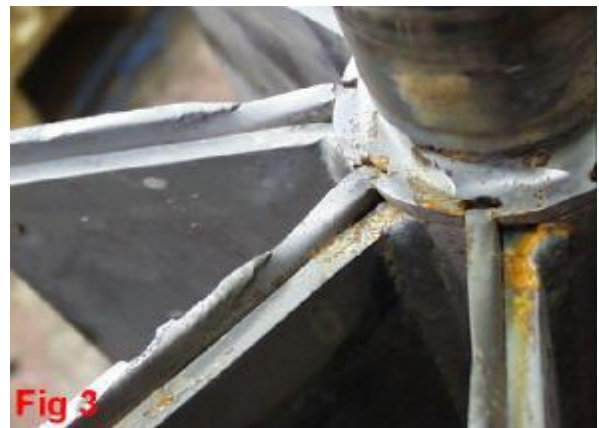
**Fig 3**  
ROTOR VANE END WEAR

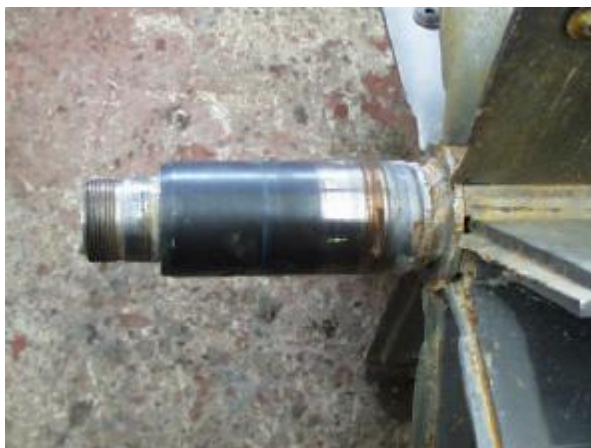
HARDENED STEEL SHAFT LINER

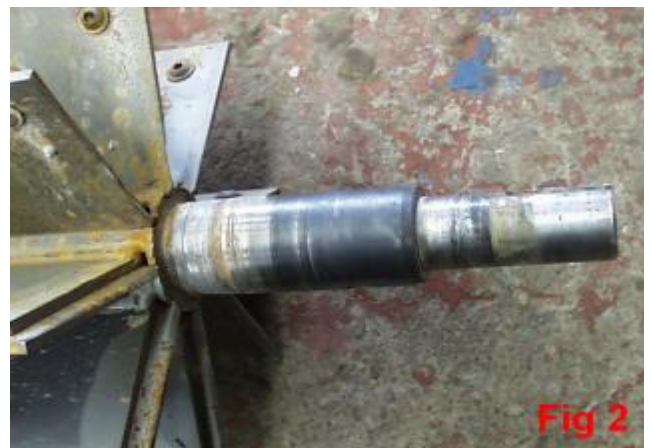
**Fig 2**  
HARDENED STEEL SHAFT LINER
