The equipment had been designed and manufactured in 1990, the facility had been commissioned in 1992 and was in operation until mid of 2007 (15 years). Since then the plant has been shut down. No signs of extensive mothballing have been observed, even though the plant obviously had been well maintained and kept clean during operation.

The following machines have been reviewed:

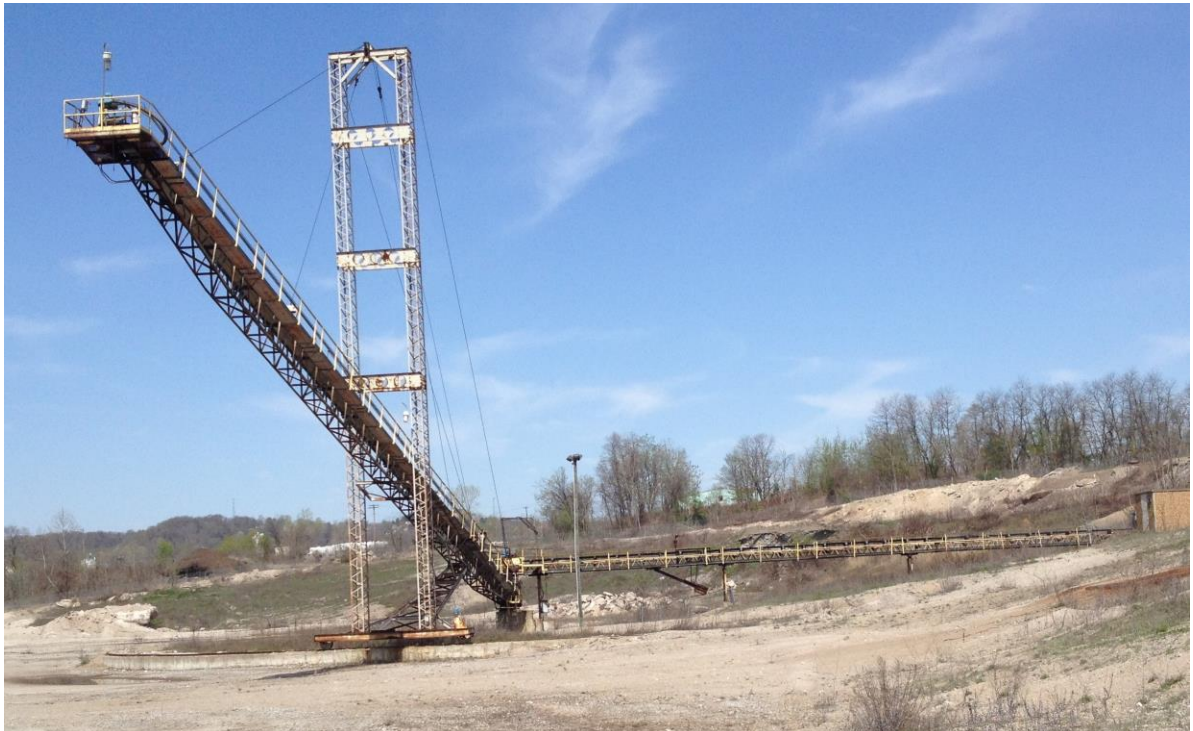
1. Stacker (200 t/h for semi-circular stockpile of 100K t of blast furnace slag; 60 HP)

Equipment is outdoors but shows minimum structural corrosion. Equipment seems to be generally sound and intact. It is not expected that any electric equipment can be re-used.

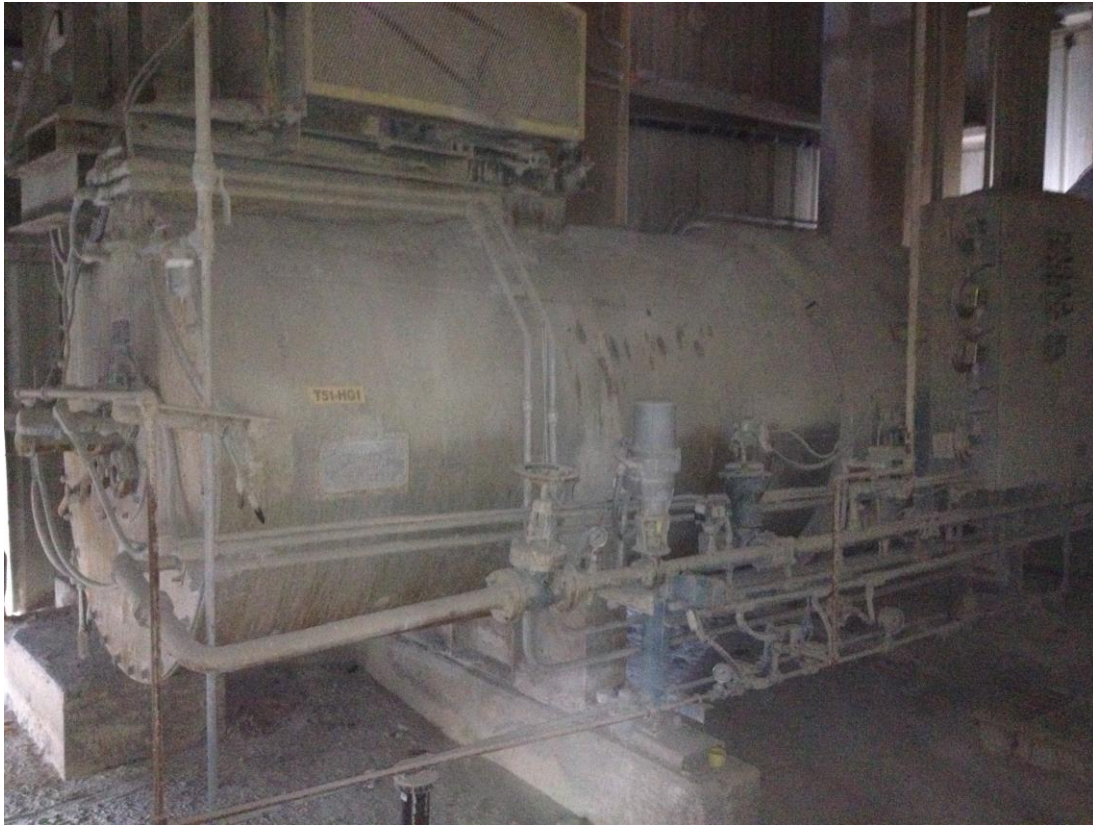
2. Hot Gas Generator (24.6 MBTU; 46,000 cfm) utilizing natural gas

Hot gas generator unit located in a corner of the building on the ground floor level. The photo shows the side with the natural gas control unit. Generally the unit is in good condition but will require cleaning. Made by the John Zink Company (Tulsa, OK) with the Serial number: 77262-1

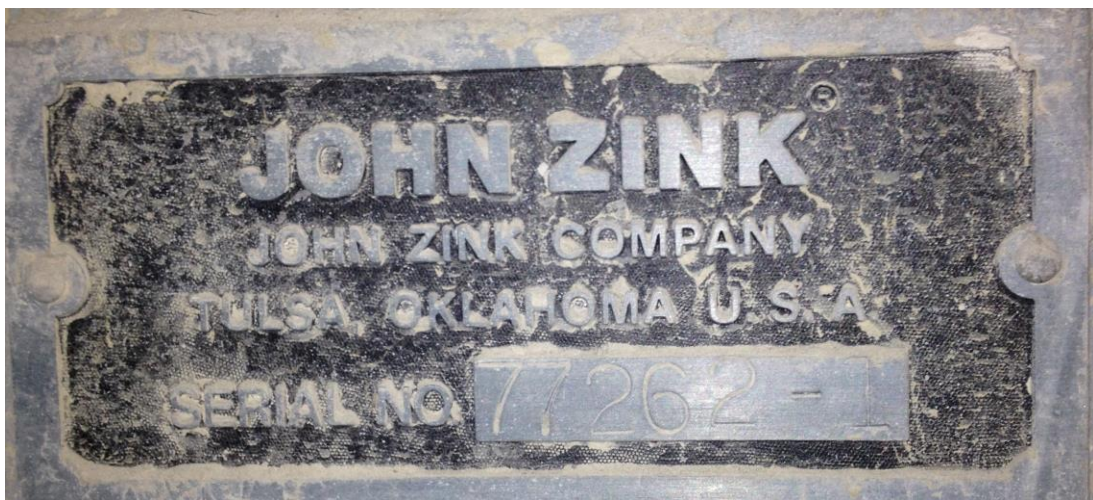
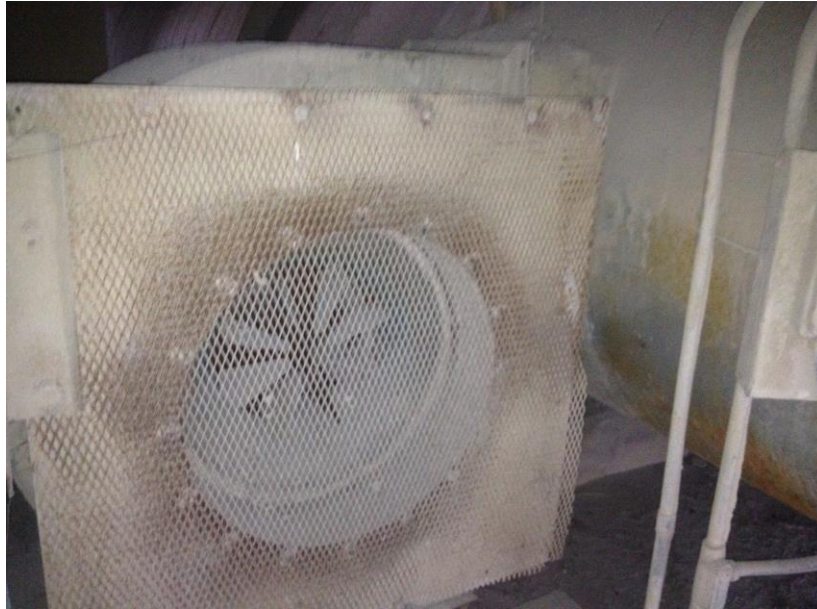
The HGG is equipped with 2 air supply fans, one thereof shown in the following picture. The fans are rated at 20 HP / 41 inch water DP and 15 HP / 25 inch water DP.

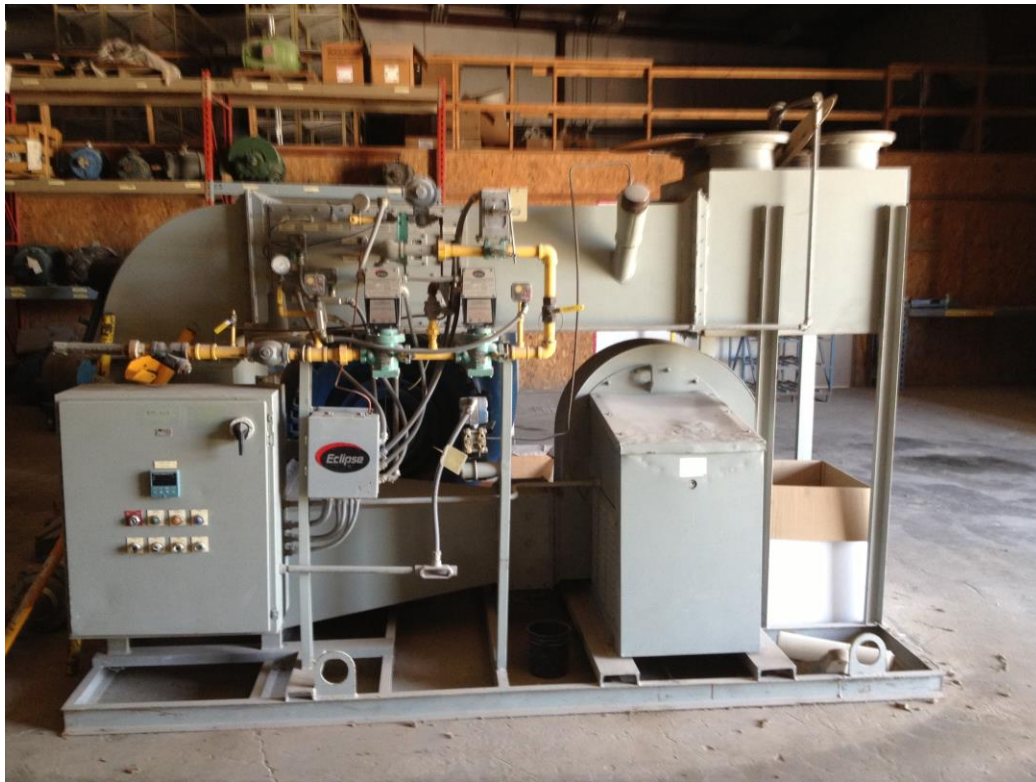
In the warehouse a new, unused heater has been discovered (Type ECLIPSE). Due to a lack of documentation no details are available at this time. Judging by size the heater unit is substantially larger than 1 MBTU but also a lot smaller than 20 MBTU. It is set up for natural gas.

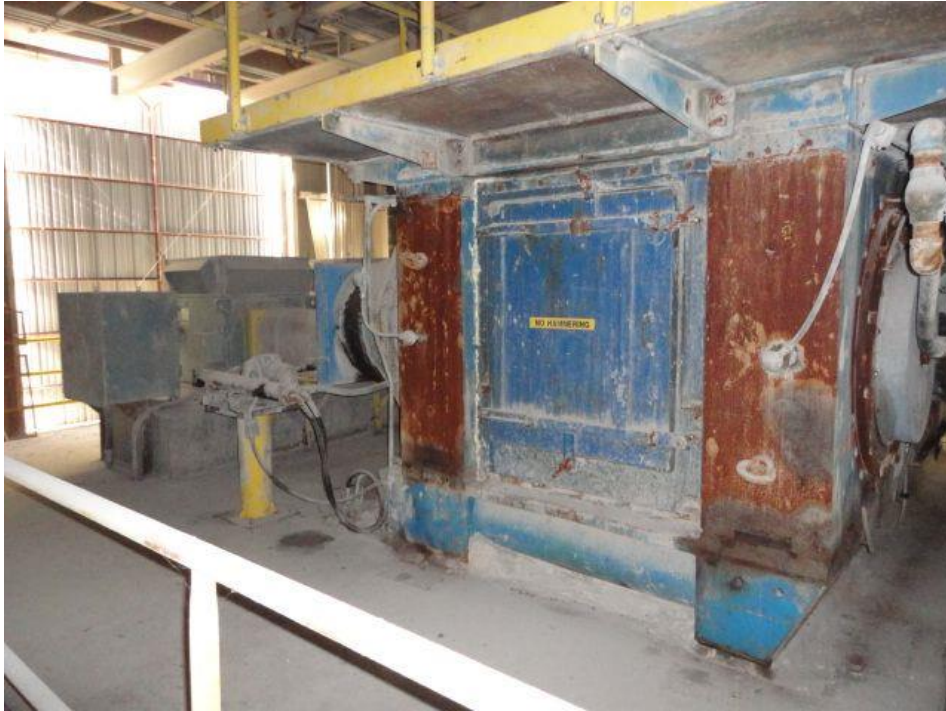
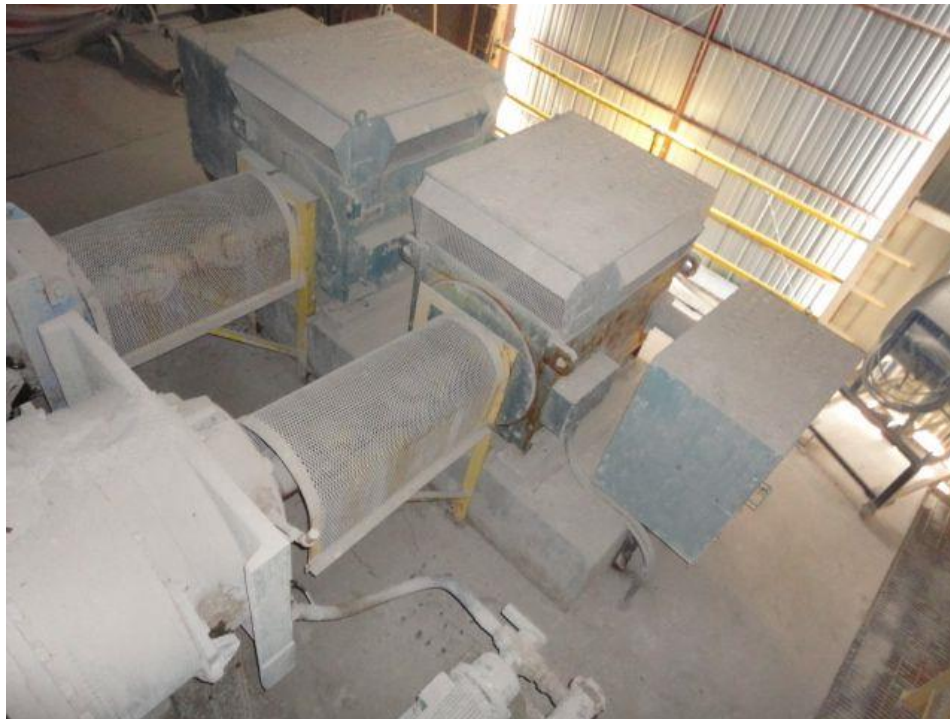
3. POLYCOM Roller Press 14/8 with Flender gear reducers, main motors and hydraulic system

The installation is a typical Polysius POLYCOM unit.

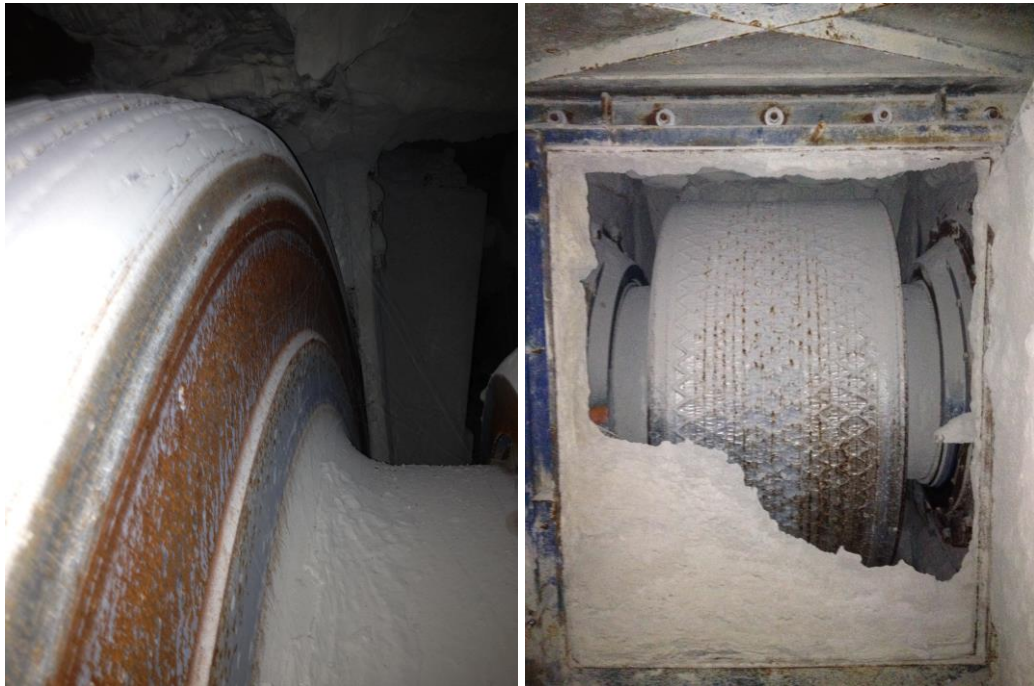
a) Rollers / Bearing units

The installed rollers are “full rollers” (not bandaged or segmented). Over the course of 17 years the rollers have been refurbished / rewelded multiple times but are in very good shape. No cracks of any kind have been observed, no breakouts or any other unusual flaws.

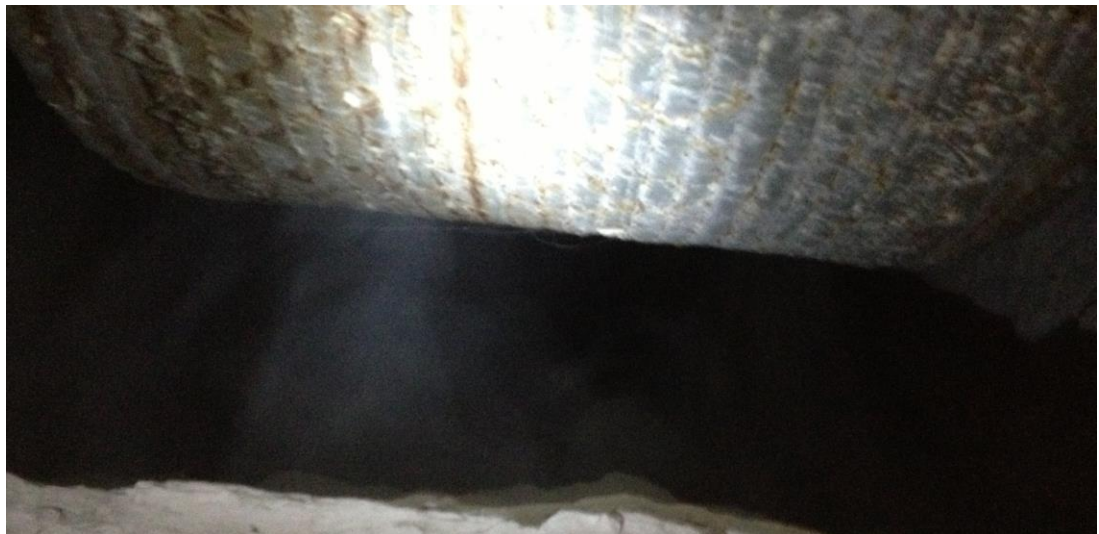
Original roller dimensions: 1.4 m Diameter by 0.75 m width. The actual roller surface is on good shape (minimal wear) as shown in the next photo.

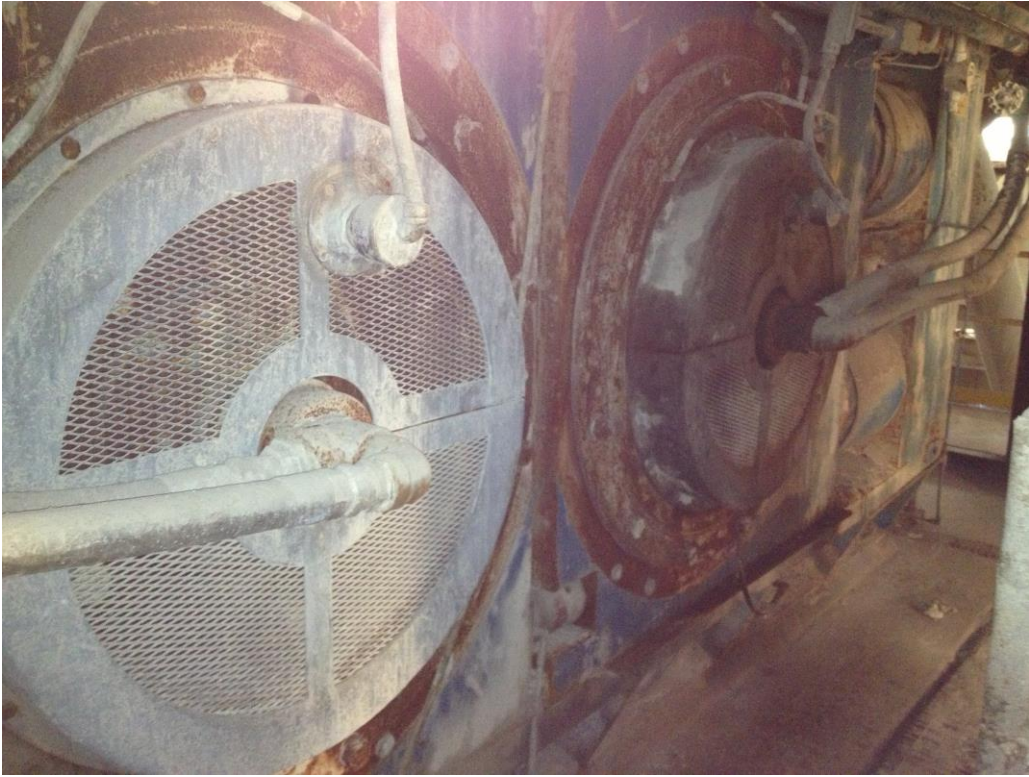
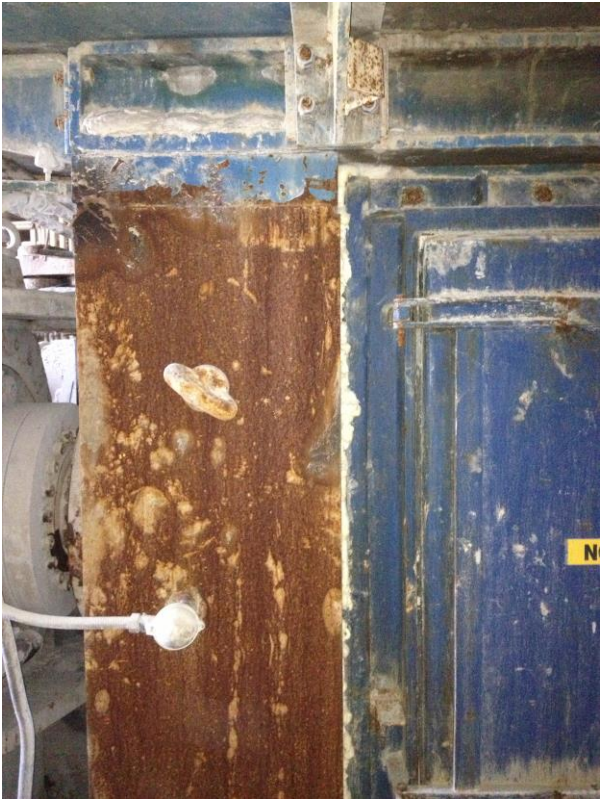
The roller bearing blocks seem to be in good condition with superficial corrosion and the need for cleaning/repainting.

After 6 to 7 years without movement it has to be assumed that the bearing spots under load have flattened out. A detailed inspection of the bearings (dismounting, cleaning, inspection) is mandatory before putting the machine back into operation. The roller lifting frames that double act as transport safety devices were found in the yard and are in usable conditions (minor corrosion, needs cleaning and paint).

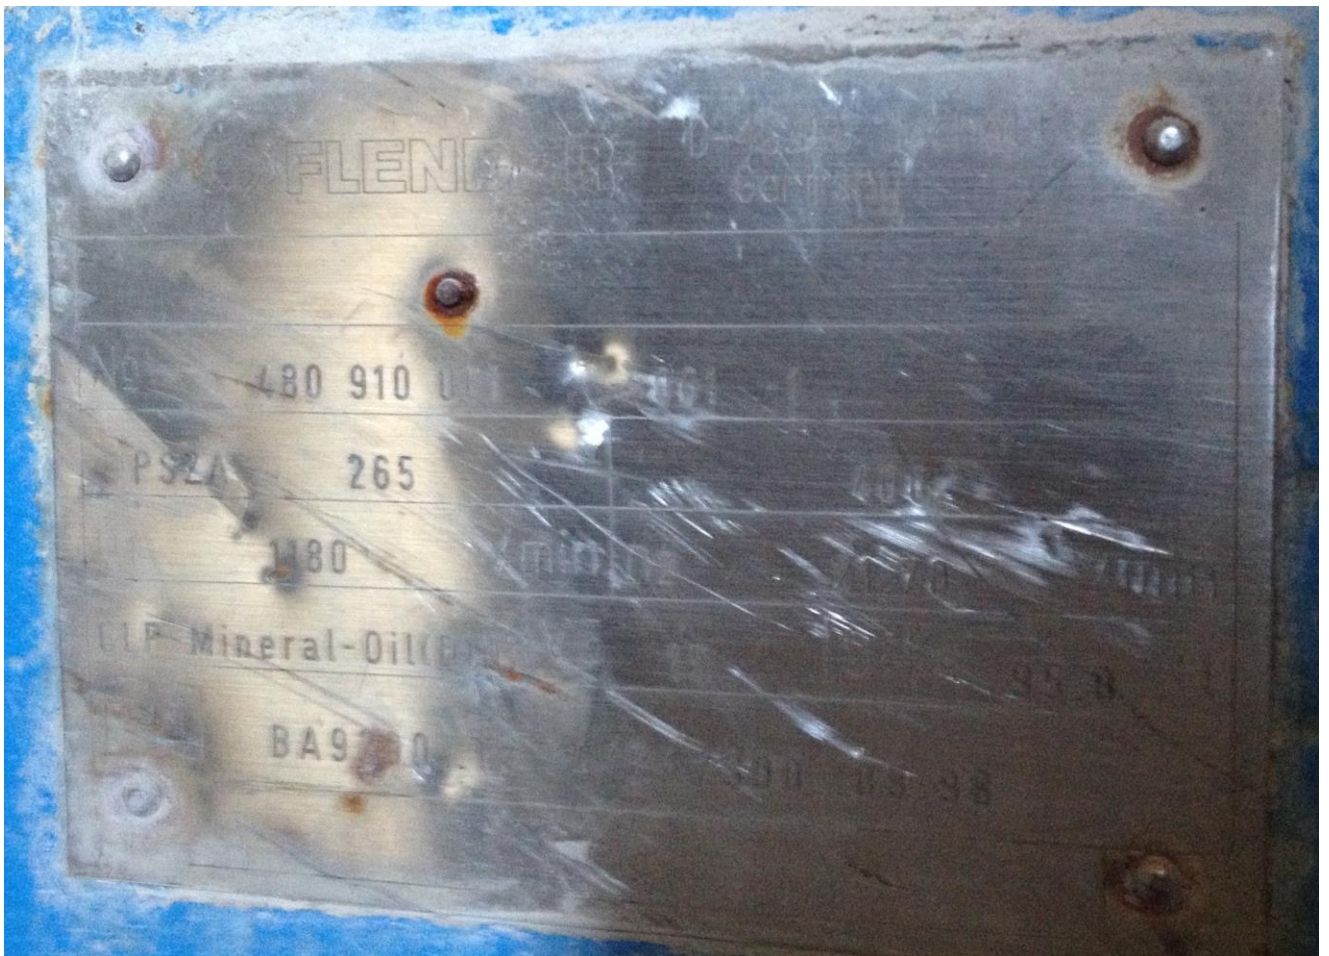
b) Gear reducers

The gear reducers have been original made by Flender and are Type PSZA 265. The rating seems to be 400 kW = 536 HP but the nameplate does not show the markings “kW” in the spot usually used for the rating. It might be recommendable to clarify with the Flender Company whether the 400 rating refers to kW or HP. In any case the rating is slightly (536) or significantly (400) below the motor rating of 600 HP.

The turndown ratio is given as 1180 rpm : 21.7 rpm resulting in a roller surface velocity of 1.59 m/s.

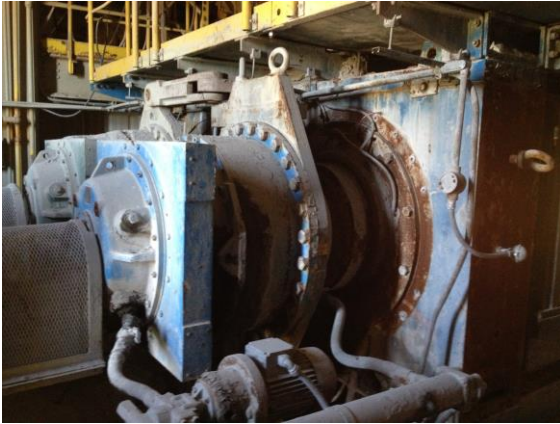
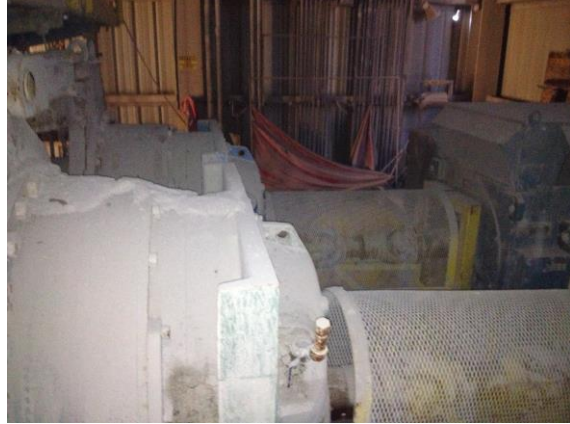
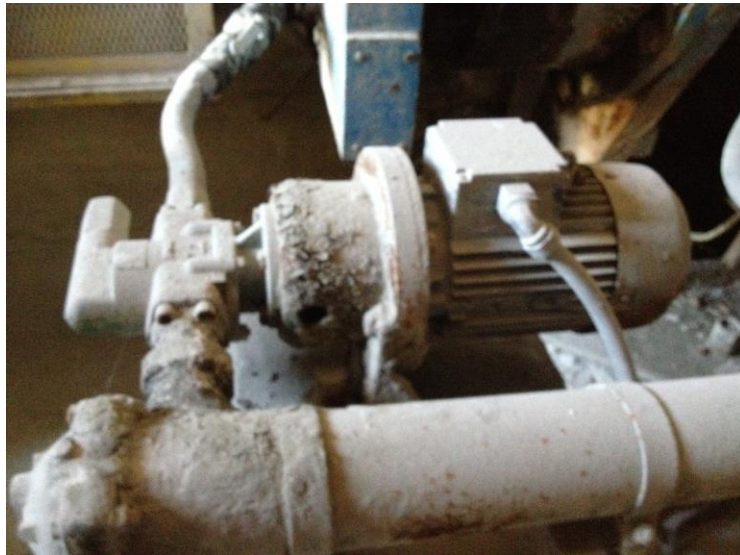
The photos on the following page show that the gear reducers are mounted and in fair to good condition. One gear reducer shows the original blue paint while the other is painted in green and shows a nametag of the company “Mull Industries, Wheeling WV”. It is assumed that this gear reducer was rebuilt or repaired by this company at one time. Both gear reducers have Safeset torque couplings mounted and are equipped with a circulating oil lubrication which includes oil/water coolers.

With all parts/components sitting for several years without motion it is recommended to perform a detailed inside and outside cleaning / inspection of all components of the gear reducers / lubrication.

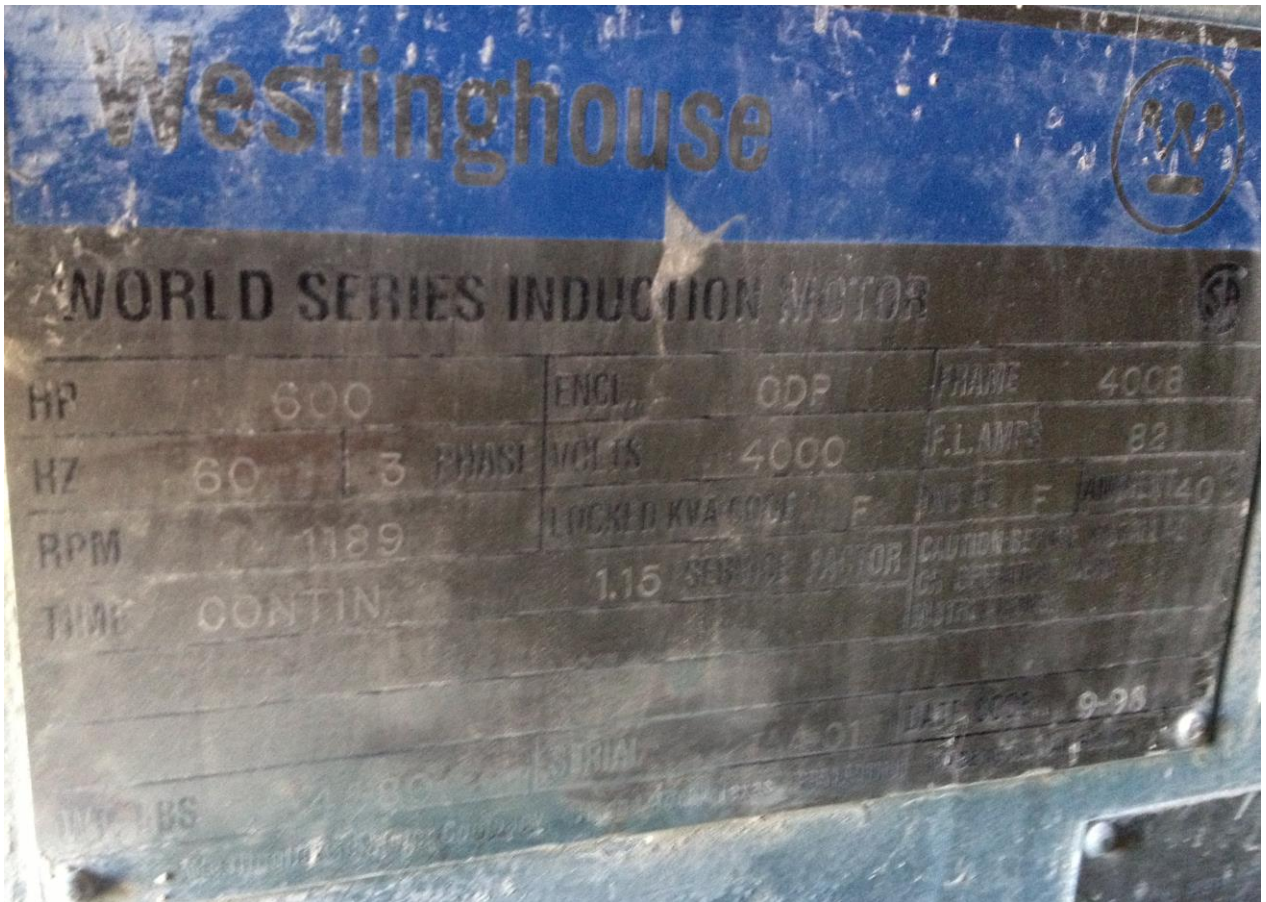
c) Motors

Both motors are from Westinghouse and are rated 600 HP at 4000 Volt with 1189 rpm.

As shown in previous photos the motors are mounted and seem to be in good shape but will need detailed cleaning / testing.

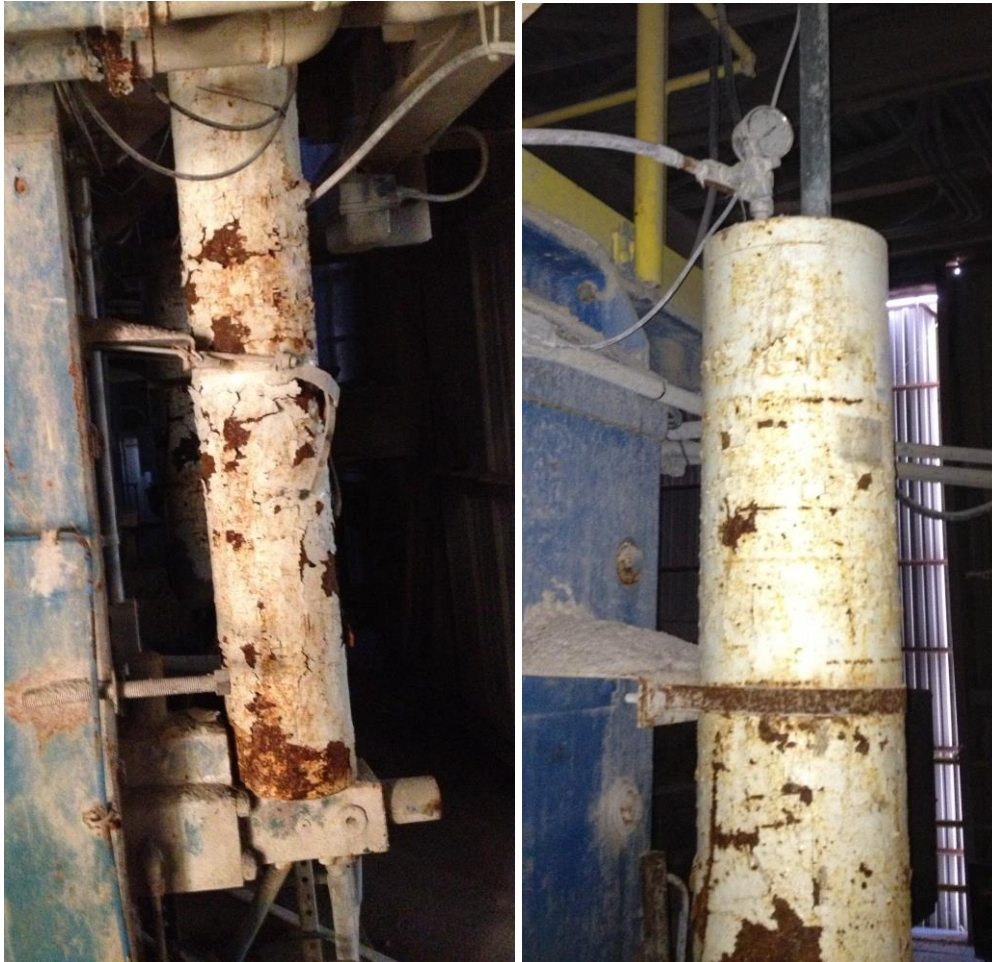
d) Hydraulic unit / Nitrogen Accumulators

The nitrogen accumulators are extremely corroded and will require a thorough refurbishing including renewal of the pressure vessel certifications. It probably is more economical to replace the 2 accumulators entirely. Due to the conditions not nameplate data were legible. Therefore the size of the accumulators is unknown but can easily be recalculated.

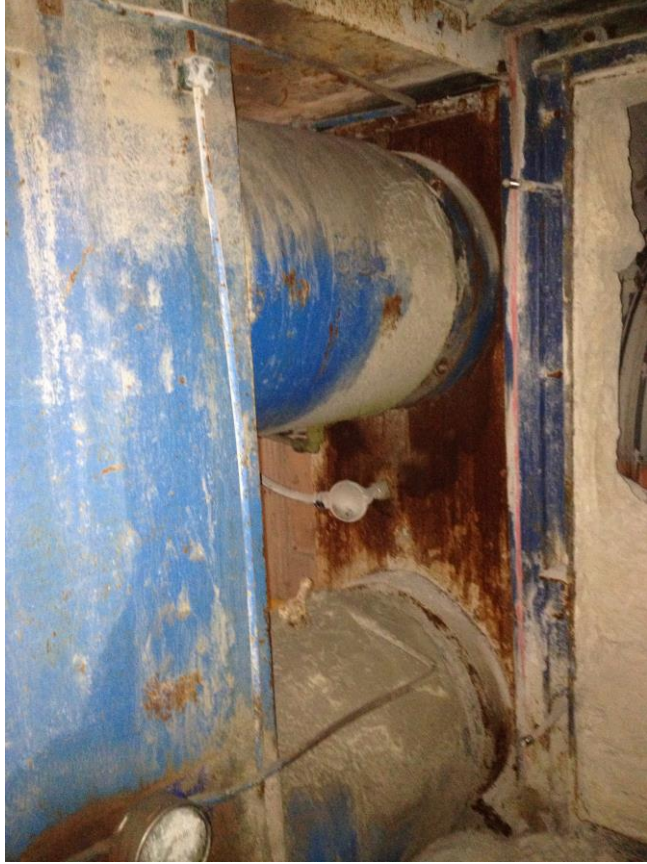
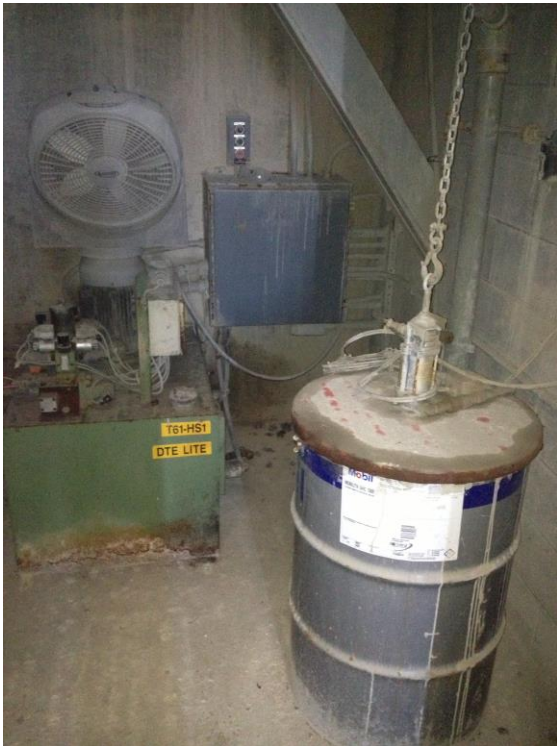
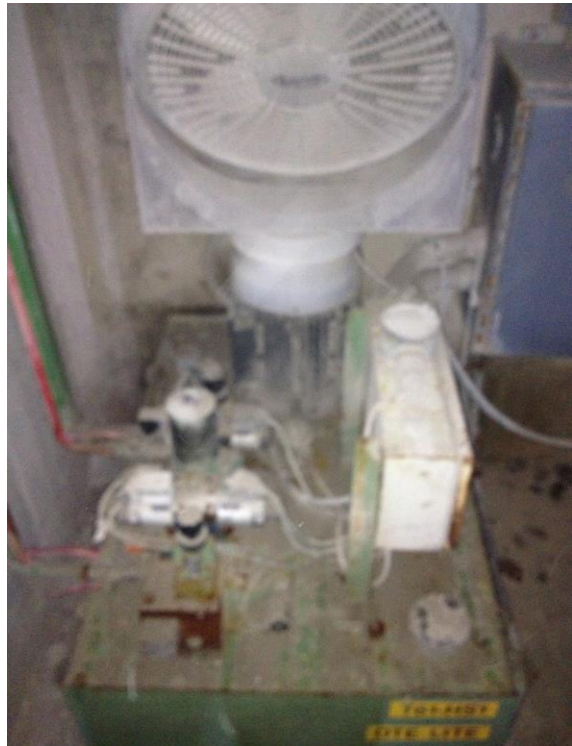
The photos on the next page show the hydraulic cylinders on the drive side (non-drive side looks the same), the hydraulic room and the hydraulic cabinet. The shown equipment seems to be in reasonable conditions and needs mainly cleaning, detailed inspection and an exchange of minor parts that will deteriorate over the years (O-Rings, sealings,...). The hydraulic tank unit shows some corrosion at the bottom that is minor but may need repair.

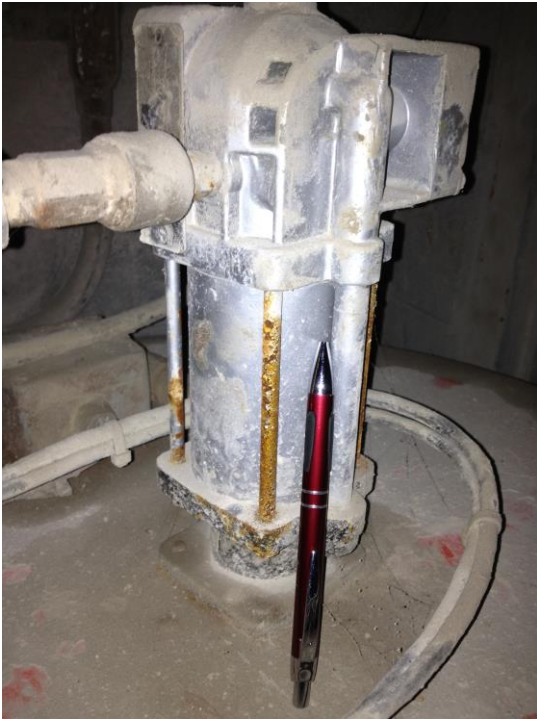
e) Grease unit

The grease system consists out of a pneumatic grease pump (barrel pump – see photo), a set of piping and grease distributors with cycle sensors.

The grease pumps looks reasonable; however, the piping and grease distribution system should be replaced.

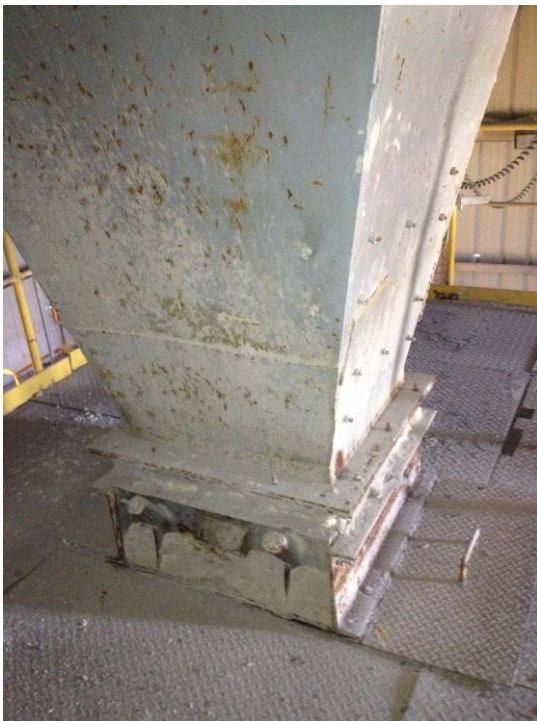
f) Feeding device

The feeding device is NOT the typical Polysius design (manual adjustable chute side walls in combination with hydraulic adjustable, angles shut of plates) but is a simple, non-adjustable chute that also cannot be shut off for a non-load start of the main motors.

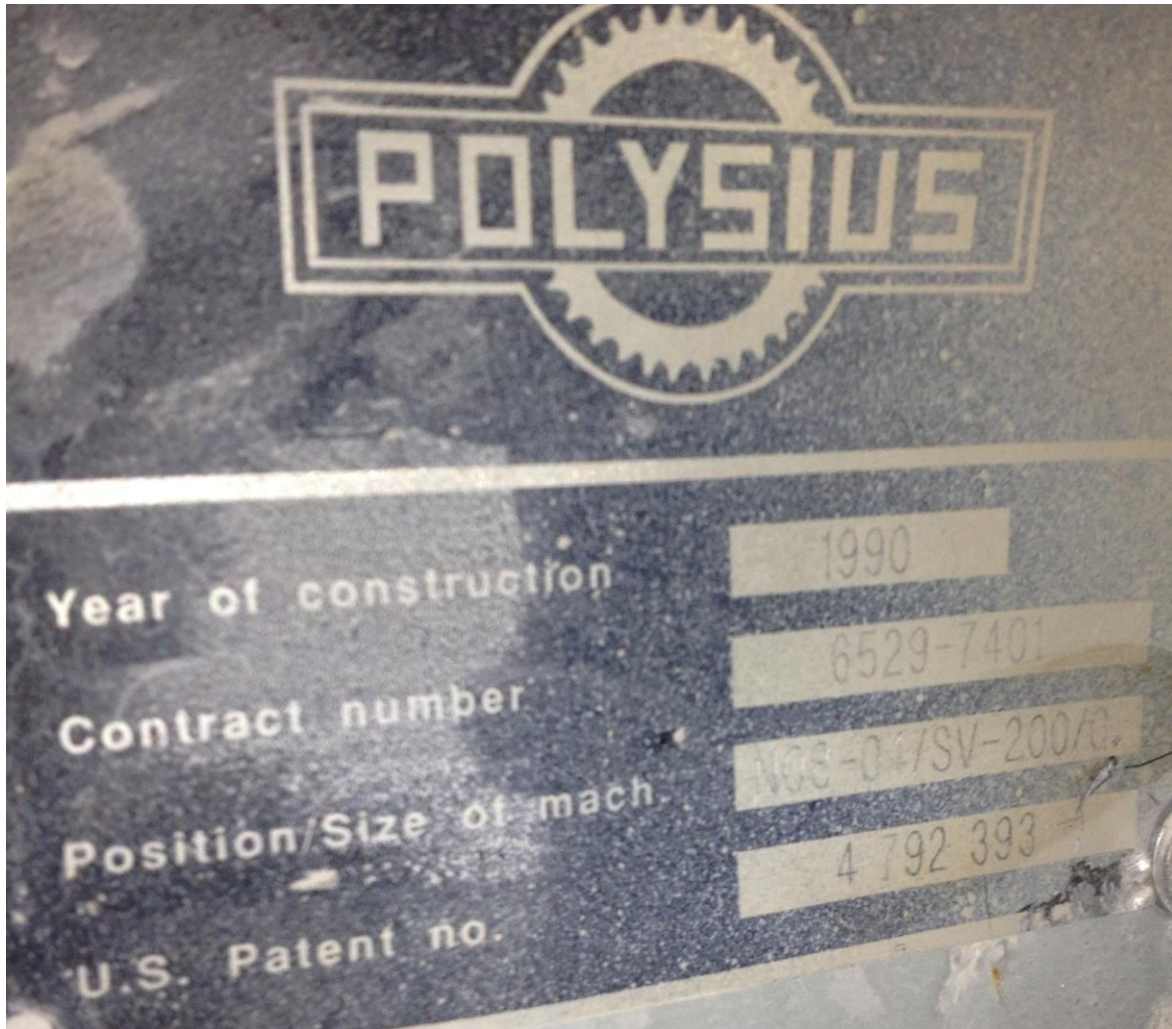
a) SEPOL SV 200 / 0

The installed Polysius SEPOL classifier has been manufactured in 1990 but was installed / commissioned in 1992. The SEPOL Type is SV-200/0 which has a rotor cage size of Diameter = 2.0 m versus Height = 1.34 m resulting in 8.4 m² rotor classifying area. The rated gas flow for this type is 61,800 cfm.

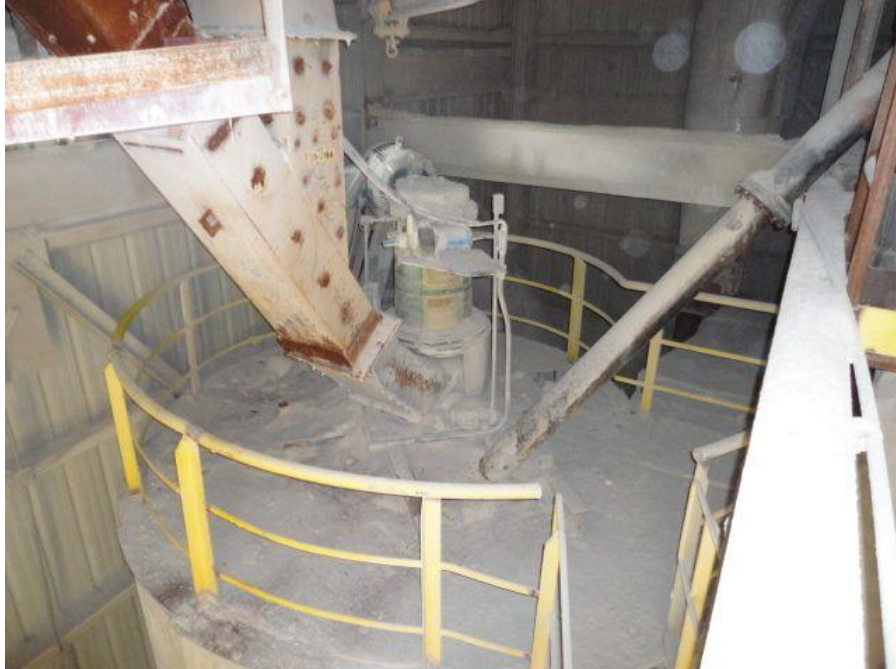
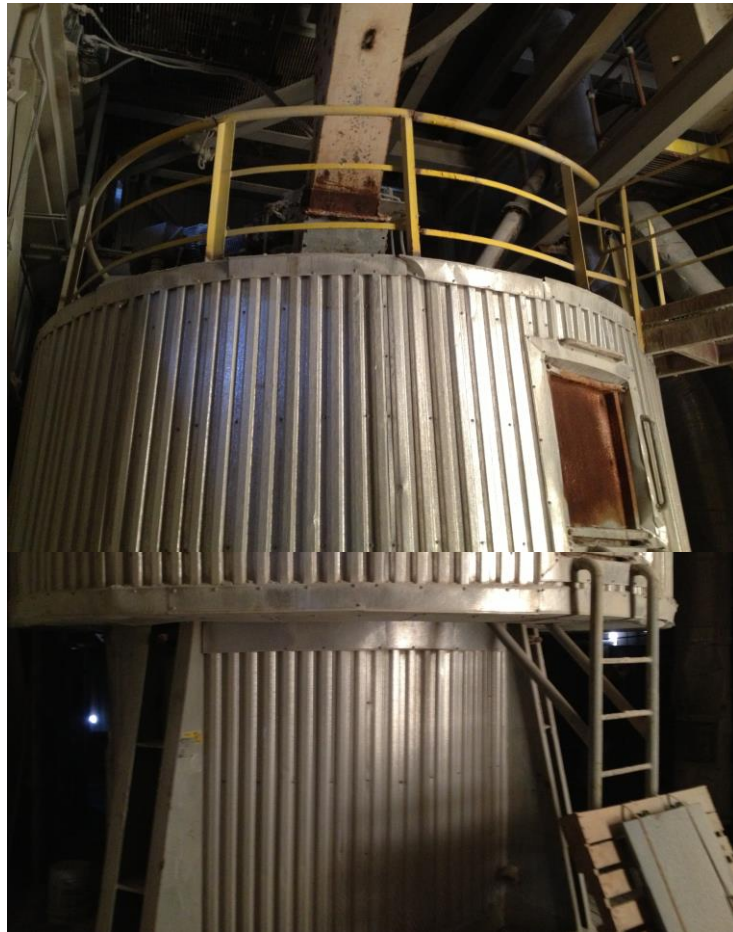
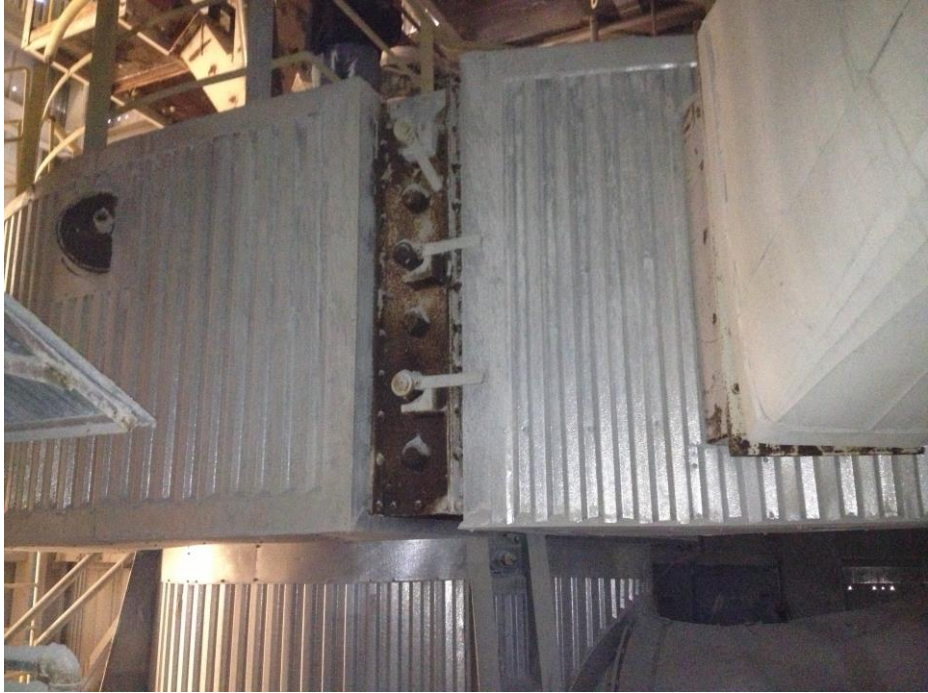
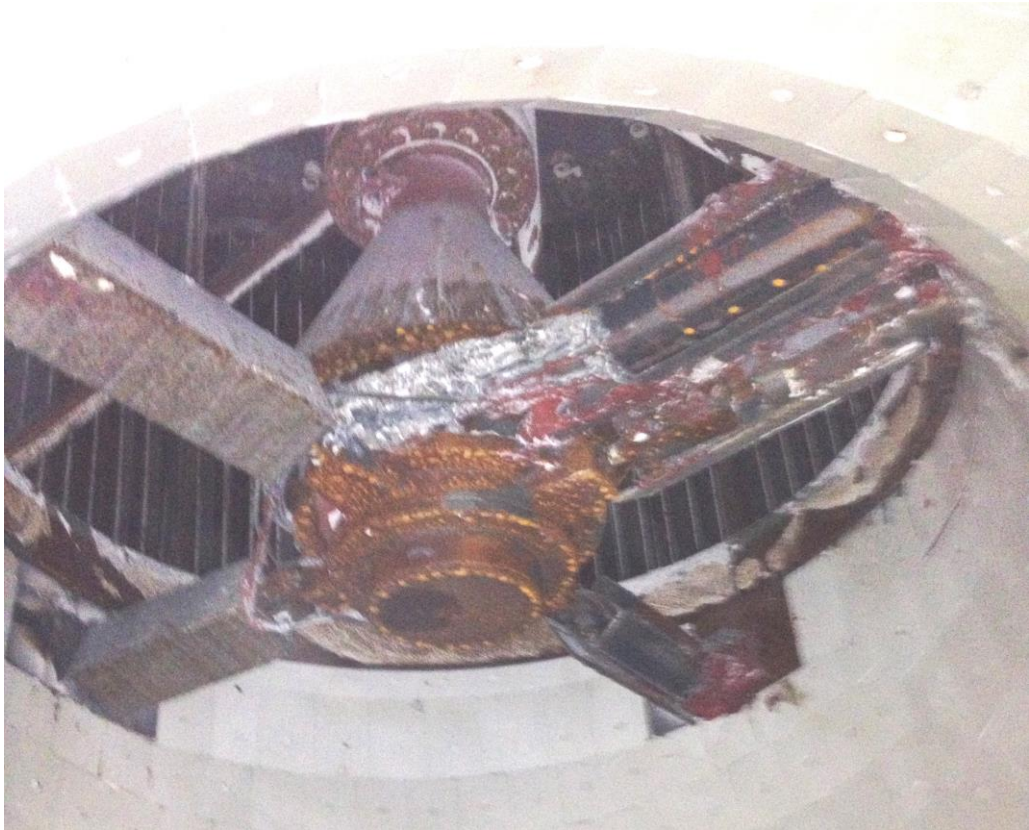
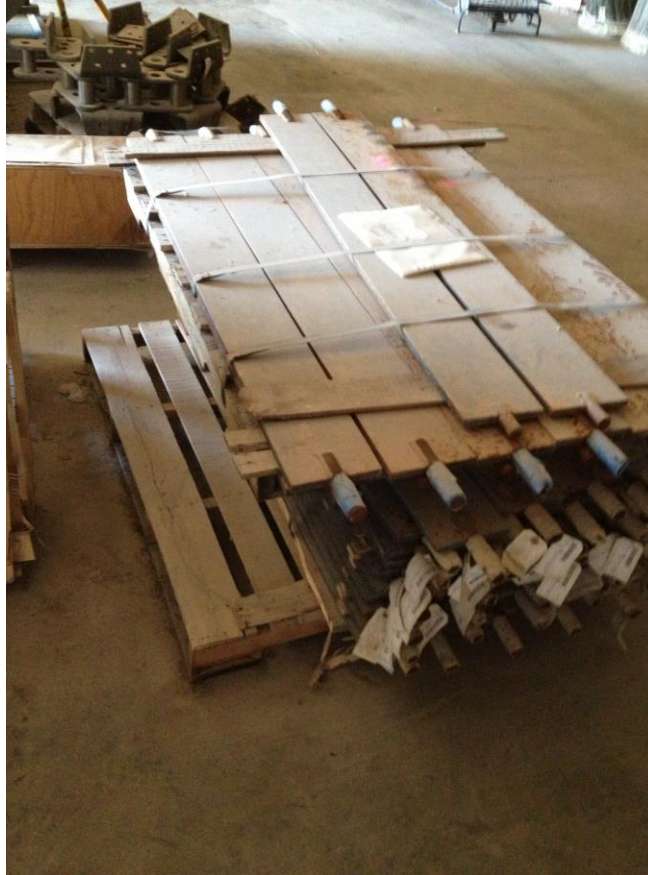
The photos on the following pages show the top feed into the classifier, a side view and the gas inlet duct. An inside inspection showed that the classifier rotor and its seal seems to be in good condition. Also the lower bearing and the bearing supports show superficial corrosion only. It was not possible to open the side inspection door towards the static flaps. However, a complete set of new static flaps was found in the warehouse (see photo).

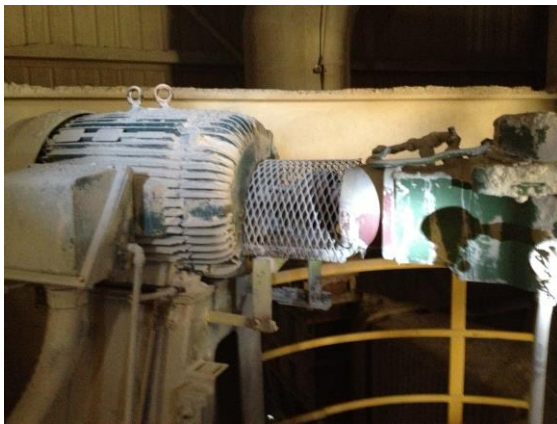
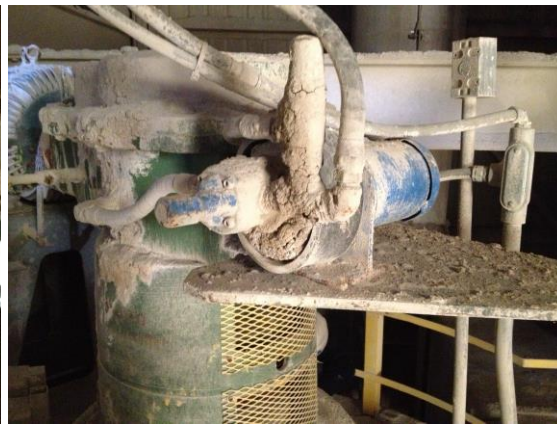
The following photos show the classifier drive. Due to the thick layer of hardened material no nameplate / tag was visible. A thorough cleaning and inspection will be needed. The installed motor was manufactured by the company “Reliance” and is rated as 200 HP @ 460 Volt and 1785 rpm max..

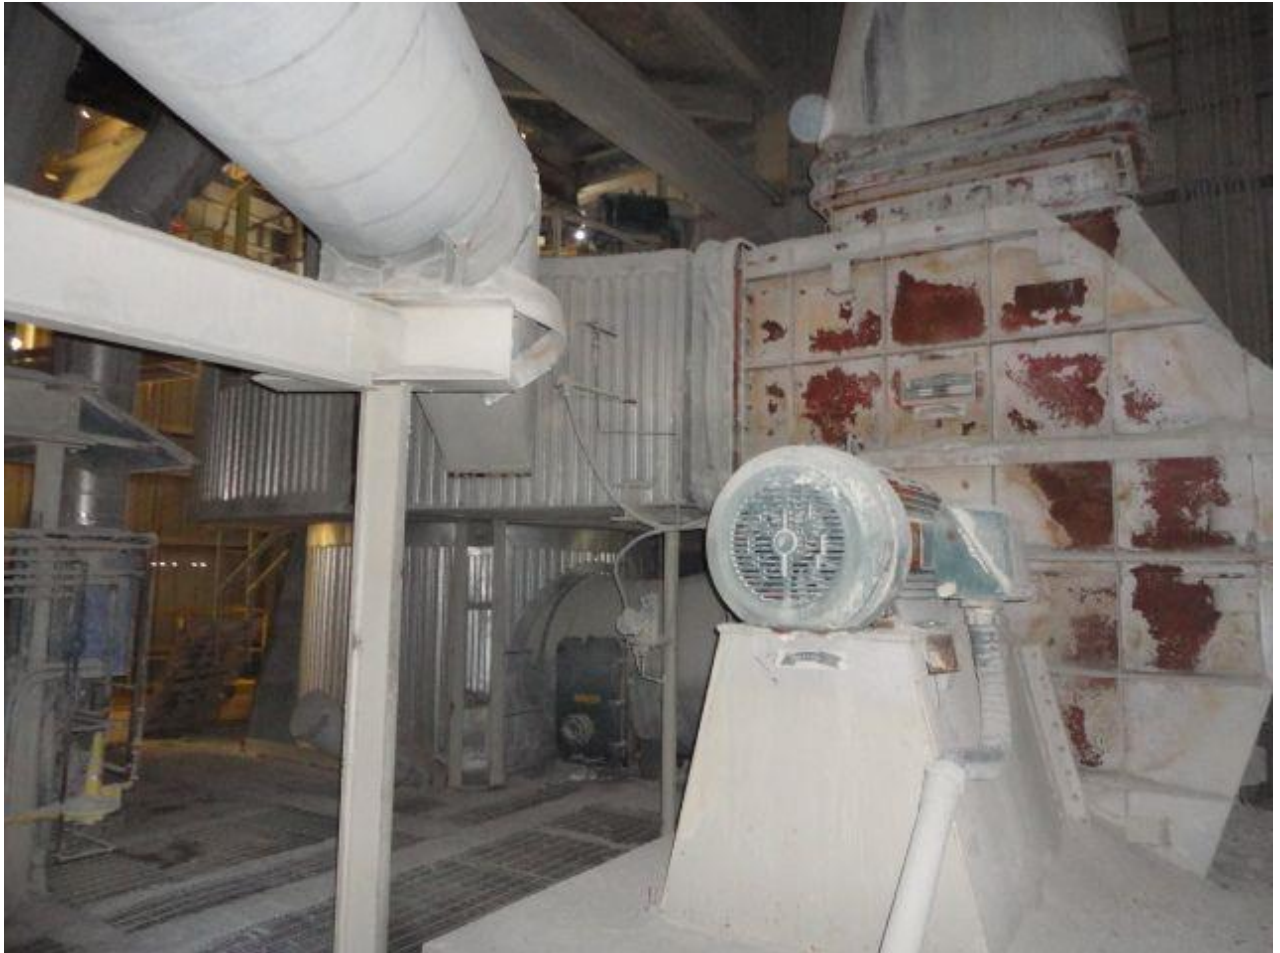
b) Pressure Fan

In this installation the distance Sepol exit to product baghouse is so long with a steep incline (see section c below) that a single fan would generate a suction above and beyond the typical baghouse design. To allow a sufficient gas flow without an excessive suction level a fan had been installed at the Sepol inlet – acting as booster fan to convey hot gas from the HGG into the Sepol and to support the final suction fan on top of the silos.

The installed fan is manufactured by “Robinson Fans, Inc” with the Type RB 1222, Serial no. 9996. The related motor is rated for 250 HP @ 460 Volt; 1185 rpm and has been manufactured by the company “Reliance”
