The equipment had been designed and manufactured in 1990, the facility had been commissioned in 1992 and was in operation until mid of 2007 (15 years). Since then the plant has been shut down. No signs of extensive mothballing have been observed, even though the plant obviously had been well maintained and kept clean during operation.

The following machines have been reviewed:

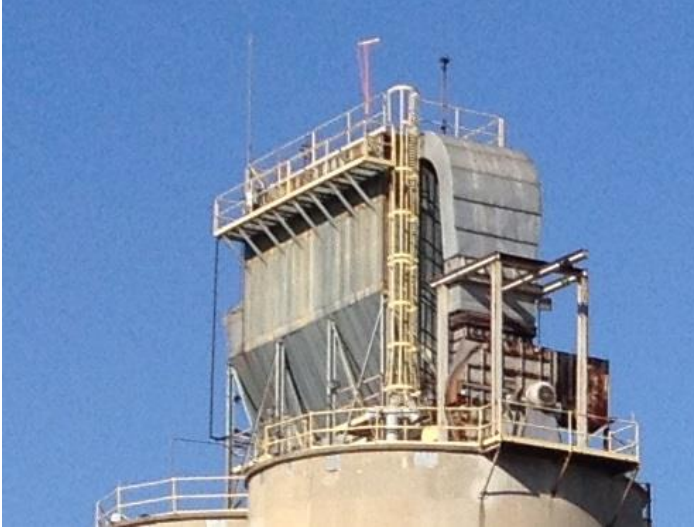
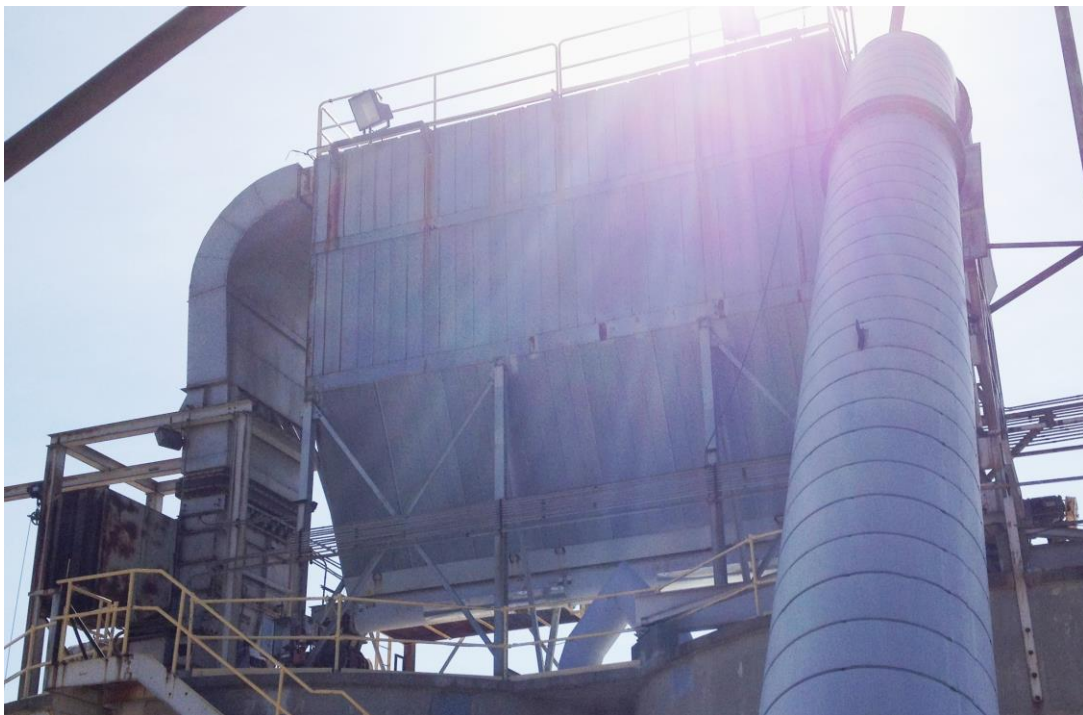
c) Baghouse and suction fan

The product baghouse is located on top of the product silos as shown in the following photos. It is equipped with a 2 way (reversible) screw conveyor. The attached suction fan is generating a gas flow that conveys the gas flow with the product from the SEPOL classifier outlet up a steep duct from the mill building over to the top of the silos.

Due to potential unsafe conditions (crossover walkway from mill building to silo top seemed corroded) no close-up inspection has been performed. The available documentation rates the equipment as following:
Baghouse suction fan (also SEPOL suction Fan): 63,000 cfm; Motor: 350 HP
Baghouse: 40 t/h material at rated gas flow, 1 compartment, by eyeballing the square housing is unusually high which points towards long bags/cages

Even though the equipment has been outdoors it looks fair (from a distance) further inspection is recommended.

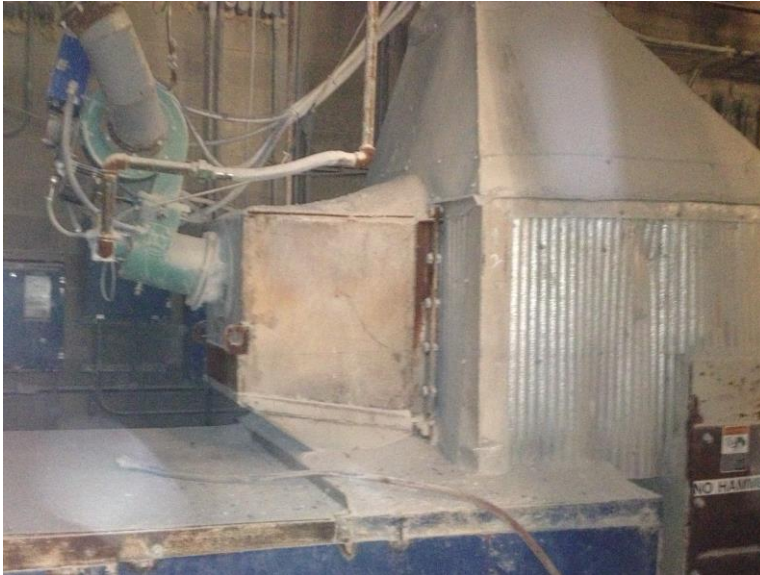
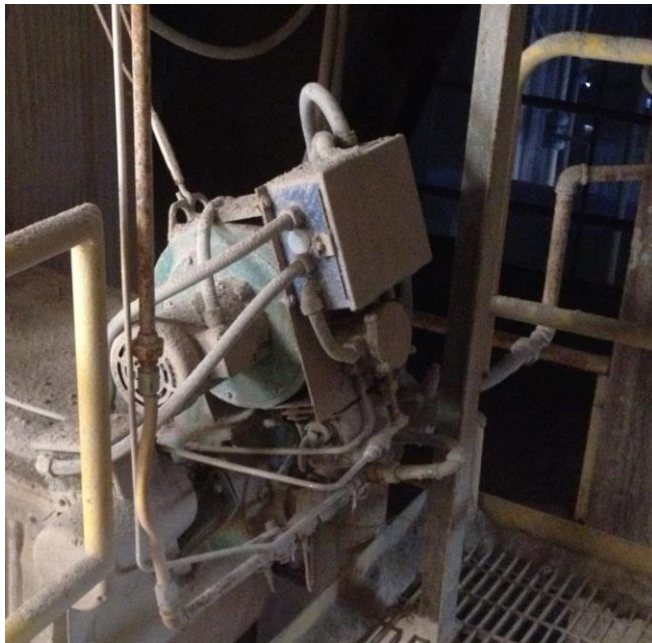
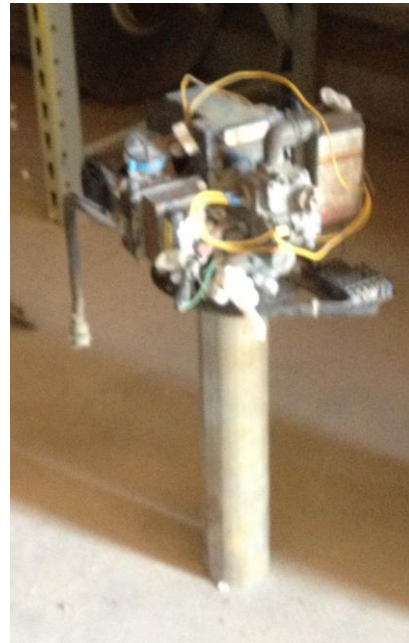
5. Auxiliary heaters from 0.5 to 1.0 MBTU utilizing natural gas to heat chutes, material transport equipment and nuisance dust collectors to prevent condensation

A total of 4 small burners are installed in the field, 1 burner was found in the warehouse. The photos document the condition of the units. As per the available documentation 2 installed units should have a capacity of 0.5 MBTU, the other 2 installed units should have a capacity of 1.0 MBTU.

The capacity of the unit in the warehouse is unknown. All units are manufactured by the company "Eclipse".
