# Conveyor Belt Transitions

## Information Paper

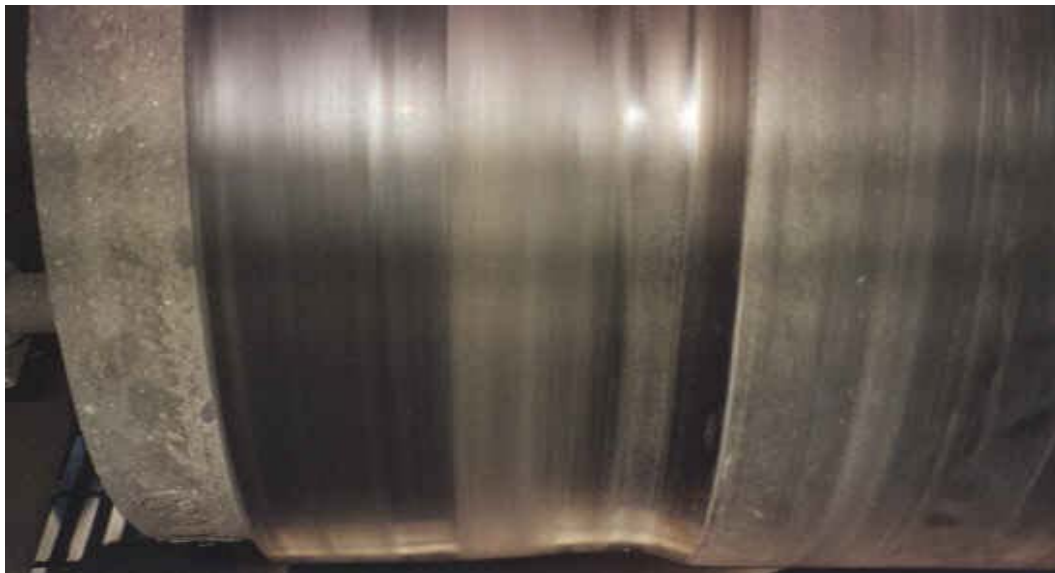
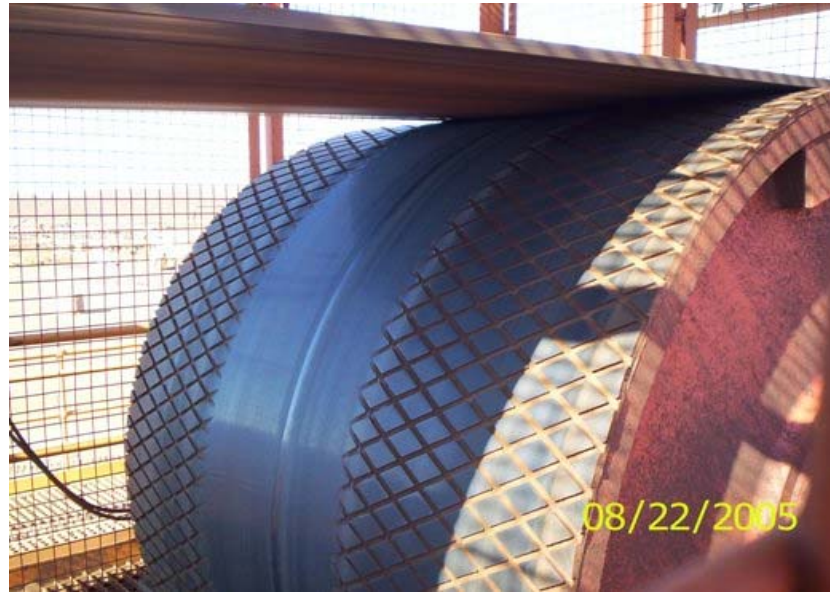
Firstly the section of belt that has contact pressure overall will dictate the pulley speed. This will usually mean the section of belt that has the shortest cables in the case of a steel cord belt. Secondly the remainder of the belt where the cables are a bit longer will move at a slightly different speed and this differential speed can lead to very rapid wearing of the pulley surface lagging. Examples of such pulley lagging wear follow.

In the case where the pulley is too low relative to the transition idlers it is generally found that belt edges have been stretched excessively so lagging wear is along the pulley sides. Where it is too high the belt has stretched along areas corresponding to centre of the idler faces and because this represents the greatest surface area of belt this dictates the belt speed so it at the idler junctions and towards the belt edge the pulley lagging wears.

The wear patterns may be different on the face of pulleys that are drive pulleys as a more complex interaction occurs as it will be a combination of face pressure and contact area that will determine how the power is transmitted.

If the belt has a permanent memory then this wear affect will repeat itself on all pulley surfaces. It will show up quickest where the tensions are highest and the angle of contact greatest.

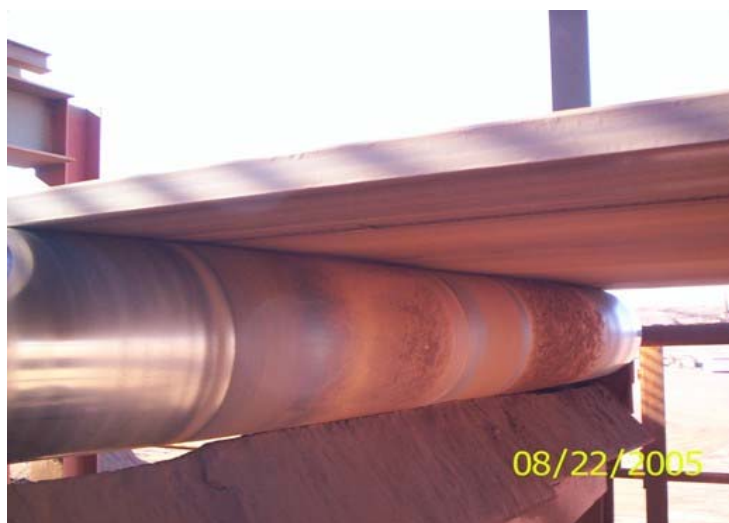
Basically what happens to the pulleys will also happen to the flat return idlers.

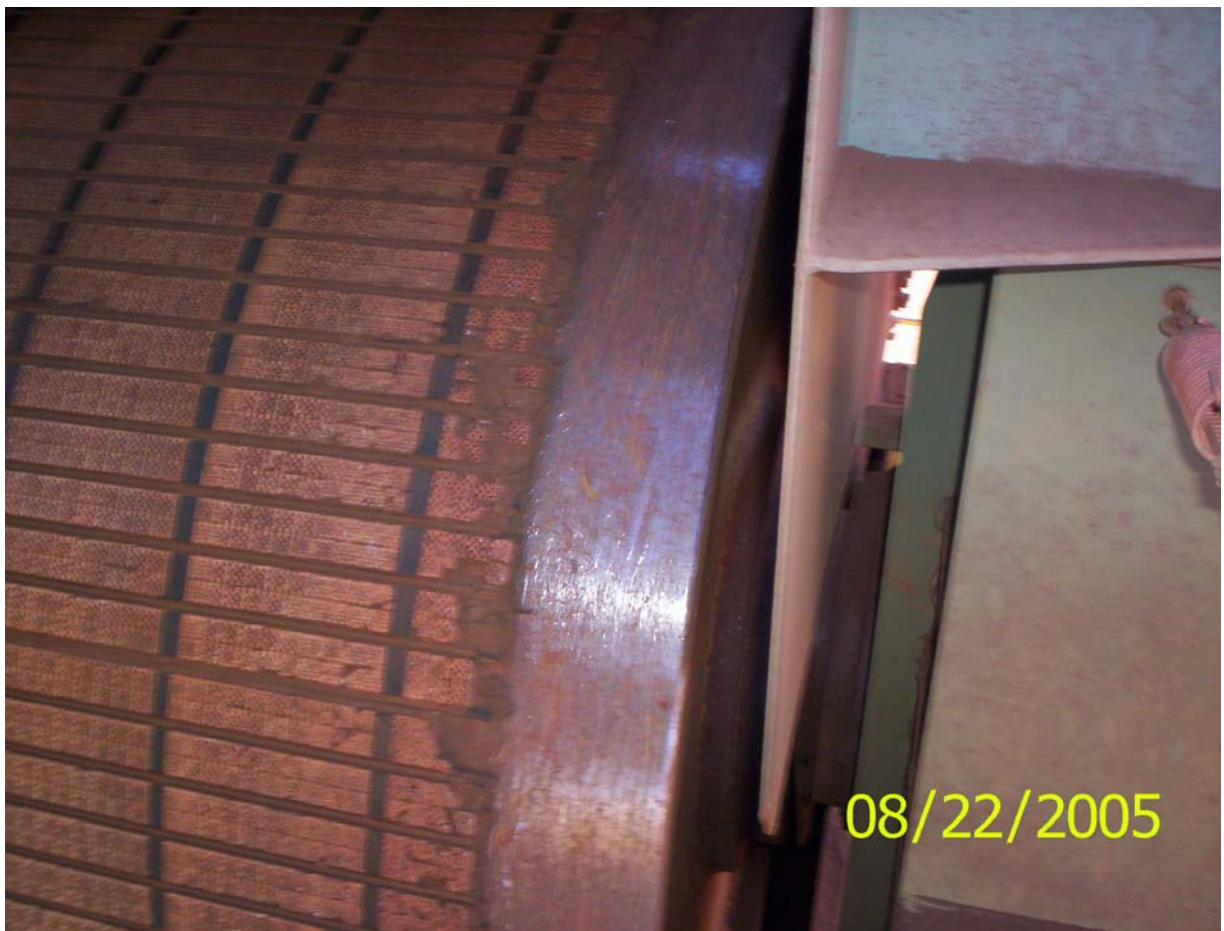
A common “solution” to fixing pulley lagging wear is to replace the rubber lagging with ceramics. This does not solve the problem, only masks it as it usually means the wear that was lagging wear is now belt bottom cover wear. In extreme tension cases, particularly when using relatively high tension steel cord belt, the tensions can be so great as to destroy the ceramic lagging. When this happens not only has the lagging been destroyed but there must be belt edge damage that in some cases will mean the belt being changing out.

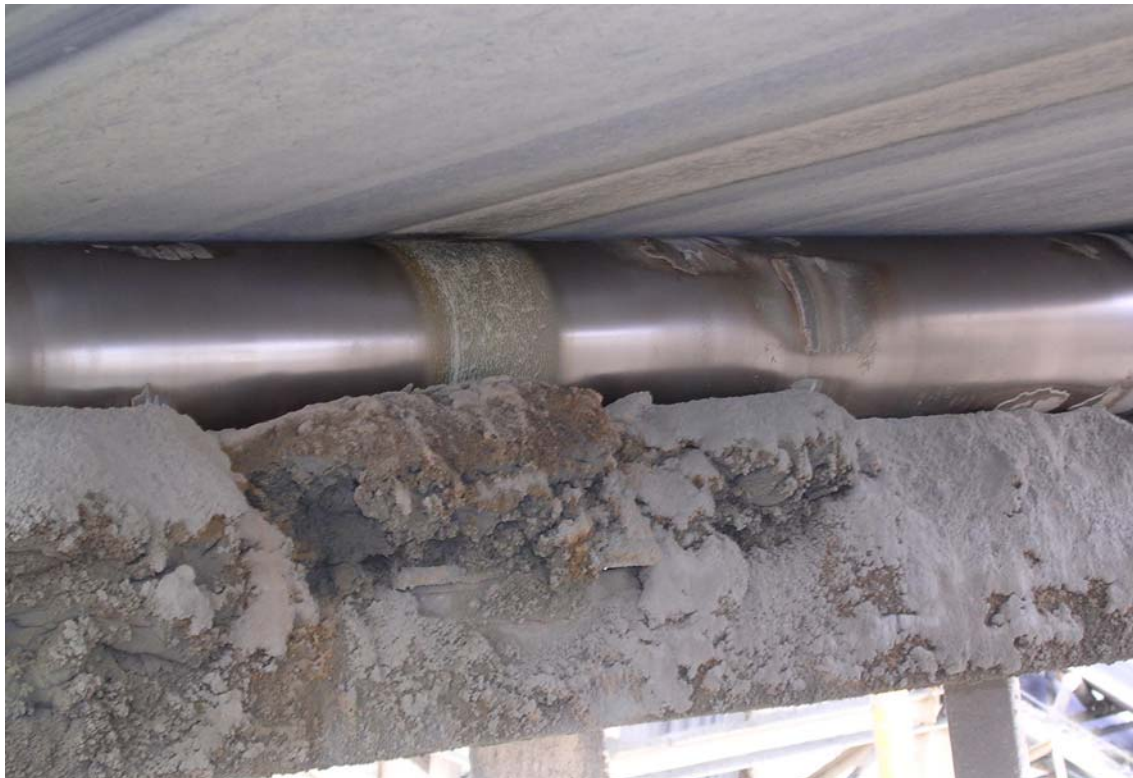
If a belt can no longer lay flat then cleaning it is very much more difficult or impossible. Belt cleaners are designed for “normal” belt wear, not “W” shaped patterns. Note the belt bellows seems to have a “W” pattern and this is not only seen by the idler contact but carry back is a consequence.

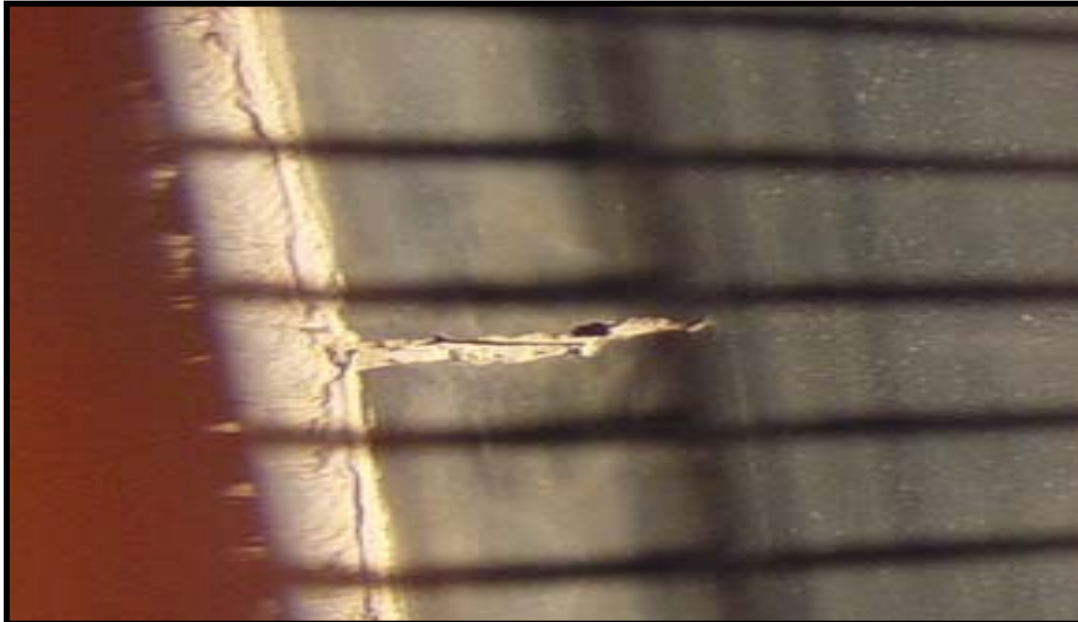
The following picture clearly shows the sort of fractures that can occur in a belt due to high edge tensions.

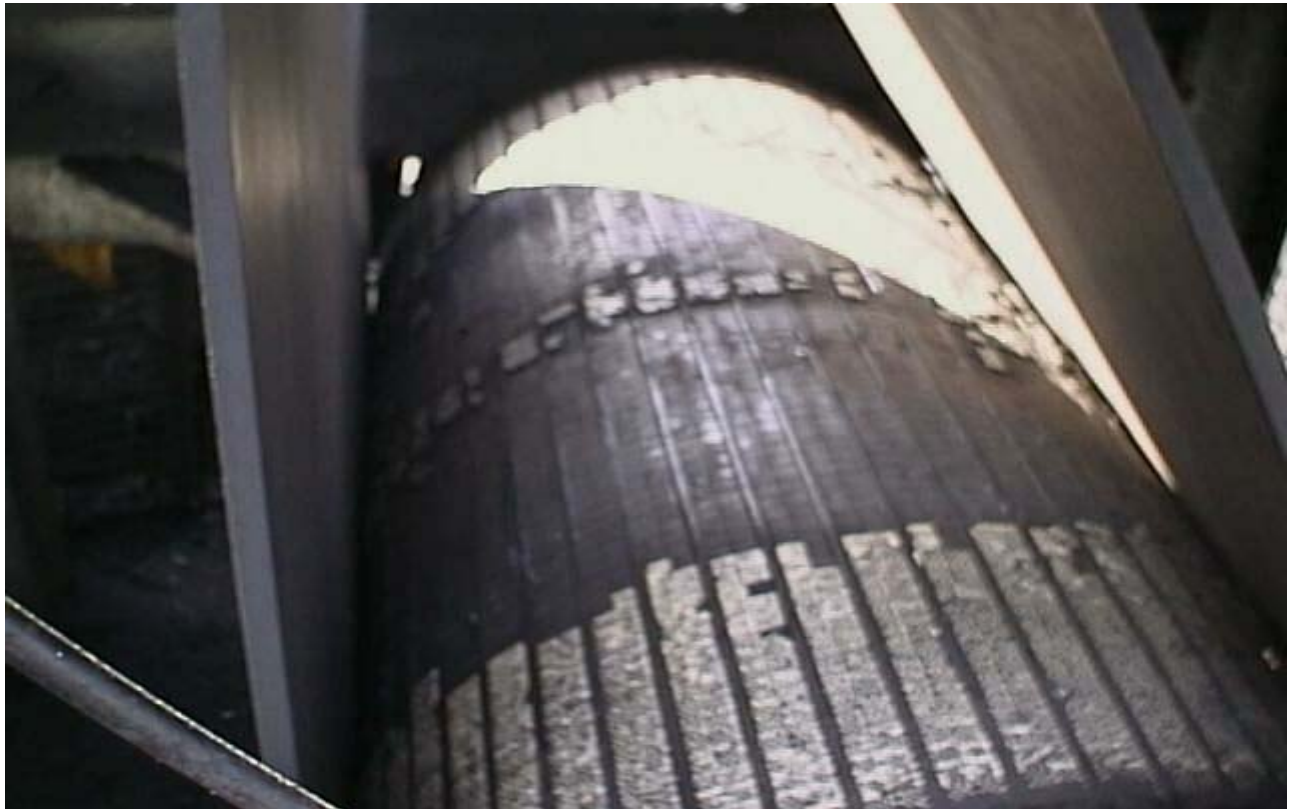
When a conveyor is started the surface area and the face pressure between the belt and the pulley is relied on to transfer the motor power to the belt such that the belt accelerates smoothly away. If the belt surface is distorted and continues to be distorted due to a poor transition then in extreme cases the effective surface area may be reduced to the point the belt may slip on start (usually on full load starts) causing catastrophic failure of the lagging on the drive and severe damage to the belt. If a tension wave is created the belt could be catastrophically broken in two. In rare cases this can also occur when the belt is running.

The following picture is just such a case. The belt was replaced due to damage to get quickly back into production; they have yet to address the pulley damage.

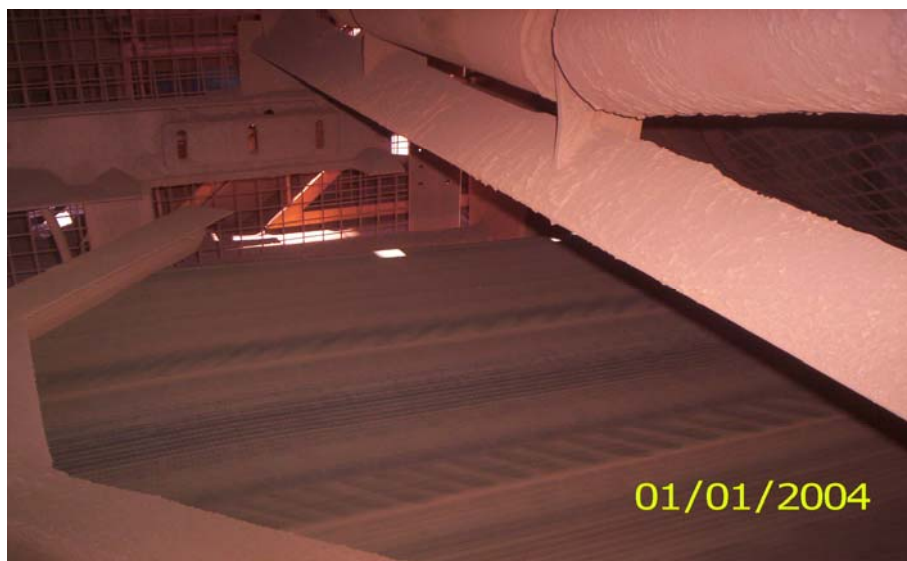
If pulley lagging and steel rollers are wearing away then so must the bottom cover of the belt. This wear will be accelerated if ceramic lagging is used to “control” the lagging wear and will be further accelerated by any failure to properly clean the belt because it no longer lays flat. It is not unusual unfortunately for bottom cover wear to be the cause of a belt being changed out and this wear is invariably related to transitions.

The above belt has exposed cables in the centre of the bottom cover, top cover fine

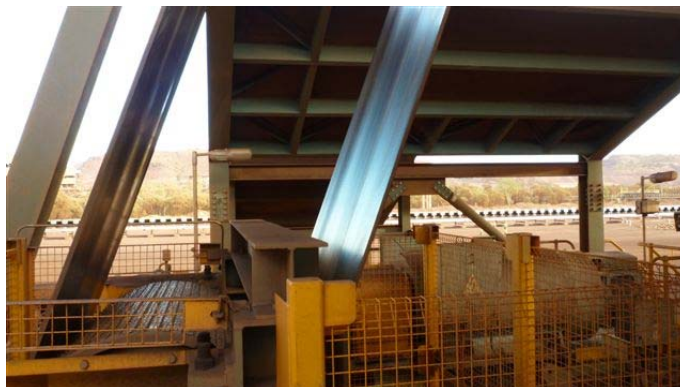
- 1) In the take up area if there is along section of belt basically hanging down. The belt quickly starts showing marks that indicate it is not evenly contacting the pulley faces as the following picture shows.

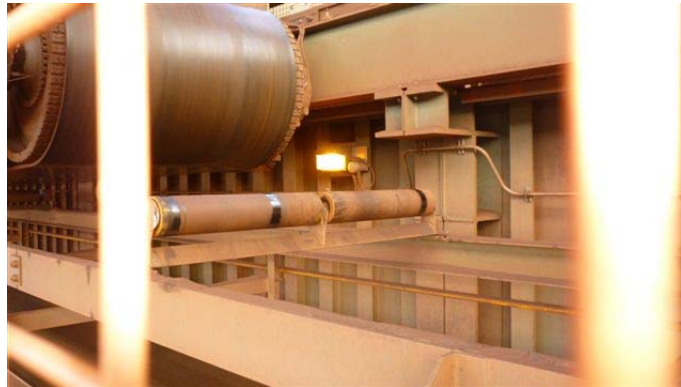
- 2) If there are flat returns in the high tension zone there will be marks on the idler face that indicate the belt is not lying flat. The following picture is a clear indicator.
