Pipe Behaviour in Bottom Ash Slurry Systems

Joseph Kovago, USA

Summary

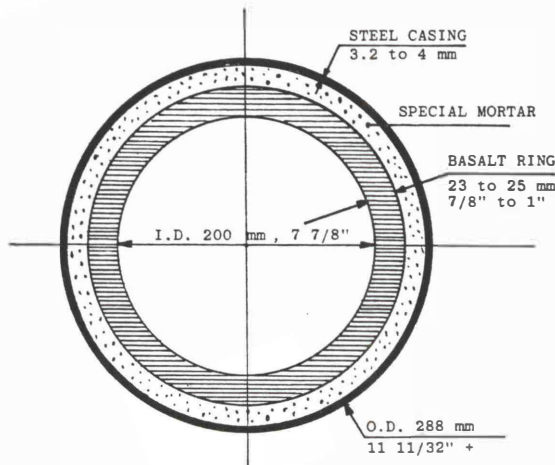
The second phase of the test program has been much more encouraging than the first phase. In 1966, a new pipe appeared on the market under the trade name of Abresist which has been used very successfully in Europe in similar service conditions. This pipe shown in Fig. 8, contains basalt rings

which are installed in a steel casing with a special mortar. Basalt is a volcanic material which has been used in Europe and elsewhere for road cover since ancient times when Roman legions needed reliable roads. For instance, in the Appian Way in Rome, the original basalt has survived 2,000

Fig. 8: Typical new Abresist pipe

years. Basalt for this Abresist pipe is mined in West Germany. It is crushed, liquified around 2,300°F and poured into molds. Recrystallization in a well controlled annealing process yields a homogeneous material with diamond like hardness. (Mohs' scale hardness is approximately 8.)

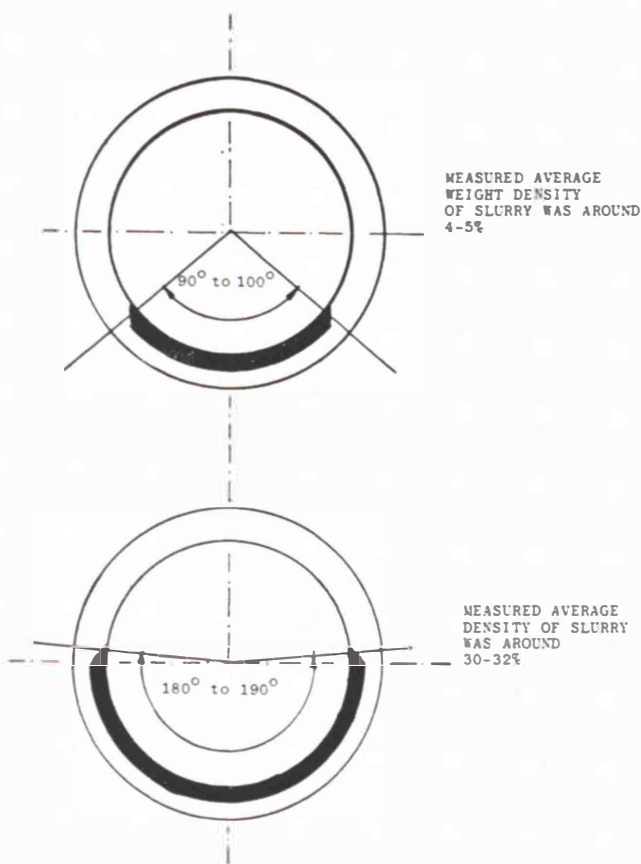
Other tests revealed that the quality of bottom ash requires attention. It was found that particle size distribution and specific gravity would influence the degree of deterioration. In addition, an interrelation between the expected angle of wear and the slurry density has emerged in this program as described in Fig. 12.

Fig. 12: Interrelation between the angle of wear and slurry density
