Whitepaper

Avoiding the Rip off - A Guide to Chevron Conveyor Belts

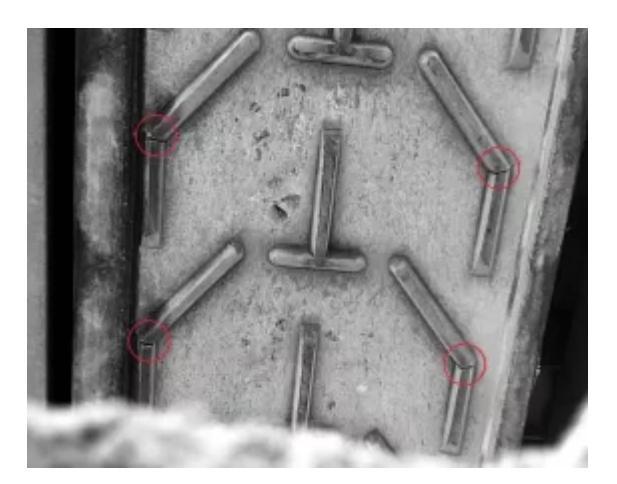
Fig. 1: A common problem – profiles that split and eventually detach from the base belt.

One of the most common problems experienced by many operators affects high chevron belting because the chevron profiles can become partly detached or ripped off entirely.

However, this directly creates the 'Achilles heel' of all chevron belts made in this way. This is because the contact point where the two different rubber compounds join then becomes a point of weakness. The chevron profiles constantly stretch and flex under tension each time they run around a pulley or drum. Unless the bond between the base belt carcass and the chevron profile is absolutely flawless then sooner or later dynamic stress fractures will start to occur, causing the profile to split. Especially on belts conveying hard, heavy lumps of material, the constant impact weakens the joint between the base belt and the chevron. Either way, eventually the chevron will part company with the rest of the belt. The problem is significantly magnified on conveyors with relatively small pulley diameters, especially mobile equipment. The smaller the pulley then the higher the dynamic stress. Failure will happen even sooner if one (or both) of the rubber compounds used are not fully resistant (as per ISO 1431 testing) to the effects of degradation (surface cracking) created by chemical reactions in the rubber caused by ground level ozone and ultra violet light.

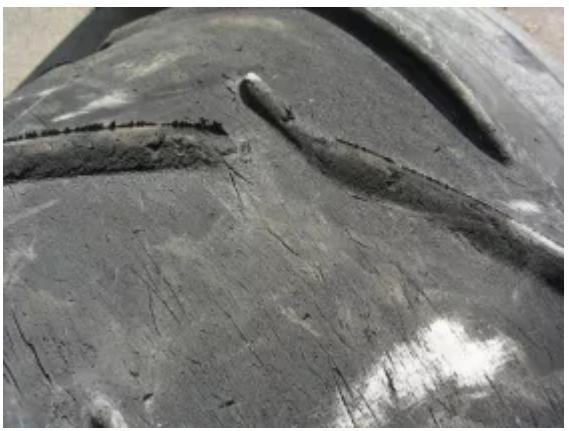
Fig. 2: Chevrons as high as 25mm or 32mm can wear almost completely flat in a remarkably short time.

Research and experience has shown that the rubber used to make the chevrons in the two-step production process almost invariably has much lower resistance to abrasive wear than would normally be acceptable. It is not unusual, especially among so-called 'economy' belts imported from Asia, that even chevrons as high as 25mm or 32mm can wear almost completely flat in a remarkably short time.

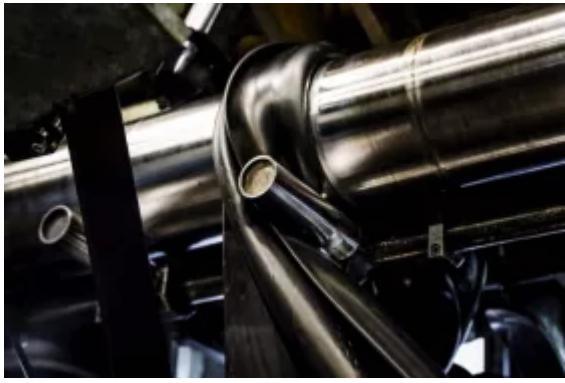
Fig. 3: A 'single structure' chevron belt needs a highly specialised rubber.

These properties include wear resistance, tensile strength and durability while at the same time also being sufficiently malleable to allow the rubber to flow smoothly and evenly into the moulds. The rubber then needs to be able to vulcanise virtually simultaneously within the mould AND the base belt structure. Not only that, the compound also needs to be fully resistant to the effects of ozone and ultra violet light (for longevity of working life) and conform to European REACH regulations so that the end product is also safe to handle.

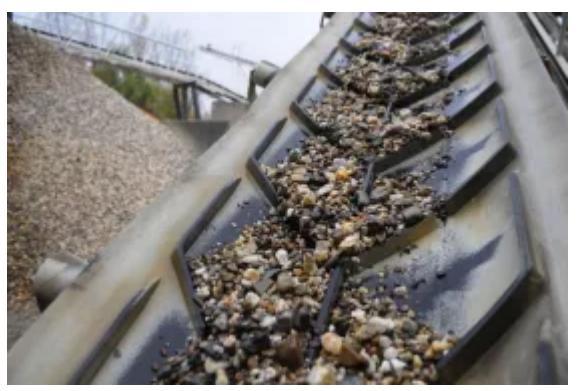
Fig. 5: Chevron belts with a single homogenous structure are stronger and longer-lasting by far.

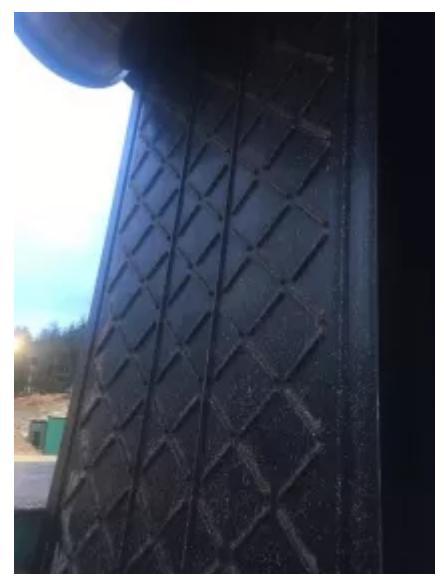
Unlike their chevron counterparts, making single, homogenous structures is relatively easy to achieve with low profiles because the rubber only has to flow a small amount compared to high chevron profiles. Yet again, the key influencer as far as performance and value is concerned is the quality of the rubber. In this case it is ability of the rubber to resist wear (abrasion) and to resist the effects of ozone & ultra violet that are the most crucial. As far as European-based quality led manufacturers like Dunlop are concerned, achieving working lifetimes as long as five years is more than possible.
