# **Troubleshooting Belt Cleaners - Optimising Productivity rather than fixing Breakdowns**

Published in bulk solids handling, Vol. 34 (2014) No. 1

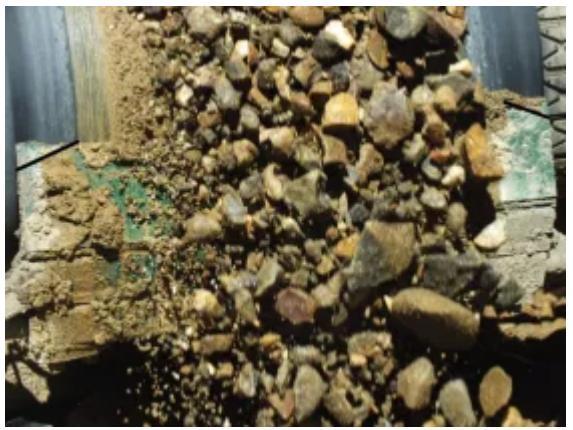
Fig. 1: Typical primary belt cleaner installation. In this picture you also find trim marks for the blade (see below). (Pictures: © Kinder & Co Pty Ltd.)

In the event of this occurrence, it is suggested that sections be cut off, where the smiling is starting to form (see Fig. 1). This will provide a more even cleaning edge, prolonging the blade's wear life and increasing overall cleaning efficiency.
