White Paper

How to achieve a clean Conveyor Path: Innovative Belt Cleaning Technology eliminates Carryback at Cement Plant

Published in bulk solids handling, Vol. 37 (2017) No. 3

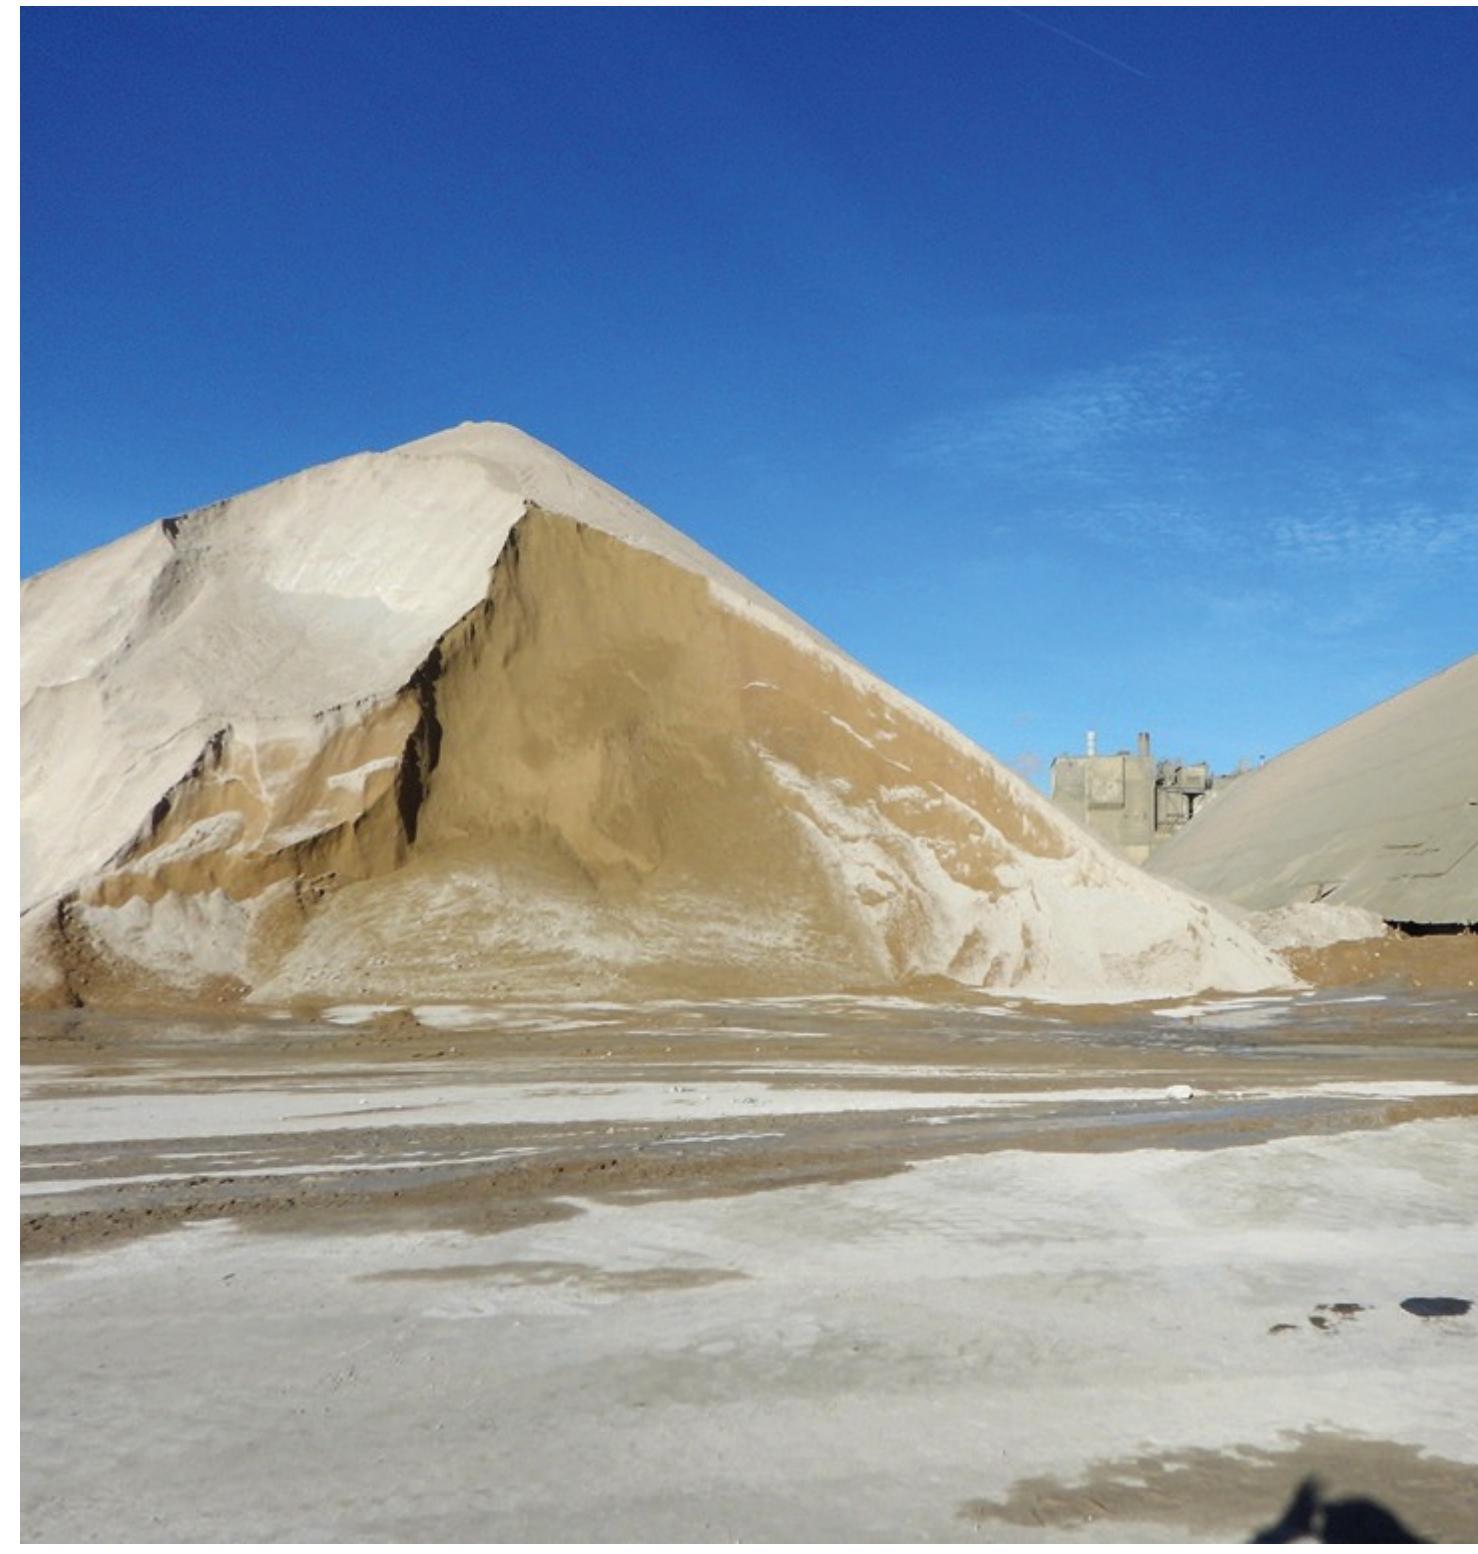
Limestone and other raw material taken from trucks and barges is stored in outdoor piles.

Front-end loaders transfer the fine grained, dust containing 1.5 to 2 inch (38 to 50 mm) minus limestone and gypsum aggregate onto the 30 inch (750 mm) wide No. 14 belt. Inclined approximately 20 degrees at the point of loading, the belt conveys cargo for 20 feet (6 m) up to ground level, moves horizontally for 200 feet (60 m), then begins another long 30-degree incline into the top of a 50-foot-

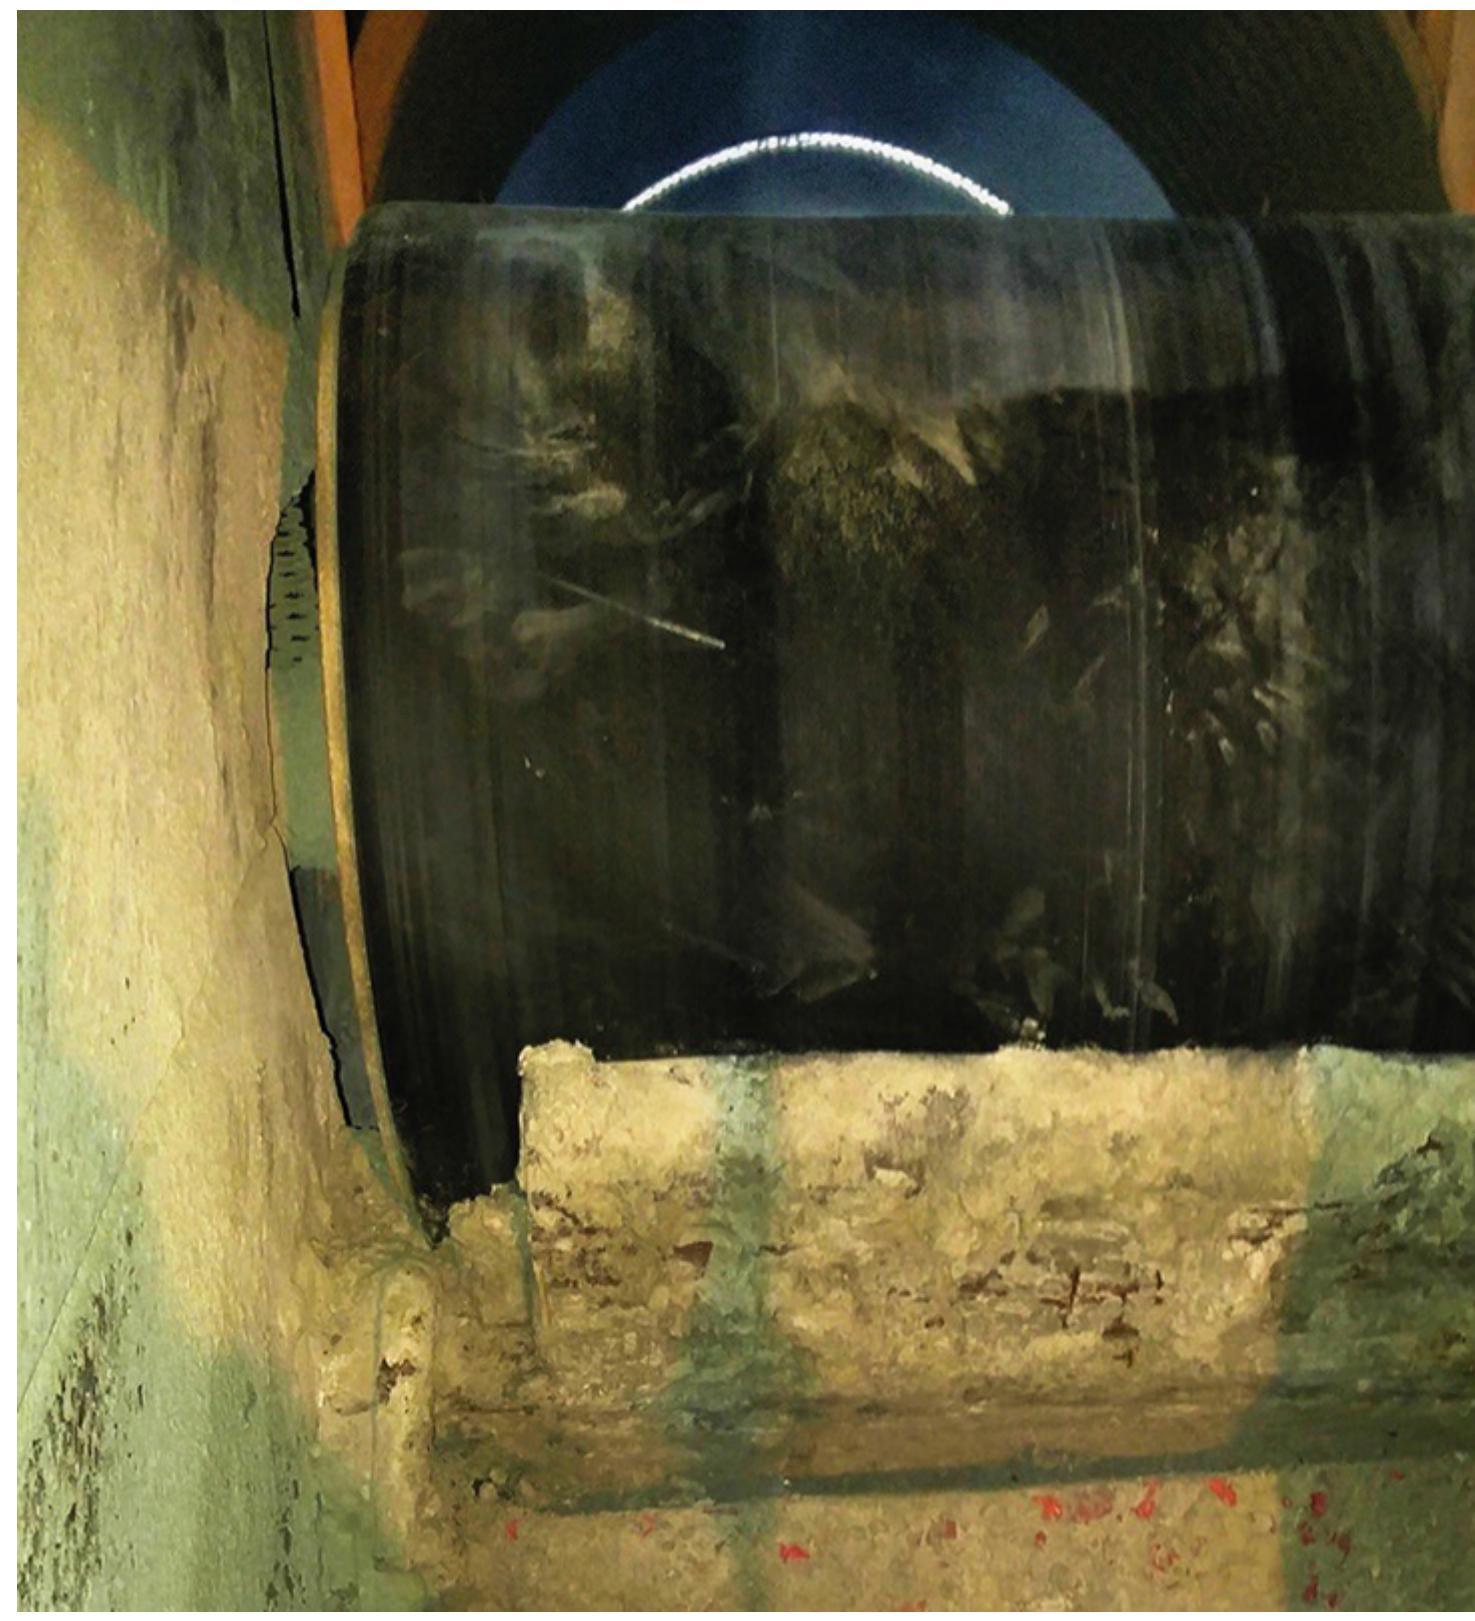
The previous blade heaped up and encrusted material, degrading cleaning performance.

tall transfer tower. In the conveyor discharge zone, with only enough room to fit one primary cleaning blade, material is offloaded into a chute.Operators found that polyurethane cleaner blades were unable to completely clean the belt. "The fines and mud take on the tacky consistency of toothpaste, causing it to cling to the belt along with smaller pieces of aggregate and shale," said David Accomando, Plant Maintenance Supervisor for St Marys Detroit. "This led to a lot of carryback spilled along the return path, where it fouled idlers and built up so high under the loading zone that it would encapsulate the tail pulley."

Maintenance technicians periodically had to stop other essential duties and shut down the system to replace frozen return idlers and prevent further damage. After digging out the tail pulley, workers needed to clean the face, which often had abrasive buildup that could reduce the belt life. The cleaner required regular tensioning and periodically needed to be removed, re-cut and shaped. In addition, 2 to 3 workers spent up to 8 hours twice per month to clean the loading zone and the belt path using shovels and a vacuum truck.

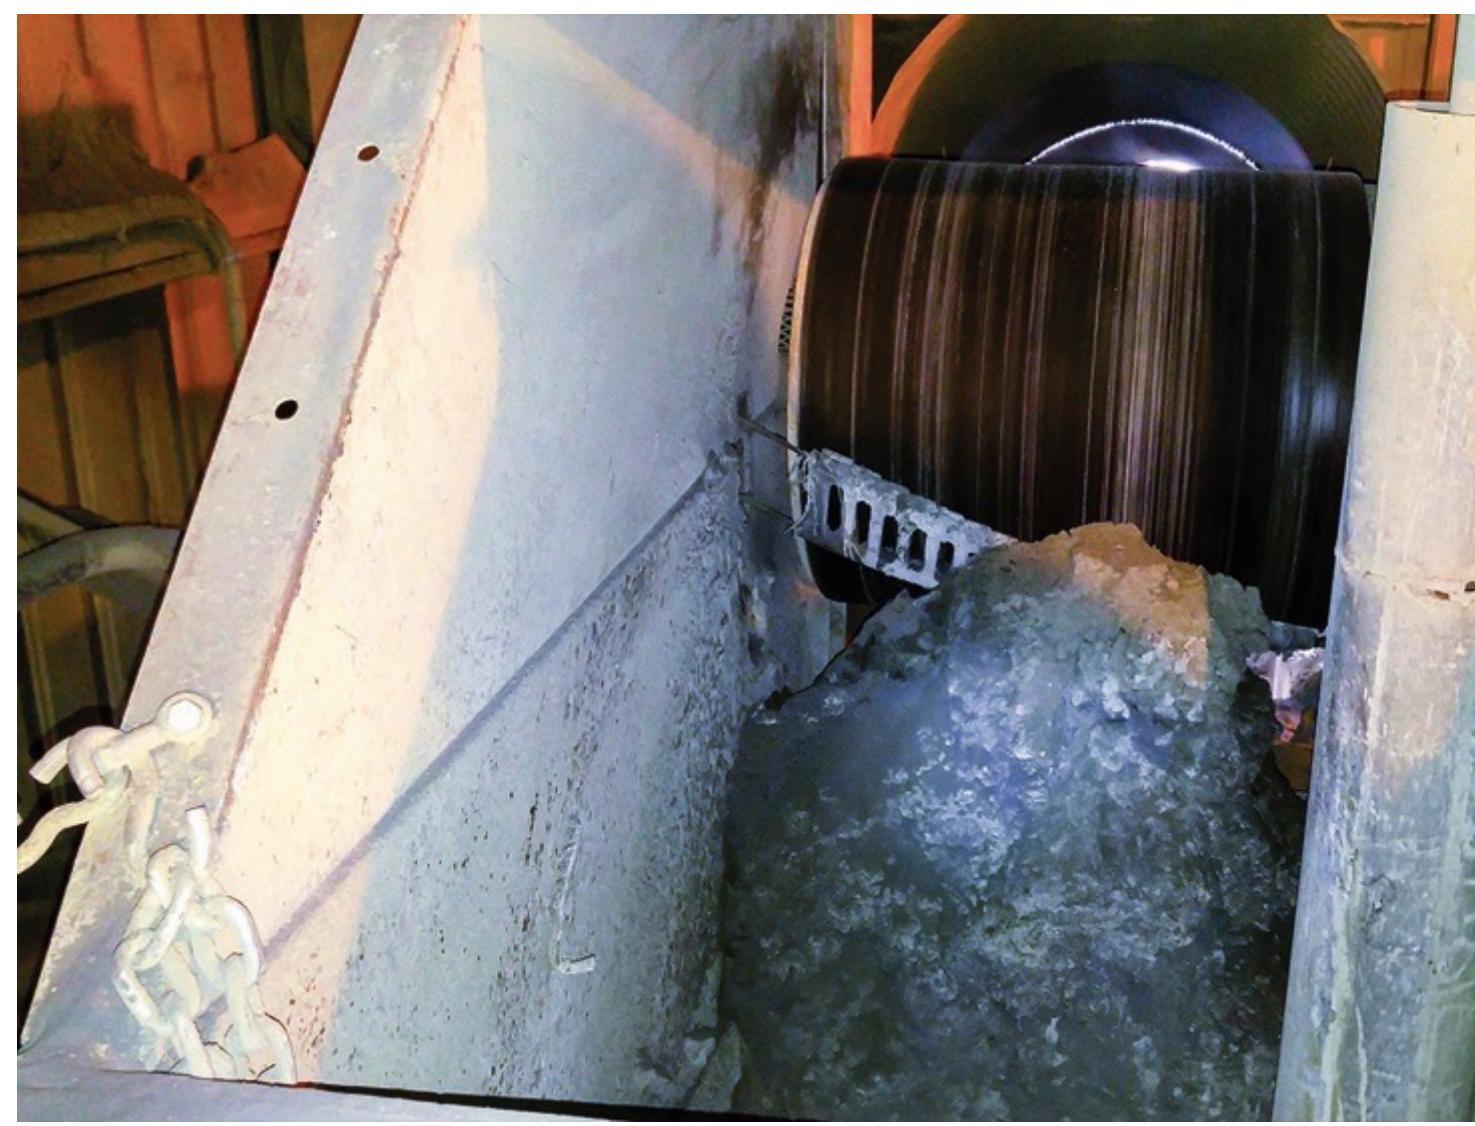
Mounted diagonally, commonly at a 17^o angle, the Cleanscrape spans the entire belt profile.

The flexible cleaner is installed diagonally across the discharge pulley, forming a three-dimensional curve beneath the discharge area that conforms to the pulley's

shape. The unique design incorporates a matrix of tungsten carbide teeth and is tensioned lightly against the belt to prevent damage to the belt or splices. Despite extremely low contact pressure, it has been shown to remove as much as 95% of potential carryback material.Designed for belt speeds up to 780 fpm (4 m/s) for mechanically spliced belts, pulley diameters up to 50 inches (1270 mm), and belt widths up to 96 inches (2438 mm), the Cleanscrape is engineered to perform under the punishing conditions of cement applications and other bulk handling industries. Its patented design requires very little maintenance. The tensioners are tightened during initial installation, and typically no further adjustment is required over the life of the blade.
