Tuning your Conveyor Accessories

Dealing with the Impacts of High-Speed Conveyors

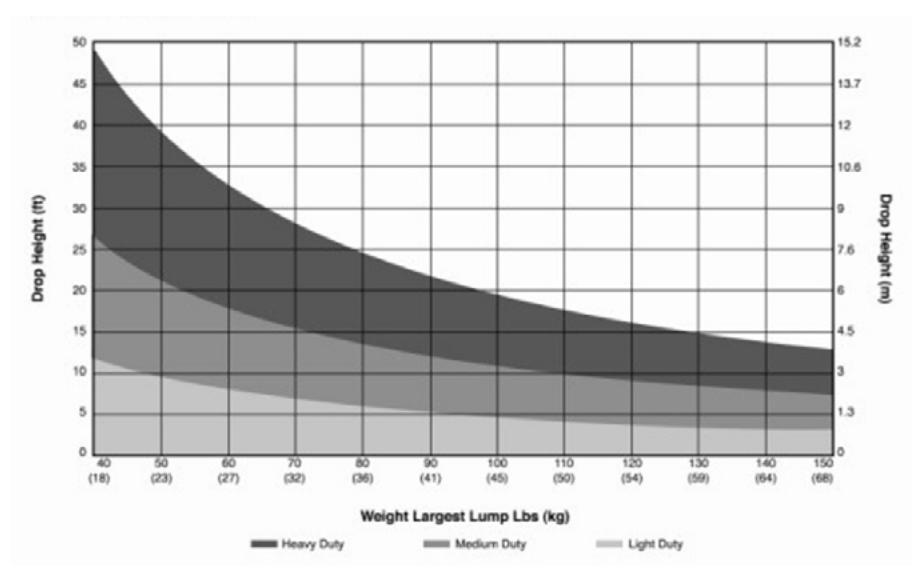
Specifying the correct cradle for the application is a function of the drop height and the weight of the largest lump

Specifying the correct cradle for the application is a function of the drop height and the weight of the largest lump. Fig. 1 provides a selection guide to help determine which cradle is most appropriate for specific lump weights and drop heights.

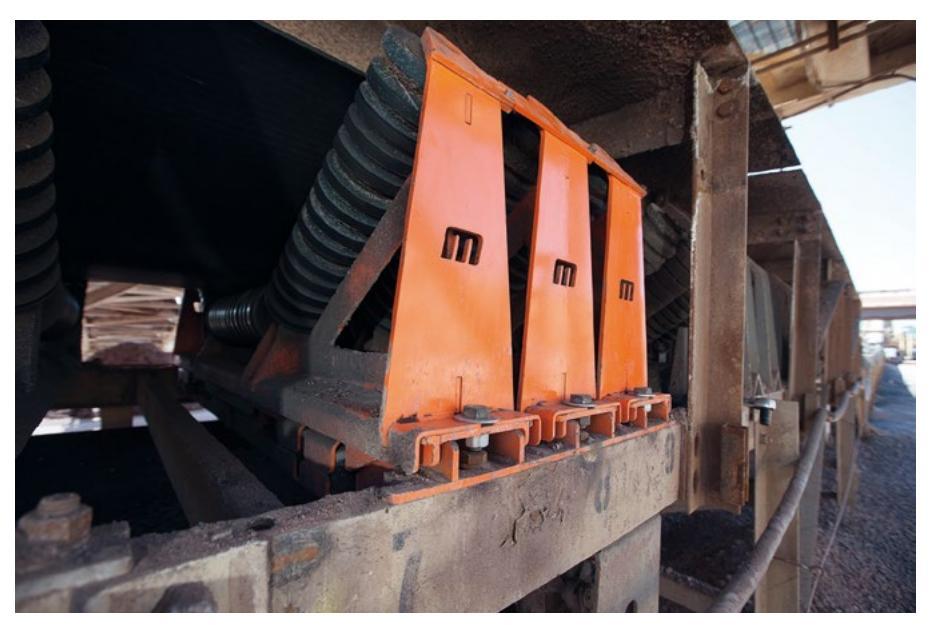
The new EVO High Speed Roller Cradle employs multiple heavy-duty impact rollers spaced close together in a track-mounted configuration.

Developed to withstand the highest speeds achievable with heavy-duty idler rolls, the new EVO high speed roller cradle takes a different approach to softening material impact, utilizing multiple heavyduty impact rollers spaced close together in a track-mounted configuration. An elastomer bar suspension allows a defined vertical travel, absorbing the shock of impact and maximizing the service life of the belt support structure and rolling components. Because of the track-mounted configuration, the new cradle delivers slidein/slide-out serviceability, without the need to tip the idler for removal.

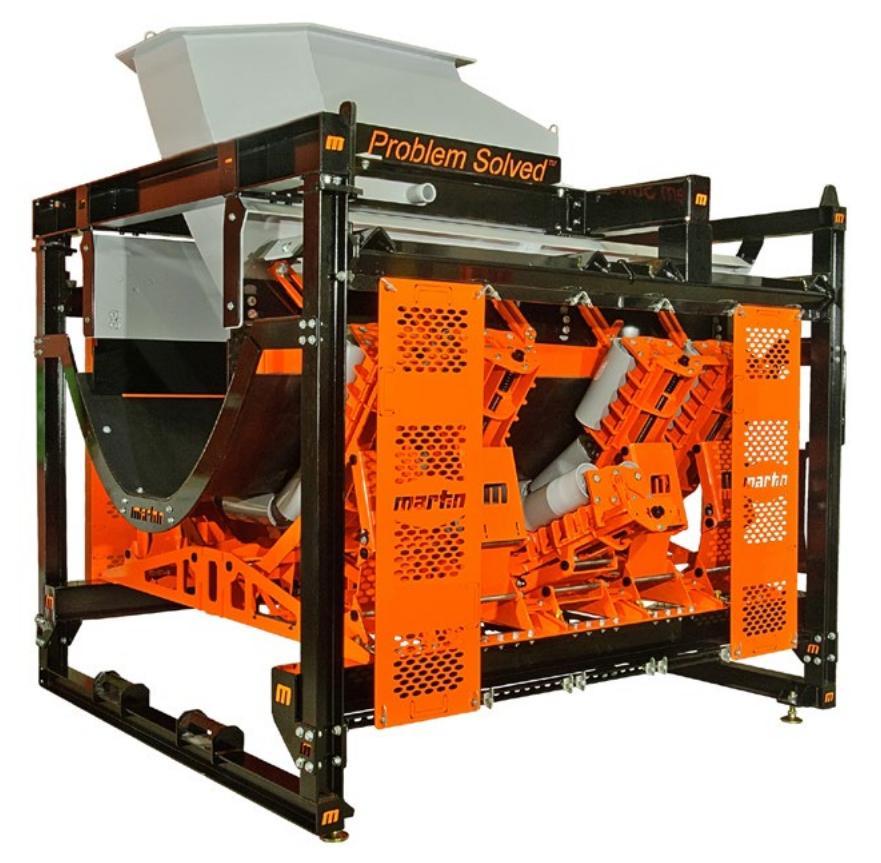
With its track-mounted configuration, the new cradle delivers slide-in/slide-out serviceability, without the need to tip the idler for removal.

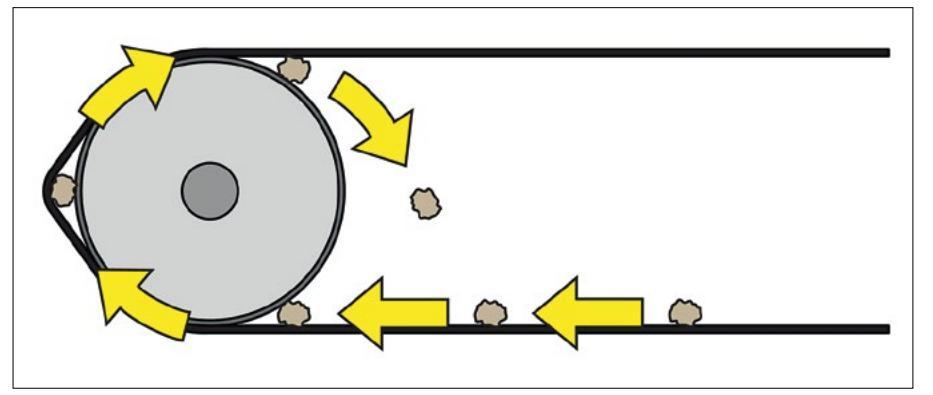
Once a piece of material reaches the pulley, it can be pinched and carried around with the pulley's rotation, then ejected back onto the return side of the belt.

If neither the material nor the belt fail, the face of the tail pulley is likely to be damaged. A gouged pulley will lead to belt misalignment, belt damage or pulley slippage. The most frustrating problem arising from the entrapment of material between the belt and tail pulley is the fact that it can become a repeating phenomenon (Fig. 4). Once a piece of material reaches the pulley, it can be pinched and carried around with the pulley's rotation, then ejected back onto the return side of the belt. Once there, it will again travel toward the pulley, where the cycle gets repeated.

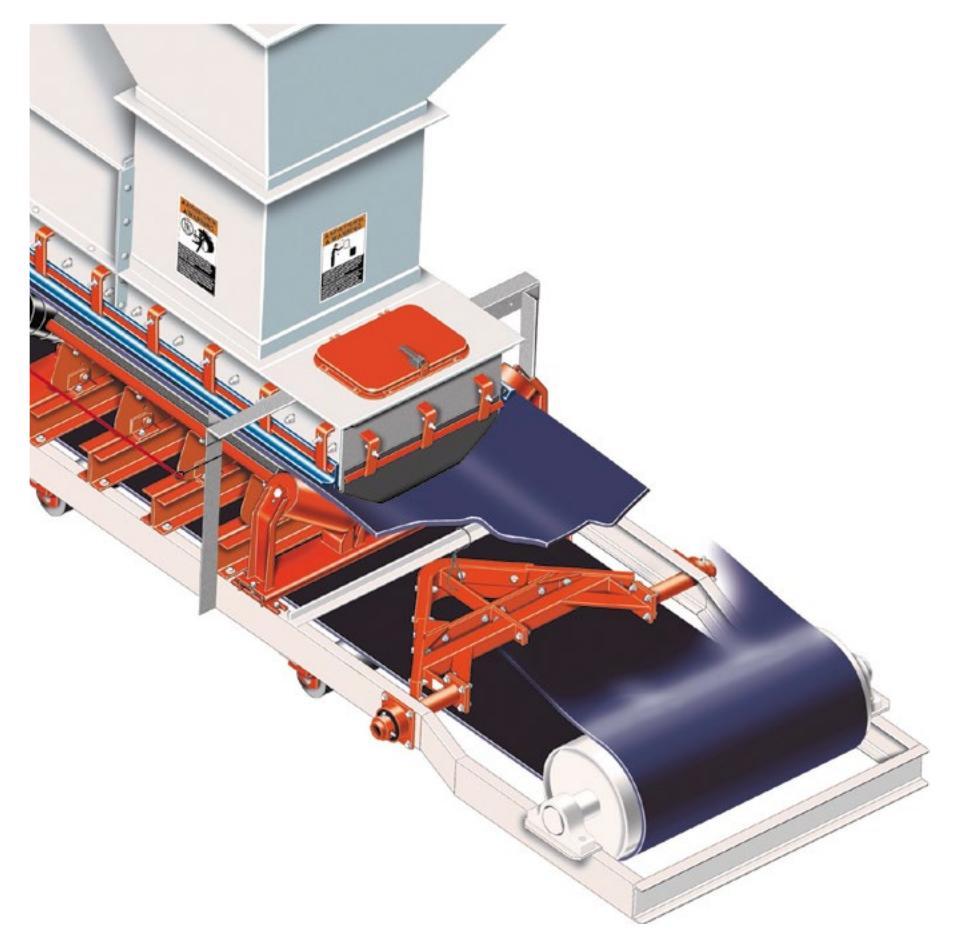
A pulley protection plow removes fugitive materials with a simple, low-pressure scraping that directs material off of the belt.

In essence, if the lump initially fails to break something, it will repeat its behavior until a failure occurs or the lump is removed from the belt. If the material is strong enough, it could eventually destroy the entire tail pulley section of a belt conveyor system. This potential damage can be minimized with proper transfer design, but regardless of precautions, there is still the possibility that dislodged components or conveyed material will come in contact with the tail pulley. An easily installed precaution against such danger is a pulley protection plow. (See Fig. 5).

A pulley protection plow removes fugitive materials with a simple, low-pressure scraping that directs material off of the belt. The mission of a plow is to block any large lumps or stray conveyor components, such as broken idler rollers, belt cleaner blades or tramp iron from entering the tail pulley section.

Pulley protection devices are usually designed as a linear or V-shaped plow, using a steel frame with a rubber, urethane or plastic blade that directs fugitive material off the belt. These plows are typically specified in heights at least as tall as the largest lump being conveyed. At very high speeds,
