White Paper

Static Electricity Hazards - Dust Cloud Ignition caused by Static Electricity

[Published in bulk solids handling, Vol. 37 \(2017\) No. 4](#)

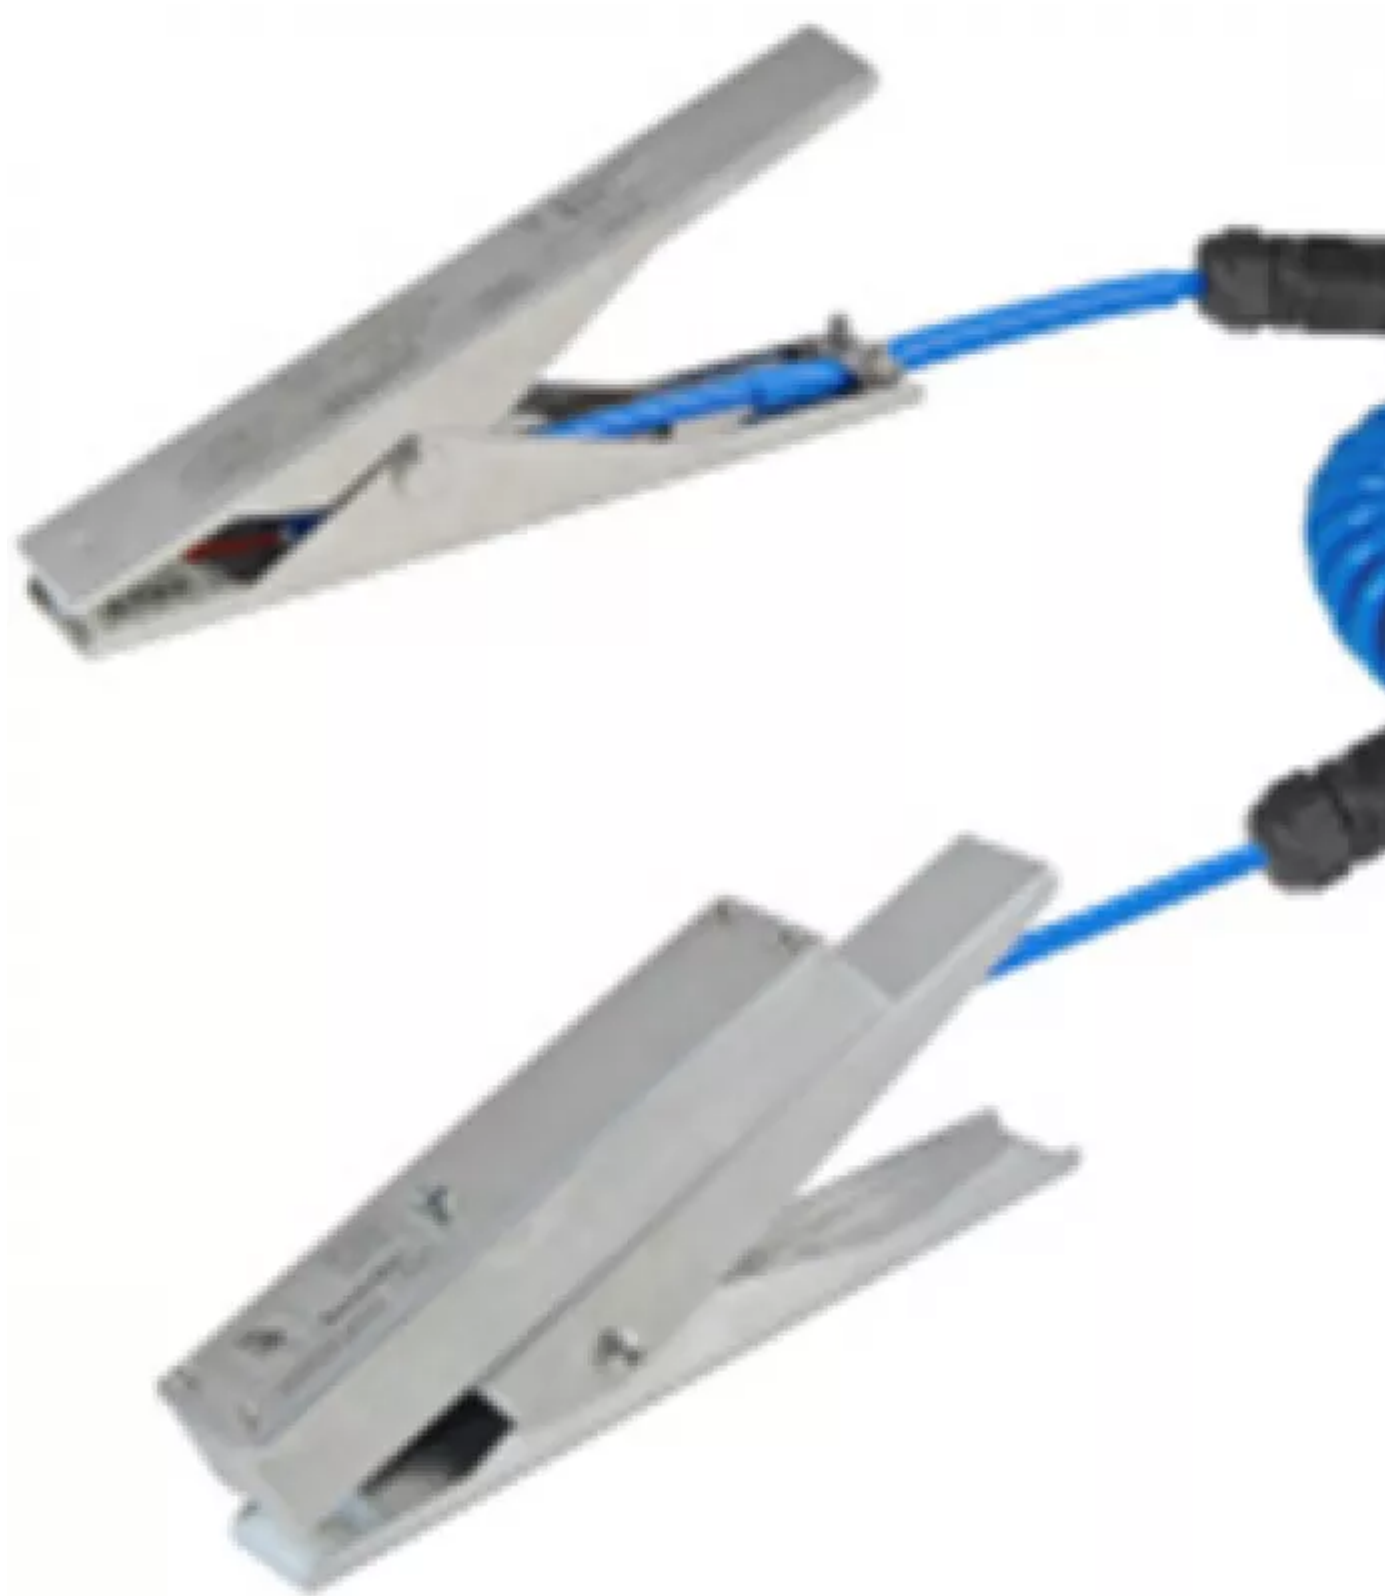
A clamp mounted LED indicates when a connection resistance of 10 ohms or less is met.

Devices like the ones highlighted in the pictures above can be used to connect the drum to the grounded process vessel. At minimum a grounding clamp with FM/ATEX approvals, like the example in the picture on the right, should be specified so that any physical impedances like paint coatings and product

deposits are fully penetrated to make contact with the base metal. The picture on the left shows a device that will inform the operator when a connection resistance of 10 ohms or less between a metal drum and the process vessel has been achieved. This is indicated via a pulsing green LED mounted in the grounding clamp that provides the operator with a simple GO / NO GO instruction to tip the powder into the process vessel.

Both IEC 60079-32-1 (13.4.1) and NFPA 77 (7.4.1.6) & (7.4.1.4) state: *“Temporary connections can be made using bolts, pressure-type earth (ground) clamps, or other special clamps. Pressure-type clamps should have sufficient pressure to penetrate any protective coating, rust, or spilled material to ensure contact with the base metal with an interface resistance of less than 10 Ω .”*
