White Paper

Avoiding the Rip off - A Guide to Chevron Conveyor Belts

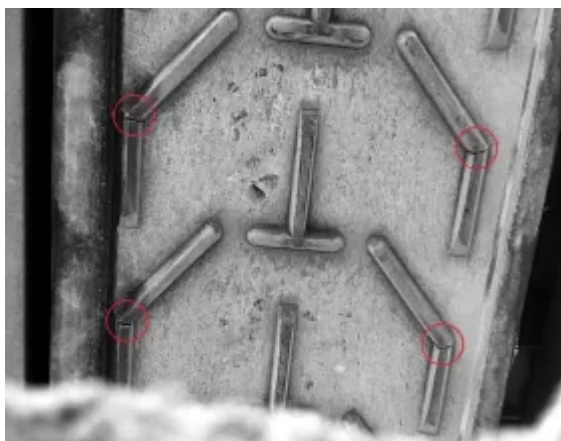
Fig. 1: A common problem – profiles that split and eventually detach from the base belt.

One of the most common problems experienced by many operators affects high chevron belting because the chevron profiles can become partly detached or ripped off entirely.

However, this directly creates the 'Achilles heel' of all chevron belts made in this way. This is because the contact point where the two different rubber compounds join then becomes a point of weakness. The chevron profiles constantly stretch and flex under tension each time they run around a pulley or drum. Unless the bond between the base belt carcass and the chevron profile is absolutely flawless then sooner or later dynamic stress fractures will start to occur, causing the profile to split. Especially on belts conveying hard, heavy lumps of material, the constant impact weakens the joint between the base belt and the chevron. Either way, eventually the chevron will part company with the rest of the belt.

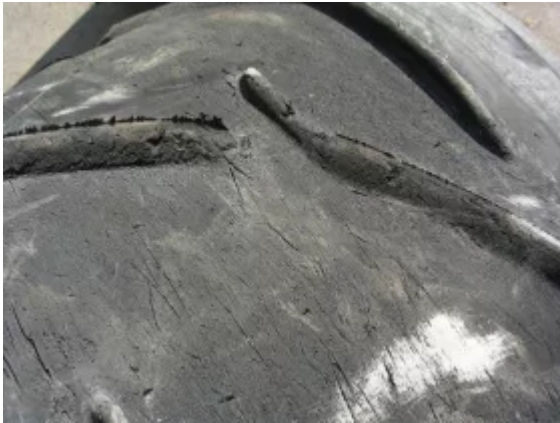
Fig. 2: Chevrons as high as 25mm or 32mm can wear almost completely flat in a remarkably short time.

Research and experience has shown that the rubber used to make the chevrons in the two-step production process almost invariably has much lower resistance to abrasive wear than would normally be acceptable. It is not unusual, especially among so-called 'economy' belts imported from Asia, that even chevrons as high as 25mm or 32mm can wear almost completely flat in a remarkably short time.

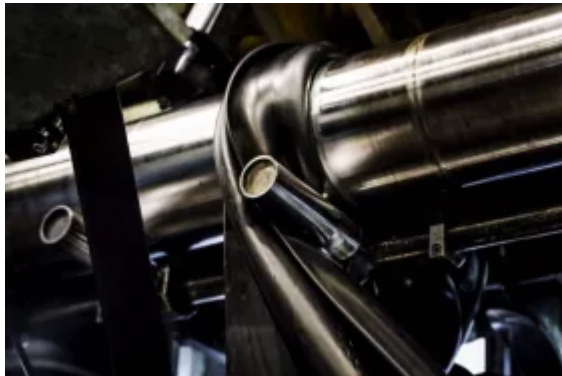
Fig. 3: A 'single structure' chevron belt needs a highly specialised rubber.

These properties include wear resistance, tensile strength and durability while at the same time also being sufficiently malleable to allow the rubber to flow smoothly and evenly into the moulds. The rubber then needs to be able to vulcanise virtually simultaneously within the mould AND the base belt structure. Not only that, the compound also needs to be fully resistant to the effects of ozone and ultra violet light (for longevity of working life) and conform to European REACH regulations so that the end product is also safe to handle.

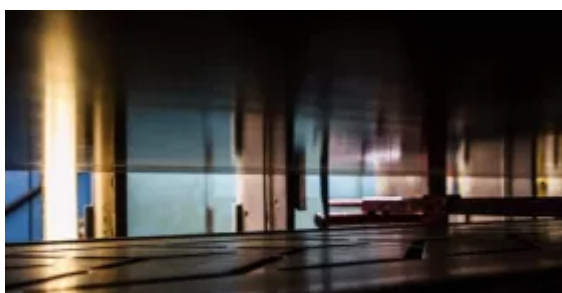
Fig. 4: The mould plate used to make a 'Single homogenous structure' chevron belt.

To create a single homogenous structure the base belt (at this stage comprising of only uncured rubber) is placed in the vulcanising press between the base plate of the press and a chevron mould plate positioned immediately below it. The base belt will already also have a specific quantity of uncured rubber on the top cover surface in addition to the volume of rubber needed to achieve the minimum thickness of the top cover of the base belt once it has been vulcanised.

The actual amount of 'extra' rubber needed depends on the design and depth of the chevron pattern. The compression of the upper and lower plates then forces the additional rubber to flow into and fill the mould cavities. Vulcanisation of both the base belt structure and the rubber-filled moulds then takes place simultaneously to form a single homogenous unit.

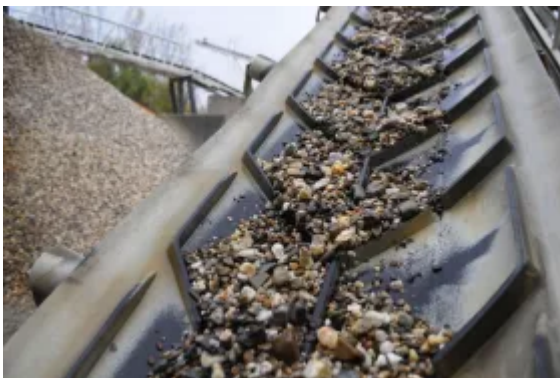
Fig. 5: Chevron belts with a single homogenous structure are stronger and longer-lasting by far.
