White Paper

Troubleshooting Belt Cleaners - Optimising Productivity rather than fixing Breakdowns

[Published in bulk solids handling, Vol. 34 \(2014\) No. 1](#)

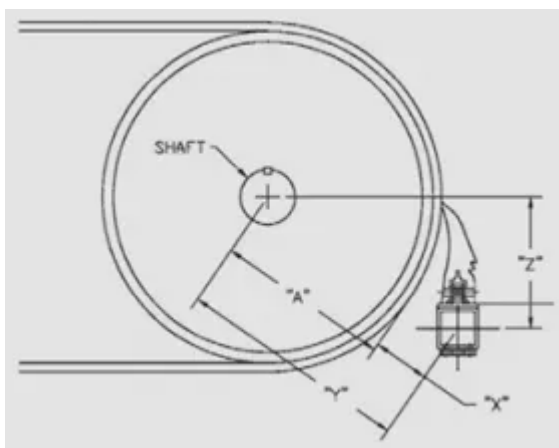
Fig. 2: Correct primary belt cleaner mounting installation: the blade tip should contact the belt below the horizontal line perpendicular to the pulley vertical line.

The incline of the conveyor needs to be considered when the cleaners are mounted. Failure to do so will result in the cleaner not correctly scraping the belt, resulting in sticky material collecting between the blade and the conveyor belt, causing inefficient cleaning and premature wear. In some unfortunate cases, incorrectly mounted blades have been positioned in such a way, that they are helping discharge the product, rather than scraping and cleaning the excess.

It is recommended that the belt cleaner be positioned below the horizontal line perpendicular to the pulley vertical line (see Fig. 2), not necessarily parallel to the stringers or conveyor belt. Material trajectory should also be taken into consideration.
