Anwenderbericht

## **BFM® fitting solves Dust and Downtime Issues for Minerals Processor**

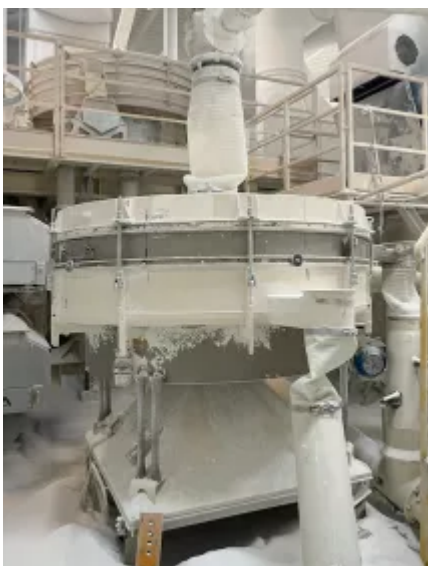
Before the switch to BFM® fitting, the customer experienced a lot of dust and material loss from their sifters. (Pictures: ©BFM® fitting)

In the initial part of their refining process, after crushing and before milling, the customer was experiencing a lot of dust and material loss from their sifters. The old-style, clamped flexible connectors they used at the inlet and outlets of the sifters constantly leaked, with product spilling out and piling up around the sifters, requiring frequent clean-ups.

The abrasive nature of the calcium carbonate powder also took its toll on the connector material, and they wore out extremely quickly, barely lasting a month at a time.

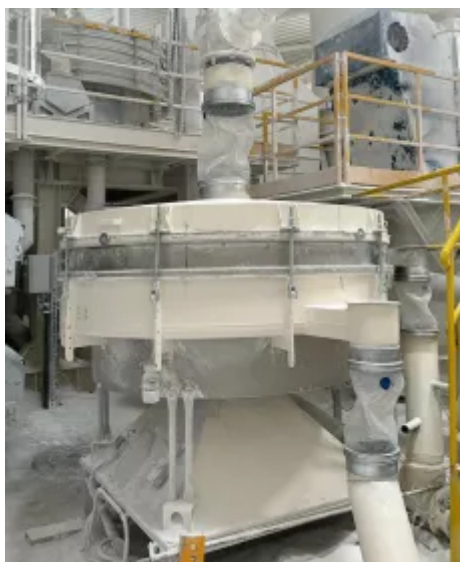
The switch to BFM® fitting stopped the leakage of the fine powder.

Local BFM® fitting distributor Rocom recommended installing BFM® fitting's durable Seeflex 040E blue-band connectors on each sifter inlet and outlet. They also suggested standardizing all diameters and connector lengths to be the same for ease of maintenance and inventory control.

To help support a long-term, sustainable approach, the IG (Installation Gap) was accurately adjusted for all the sieves, so now, only one standard-sized connector needs to be held in stock.

The elimination of excessive downtime for replacements is just one of the advantages experienced by the plant. Although abrasive, the leakage of the fine powder has been stopped thanks to the internal seal of the BFM® fitting snap-fit system and the durability of the Seeflex 040E material.
