Anwenderbericht

## **Korn Recycling opts for Flexco Secondary Belt Cleaners with Finger Segments**

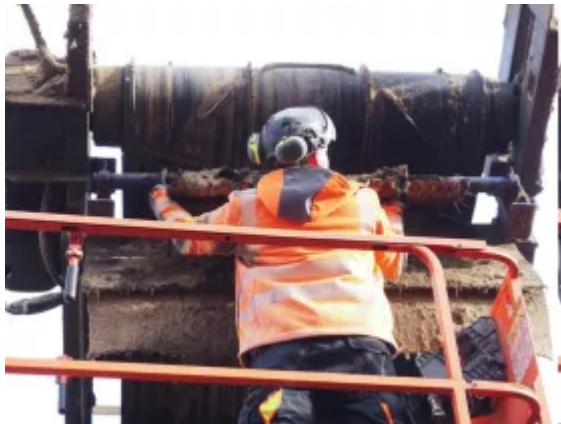
Now the prototype can be removed.

The CFC cleaner is now ready to be installed below the load zone of the conveyor, in direct contact with the running belt. Weigold, standing on the work platform, opens the bolts of the prototype. Some are a little stiff, but he manages. “Installation is relatively simple, because the cleaner has only a few parts,” says the Flexco expert. “But of course it’s a little more difficult out here than in the training room, where everything’s very clean.”

Weigold removes the cleaner from its support and brings it down on the work platform. “When we installed the prototype, we didn’t yet have a name for it,” he says. “All we knew was that we were going to develop a cleaner with finger segments.”

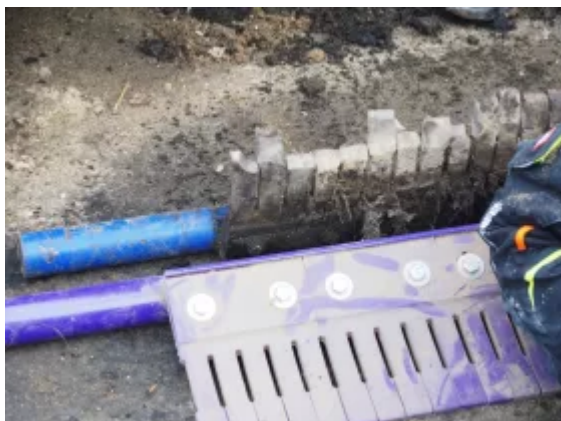
The prototype (top) compared with the new CFC cleaner (bottom). The finger elements can be easily replaced during operation.

The device has worked well over the past year. Its segmented blades with flexible finger contours are especially effective for cleaning chevron belts with ribs, even with cleat heights of up to 32 millimeters and belt speeds up to 2.5 meters per second. Another key factor is the high-quality polyurethane used for the fingers. The wear is low, which means a longer service life.

Weigold descends on the work platform and sets the prototype next to the new CFC for comparison. The fingers are slightly worn. However, they can be easily and quickly replaced during operation. He saws off both ends of the robust 60 mm diameter pole, bringing it to the right length. Then he rides the work platform with a coworker up to the conveyor belt and inserts the new cleaner. He tightens the
