Whitepaper

Wearing thin - Causes and Solutions for Conveyor Belts that have to be replaced prematurely due to Surface Wear

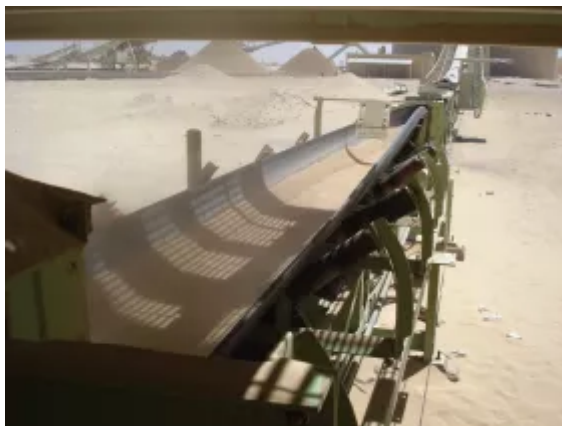
Fine materials act like sandpaper on the rubber surface.

It is a common misconception that a belt specified by a supplier as being 'abrasion resistant' should naturally be expected not to wear quickly. Different causes of wear and abrasion require different kinds of abrasion resistant covers. For example, belts that transport heavy and/or sharp objects such as rocks, timber or glass that cause cutting and gouging of the belt surface need different resistance properties compared to belts carrying 'fine' materials such as

aggregate, sand and gravel, which literally act like a piece of coarse sandpaper that is constantly scouring the rubber cover.

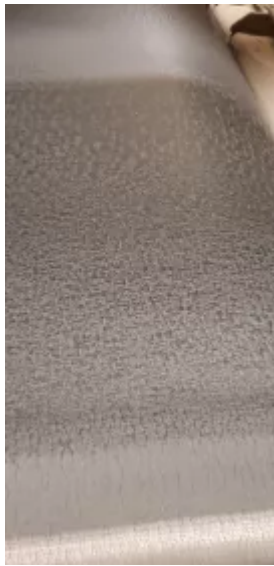
Close up of ozone cracked belt.

There is absolutely no question that ALL rubber conveyor belts should be fully resistant to the damaging effects of ozone and ultra violet light. This is because ozone becomes a pollutant at ground level. Exposure increases the acidity of carbon black surfaces and causes reactions to take place within the molecular structure of the rubber. This has several consequences such as surface cracking and a marked decrease in the tensile strength of the rubber. Likewise, ultraviolet light from sunlight and artificial (fluorescent) lighting also accelerates deterioration. This is because it produces photochemical reactions that promote the oxidation of the surface of the rubber resulting in a loss in mechanical strength. In both cases, this kind of degradation causes the covers of the belt to wear out even faster than it should.

Rubber belts that are not fully resistant to ozone and UV can start to show signs of degradation even before they have been fitted to a conveyor simply by being exposed to the open air and daylight. Sadly, despite its crucial importance in terms of operational lifetime, ozone and UV resistance is very rarely, if ever, mentioned by traders or manufacturers. This is almost certainly because the anti-ozonants that need to be used during the mixing process of the rubber compounds are relatively costly. Building that 'avoidable' cost in would immediately make the belt less competitive on price. My advice is to always make ozone & UV resistance a required part of the specification when selecting any rubber conveyor belt.

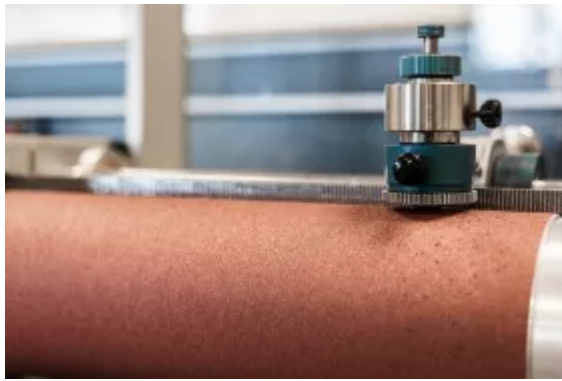
ISO 4649 / DIN 53516 abrasion testing.

The test method for abrasion (ISO 4649 / DIN 53516) is actually quite simple. Abrasion resistance is measured by moving a test piece of rubber across the surface of an abrasive sheet mounted on a revolving drum. It is expressed as volume loss in cubic millimeters, for instance 150 mm³. The most important thing to remember when comparing abrasion test results (or promises!) is that higher figures represent a greater loss of surface rubber which means that there is a lower resistance to abrasion. Conversely, the lower the figure the better the wear resistance.
