Anwenderbericht

BEUMER assists Cement Manufacturer in Modernisation of Bucket Elevators

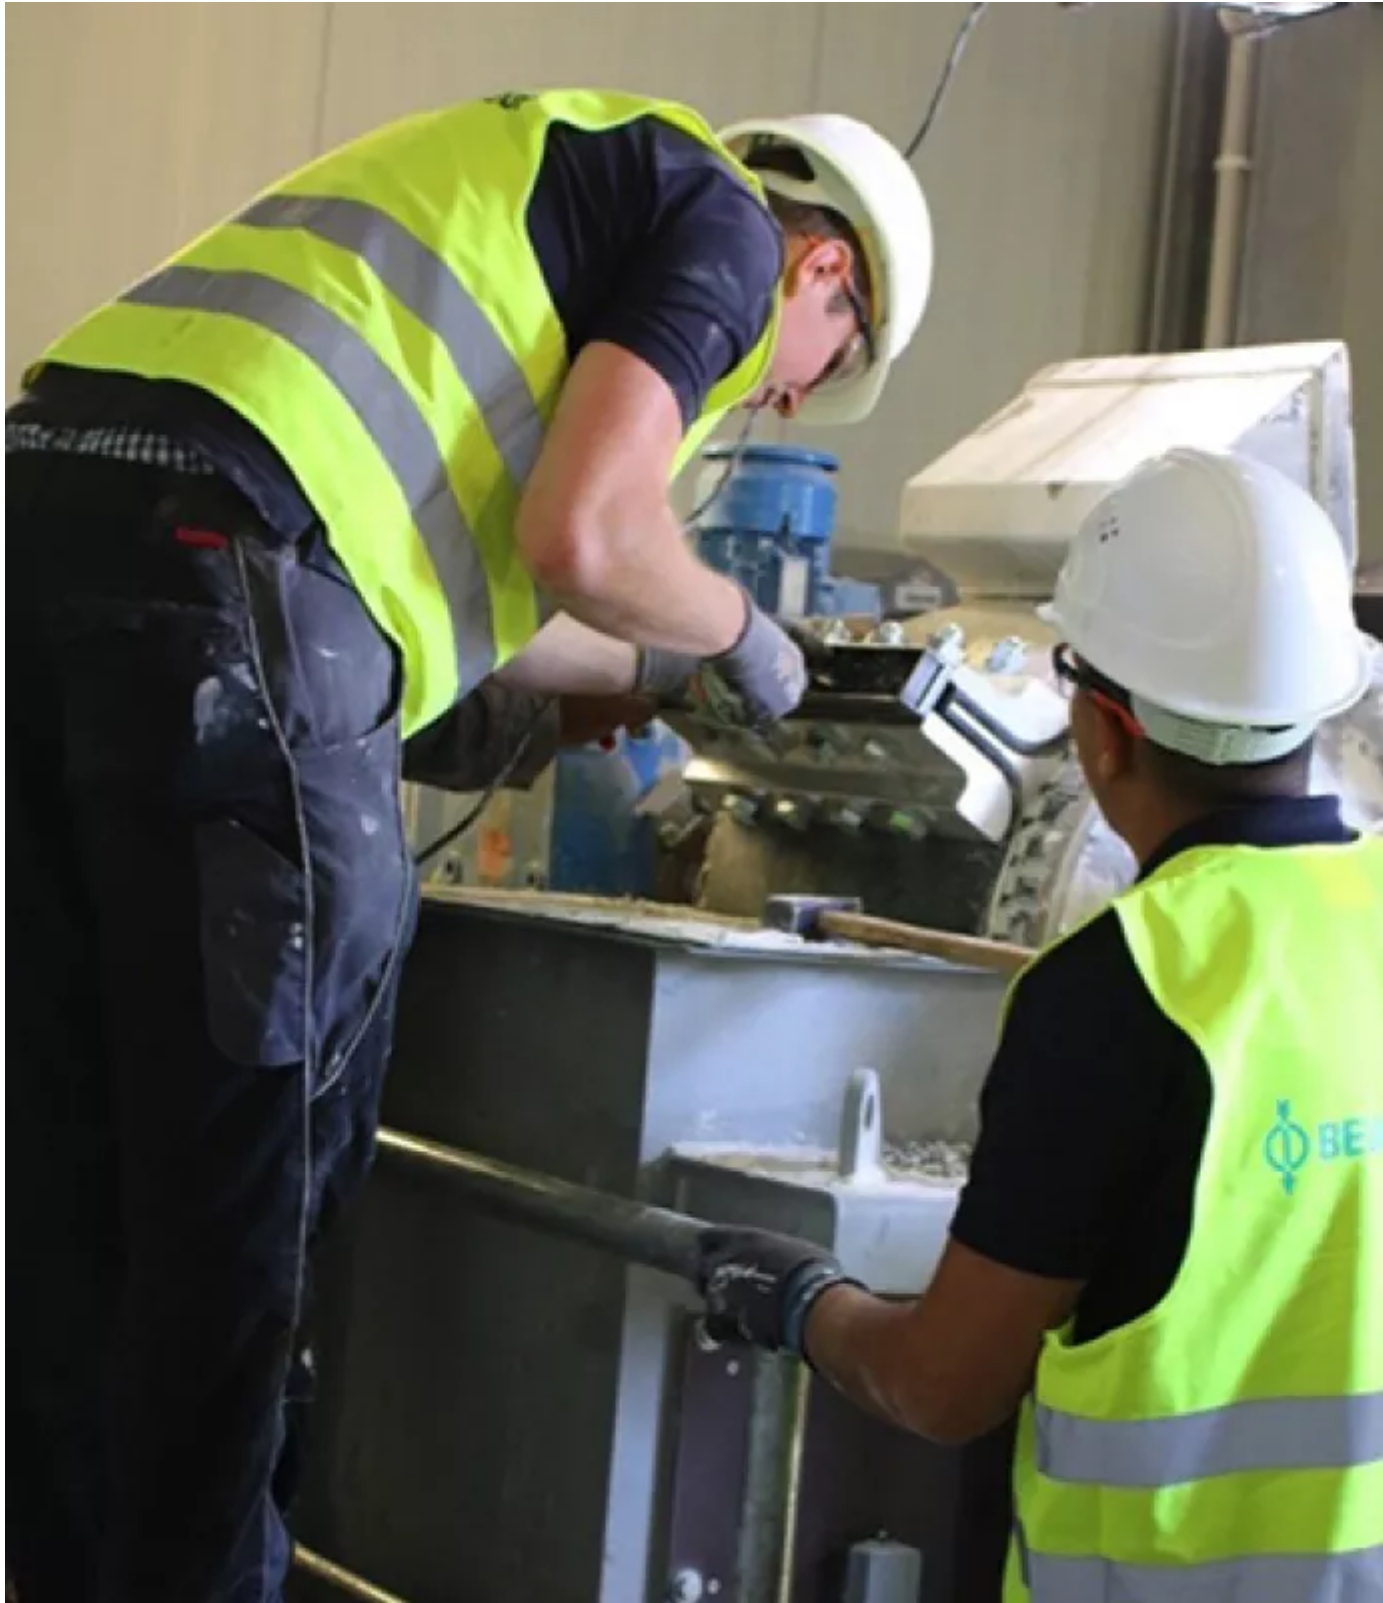
The ends of the steel cords are divided into individual strands in the U-shaped part of connection, twisted and cast with white metal.

Another important factor is the belt clamping connection: The rubber of the steel cord ends is first removed on all BEUMER steel cord belts.

The technicians divide the ends into individual strands in the U-shaped part of the belt clamping connection, twist and cast it with white metal.

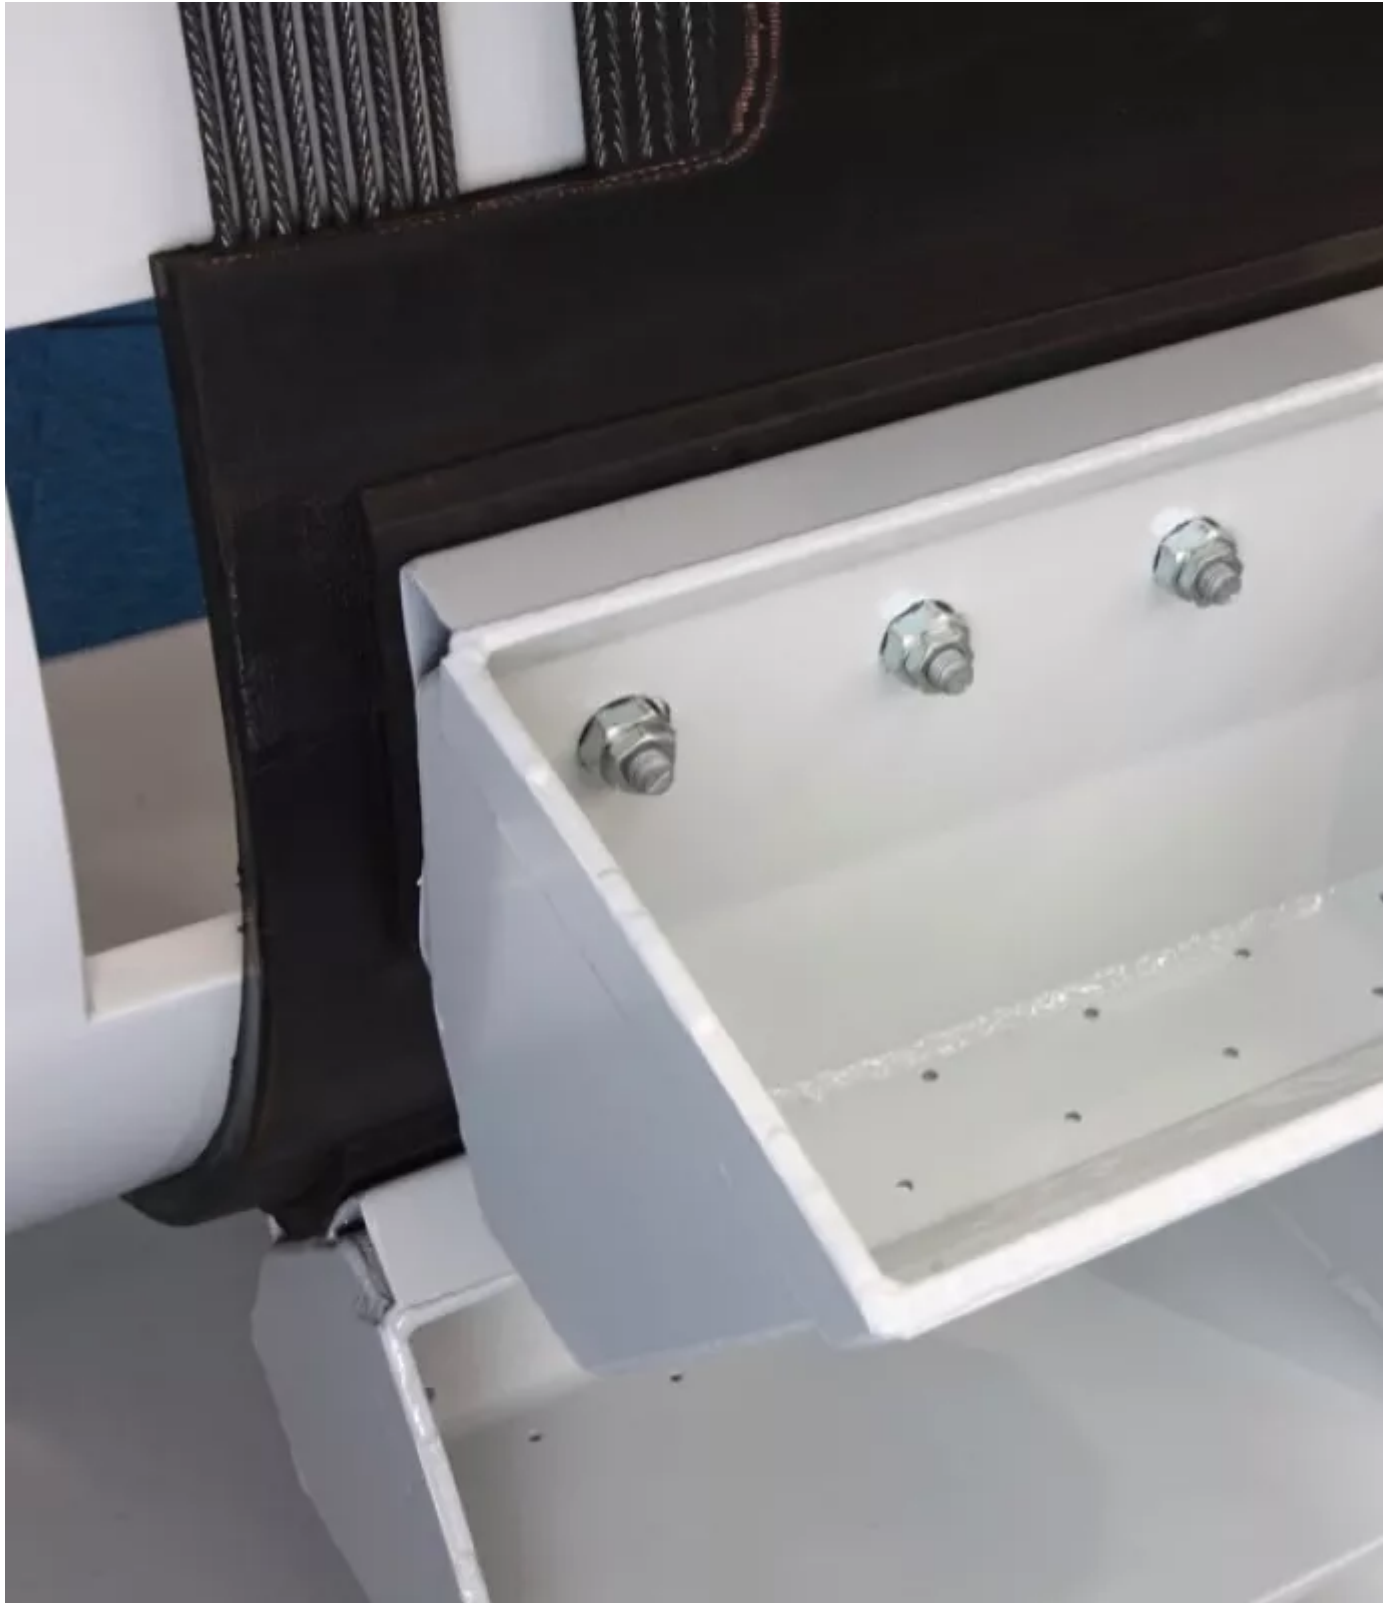
The drive pulleys are equipped with segmented laggings. A steady running of the belt (BEUMER Group GmbH & Co KG)

In order to enable a steady running of the belt and to extend the service life in view of the abrasive material, the BEUMER team exchanged the existing segmented laggings of the drive pulley by specially adapted ones equipped with ceramic. These are crowned for a steady straight run.

The design, which is easy to maintain, enables to quickly replace the single segments of the segmented lagging through the inspection hatches. Thus, it is no longer necessary to exchange the complete drive pulley. The segmented laggings

are rubberised, with linings made of full ceramics or steel. The choice depends on the material conveyed.

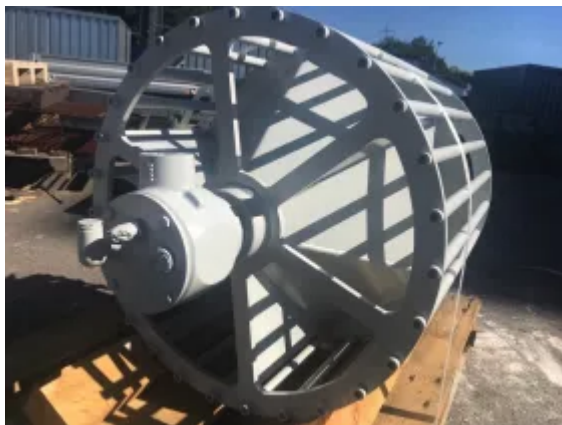
To avoid caking, the take-up pulley is designed as cage-type foot pulley and is provided with a double deflection cone. For this order, the screwed and hardened version of the cage-type foot pulley has been used.

“A part of our HD technology is the cage-type foot pulley which is easy to maintain. The bars are hardened due to the abrasive material conveyed and screwed into the cage-type foot pulley to enable a rapid replacement. The take-up pulley is equipped with a double deflection cone, which reliably prevents damage to the belt caused by jammed bulk materials,” explains Papenkort.
