Coal Storage Flow Problems - Improving Flow in a 4000 tonnes Coal Bunker using Insert Technology

[Published in bulk solids handling, Vol. 32 \(2012\) No. 6](#)

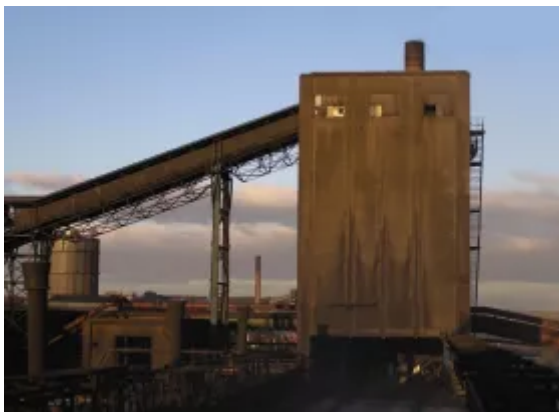
Fig. 1: Service bunker at Appleby Coke Ovens in Scunthorpe, United Kingdom. (Pictures: Ajax Equipment Ltd.)

The concrete service bunker (Fig. 1) was built in 1937 and is divided into two rectangular sections, one section holding 3000 tonnes of coal and the other holding 1000 tonnes of coal. It is about 17.5 metres tall and the 1000 tonnes section is 8 metres \times 13 metres, whilst the 3000-tonne section is 20 metres \times 13 metres. Coal is fed into the top of the bunker where it is distributed to one of the two sections and stored ready for discharge under gravity. Coal is discharged via a number of rows of outlets at the base of the bunkers into the charge cars.

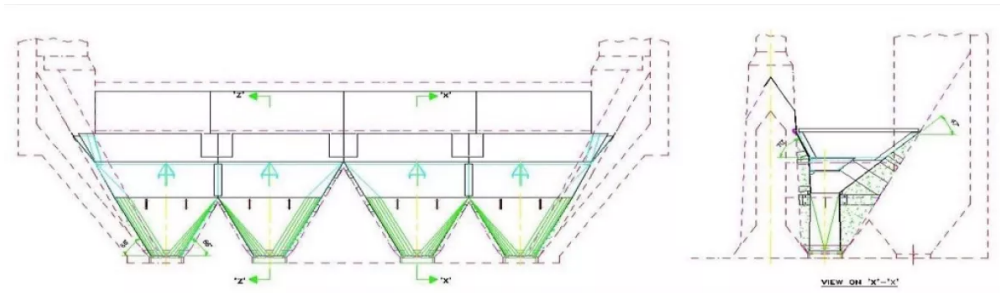
Fig. 3: Drawing of bunker with insert system.

The second mass flow stage expanded the flow channel to a reliable flow width and connected a full row of four outlets together. To destabilise any large rat hole or cliff which might form, a third stage was added which would not mass flow but instead provide self-clearing of the remaining hopper contents. Due to the offset outlet construction, a set of inserts was fitted to reduce compacting pressures in the outlet region and encourage flow from the shallow side of the hopper (Fig. 3).

At Scunthorpe, a three-stage design with an insert was devised by Ajax. The first mass flow sections were internal hoppers which comprised of plane flow converging to the existing outlets. These hopper sections actually diverged slightly in the opposite plane to give the best chance of squeezing through the outlet – a technique called Sigma Two relief. The form of these sections was developed so that two adjacent outlet sections actually joined together to provide the one slot.

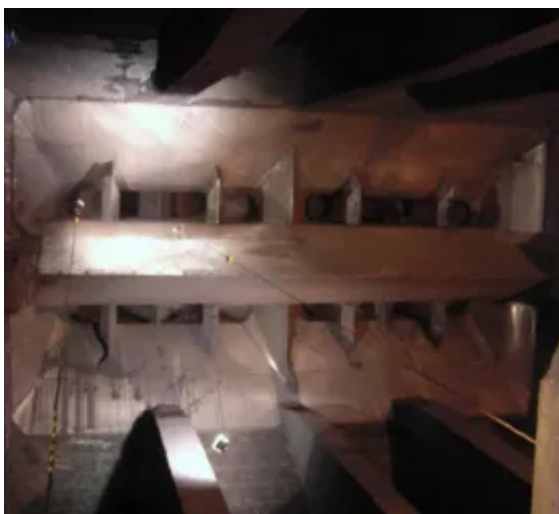
Fig. 4: Two rows of inserts installed in the 1000 tonne section.

The first row of inserts made such a huge difference to the flow of coal from the bunker; that a financial case was put together to line a further three rows of outlets. There are now two rows of inserts in the 3000-tonne section and two rows in the 1000-tonne section (Fig.4).

Prior to fitting the inserts poking for coal was required at least once per shift from November to March. This is no longer necessary. Moreover, there have been no reportable injuries sustained from poking activities from the service bunker since

When poking for coal there was a tendency for the charge-cars to be under filled. This resulted in the ovens not being filled to the required standard, lower coke yield and subsequent refractory damage to oven chambers. Since the inserts have been installed, better filling of the charge-cars has occurred resulting in improved oven filling and a higher coke yield. The live capacity of the 1000-tonne section is now approaching 80 percent.
