## **GKD: Sewage Treatment Plant enjoys greater Planning Reliability for its Belt Press**

Sonneberg Waterworks, Germany, operate four sewage treatment plants for around 50,000 residents. The Sonneberg-Heubisch sewage treatment plant has been using a Type 1003 filter belt with integrated wear indicator from GKD Gebr. Kufferrath AG (GKD) to dewater sewage sludge since January 2016. Beside efficient dewatering and a reliable PAD seam, the key factor that spoke in favor of the belt was its increased planning reliability for belt changing intervals.

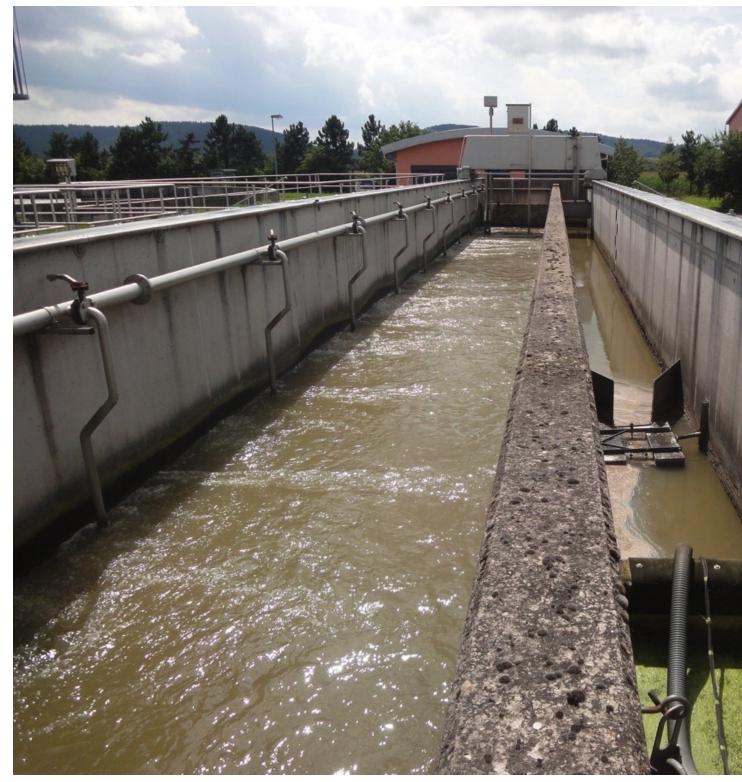
In the sand trap any sand in the material is released, washed and dewatered, allowing it to be used as backfill material in ditch and trench digging operations. (Picture: ©GKD)

At the four plants, mechanical cleaning is initially performed using a rake system with screw compactor for dewatering the raked material. In the ventilated sand trap with sand washer, any sand in the material is released, washed and dewatered, allowing it to be used as backfill material in ditch and trench digging operations. At the same time, light substances such as oils and greases are removed here.

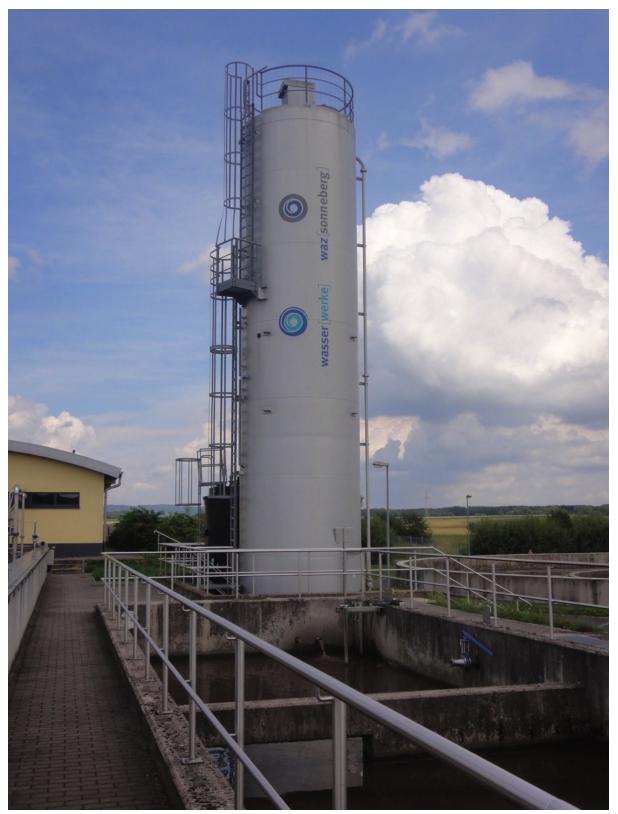
Lime hydrate must be added to the wastewater due to the very soft nature of the water in Sonneberg. (Picture: ©GKD)

bacteria and associated formation of bulking sludge stimulated by the large volume of fecal sludge. In two aeration tanks, designed as circulation basins measuring 95 meters in length and boasting an effective volume of 13,540 cubic meters, the nitrogen contained in the waste water is removed and the sludge aerobically stabilized. A blower station with five rotary piston blowers guarantees pressure ventilation of the basin. Two blowers supply each basin, while the fifth serves as a reserve unit and is also used to cover peak loads. The blowers are operated intermittently. The organic carbon is removed and the nitrogen nitrified during the ventilation phases. Denitrification is performed in the non-ventilated phases. To stabilize it, lime hydrate must be added to the wastewater in the second phase of the selector basin due to the very soft nature of the water in Sonneberg. It is metered from a 70 cubic meter lime silo that is heated in winter.

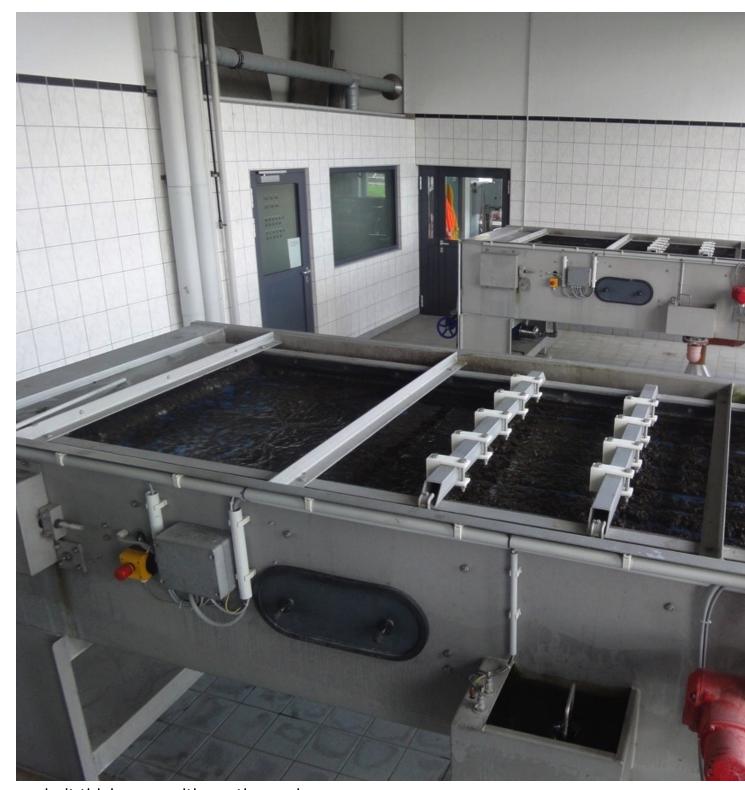
wo belt thickeners with continuously circulating Type 5060 GKD filter belts increase the solids content of the surplus sludge from 0.75% TS to around 5% TS through the addition of flocculant. (Picture: ©GKD)

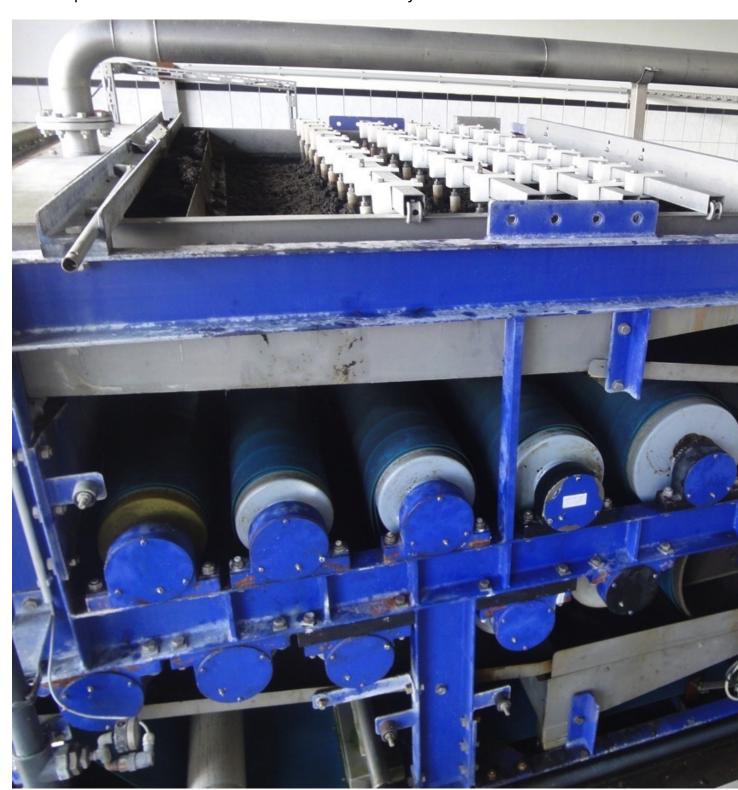
The belt press is fed directly from the thickener, so around 160 cubic meters of sludge is dewatered per day.

The belt press is generally fed directly from the thickener, so around 160 cubic meters of sludge is dewatered per day, whereby the belt speed is based on the grade of the sludge. With easily drainable sludges, approximately twelve cubic meters per hour are fed and then remain in the system for around half an hour.

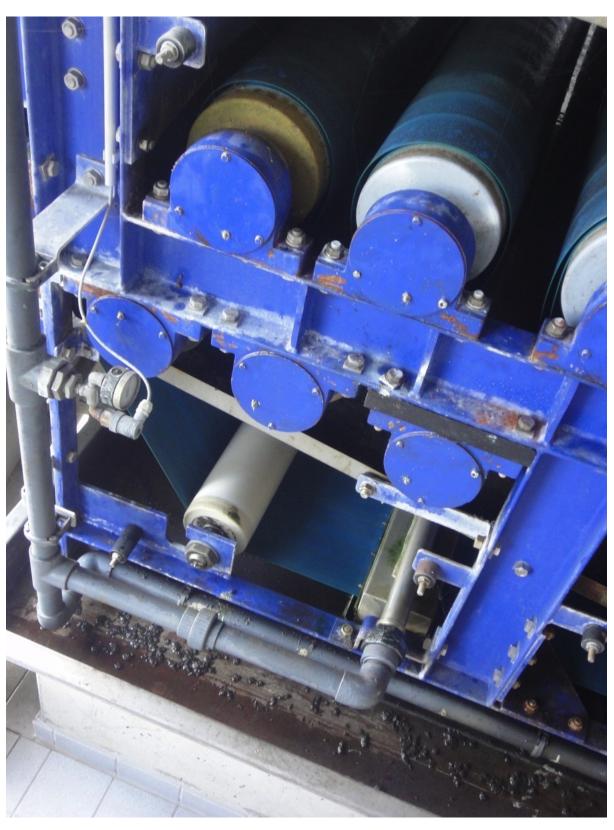
In the pressing area the sludge passes through eleven rollers between the upper and lower belt with belt pressure of 8 bar. (Picture: ©GKD)

After the thickened sludge has been deposited in the belt press infeed area, two scrapers distribute it evenly across the Type 1003 GKD filter belt, which then transports it to the pressing area. Here, the sludge passes through eleven rollers between the upper and lower belt with belt pressure of 8 bar. The belts are subjected to high loads as a result of the forces applied. The woven seams in particular were therefore a much feared weak point in Sonneberg for a long time. This was because the belts previously used at the Sonneberg sewage treatment plant regularly suffered from damaged seams due to the loads they must handle. In fact, these belts were repeatedly torn apart in an uncontrolled way, causing costly downtimes. Plant manager Bernd Hubner remembers: "The most important part of the belt is the seam. With the old belts, sudden failure of these seams led to a great deal of work and costs caused by the sludge that was still in the press. Yet despite the higher personnel costs associated with this work, the significantly longer downtime in comparison with a scheduled belt change was what actually had the greatest negative impact."

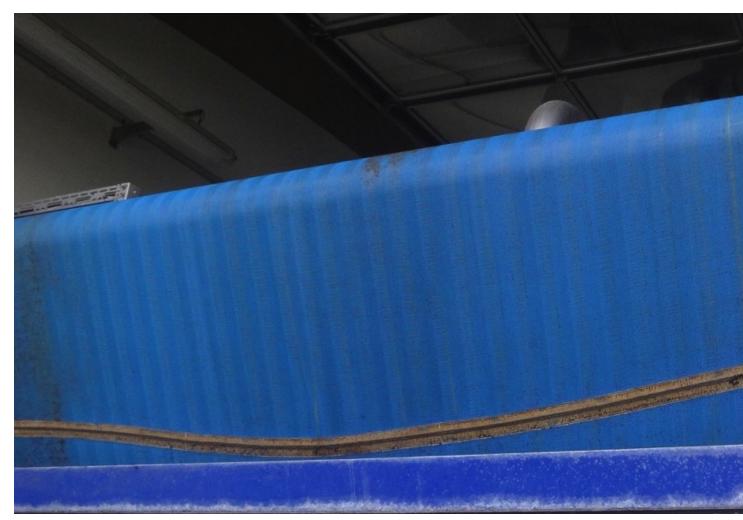
Besides efficient dewatering, the key factor of the GKD-belt Type 1003 with integrated wear indicator is a reliable PAD seam. (Picture: ©GKD)

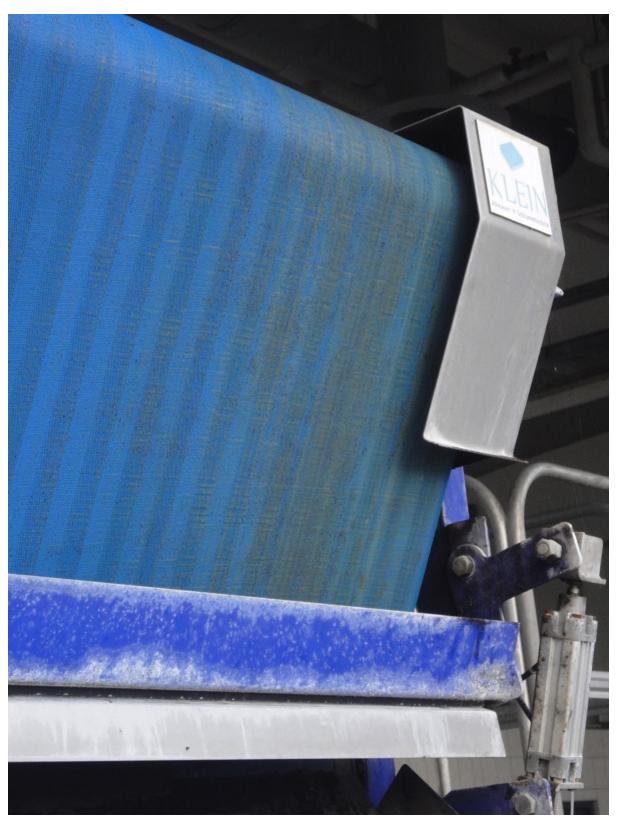
The wear indicator integrated into the GKD-belt Type 1003 allows distinct conclusions regarding the service life to be drawn. (Picture: ©GKD)

The yellow inner core of the 15.25 meter long and 2.50 meter wide GKD polyester belt displays the degree of mechanical wear – similarly to the wear indicators on car tires. This allows damage caused by defective plant components or process-related wear to be detected early on.
