Case Study

Air Cannon's Ambiance too hot! Innovative Air Cannon Positioning at Clinker Cooler for easier Maintenance

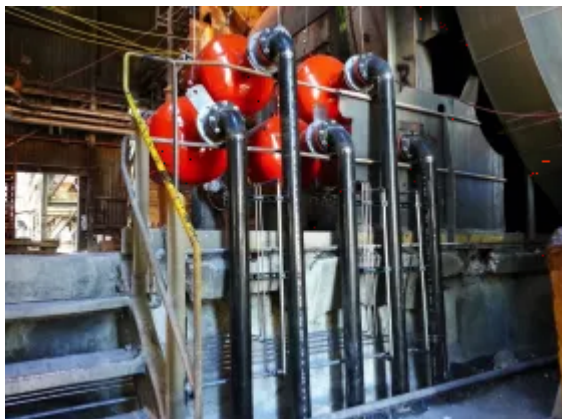
11.5 mm pipes lead down to holes drilled into the concrete floor, then continue under the subfloor.

Technicians installed five 150 l Martin Hurricane Air Cannons, lifting the units away from the discharge area and up several meters to a preexisting platform. Located well away from the hot wall and the kiln’s discharge zone, the cannons can be serviced without having workers wear the special high-temperature equipment.

fires a shot of air up to 120 PSI (8.27 BAR) from a pressurized tank through the long pipes and spreads the airstream across the area of buildup.

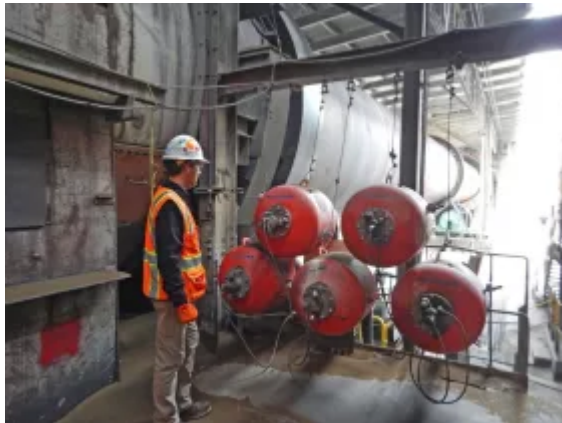
Valves face outward for convenient maintenance, requiring no tank removal to service them.

The Hurricane's valve faces outward, opposite the pipe end, and is serviced without removing the cannon tank. A single technician simply detaches the air and solenoid connections, removes the 8 bolts from the valve assembly and slides it out for inspection and maintenance.

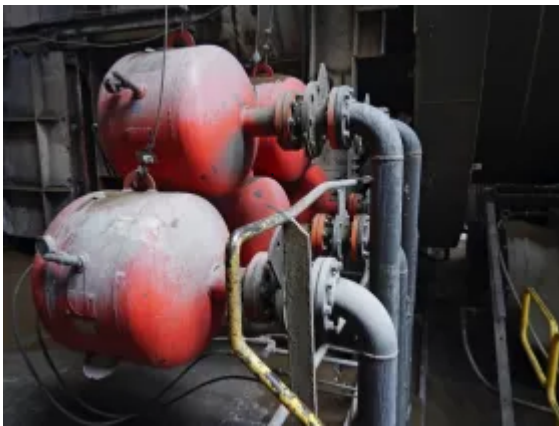
After five years of service, the cannons continue to operate at a high level of reliability.

The lack of heat exposure has reduced the impact on the equipment itself, increasing the life of the valves and the tank. Setting the tanks in an easily accessible and safe area means that workers can inspect the equipment more often and perform maintenance on a single cannon without downtime.
