White Paper

Conveyor Dust and Spillage: The Importance of Skirtboard Sealing Systems

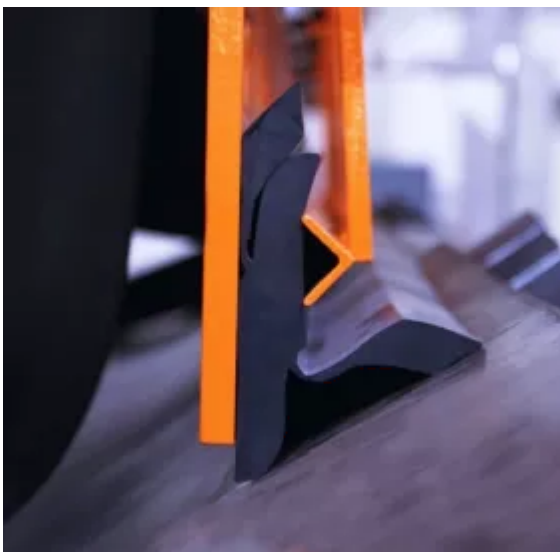
ApronSeal™ Double Skirting offers a dual seal and can be flipped for extended equipment life. (Pictures: ©Martin Engineering)

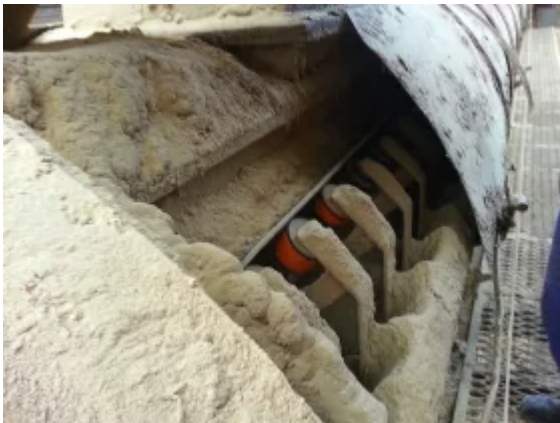
Dust and spillage clogs idlers, requiring them to be replaced and raising the cost of operation.

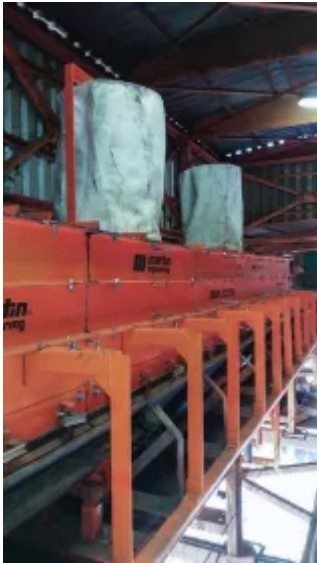
The new loading zone featured a sealing system that mitigated spillage and dust supported by dust bags.

Martin Engineering technicians constructed a longer sealed enclosure with the ability to control airflow and give dust extra space to settle. They added several other critical components including external dual seal skirtboard and wear liner system. Impact cradles and slider cradles replaced the idlers to seal gaps in the chute.

Operators immediately observed significant results. As material moved through the system, particulates remained within the enclosure and either collected in the dust bags or settled back into the cargo flow. After a lengthy observation period, operators report that there has been less downtime for cleanup and maintenance, as well as improved workplace safety.
