White Paper

## **Wearing thin - Causes and Solutions for Conveyor Belts that have to be replaced prematurely due to Surface Wear**

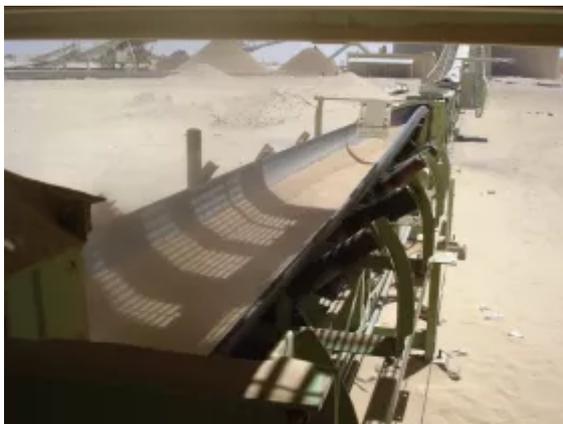
Fine materials act like sandpaper on the rubber surface.

It is a common misconception that a belt specified by a supplier as being 'abrasion resistant' should naturally be expected not to wear quickly. Different causes of wear and abrasion require different kinds of abrasion resistant covers. For example, belts that transport heavy and/or sharp objects such as rocks, timber or glass that cause cutting and gouging of the belt surface need different resistance properties compared to belts carrying 'fine' materials such as

aggregate, sand and gravel, which literally act like a piece of coarse sandpaper that is constantly scouring the rubber cover.

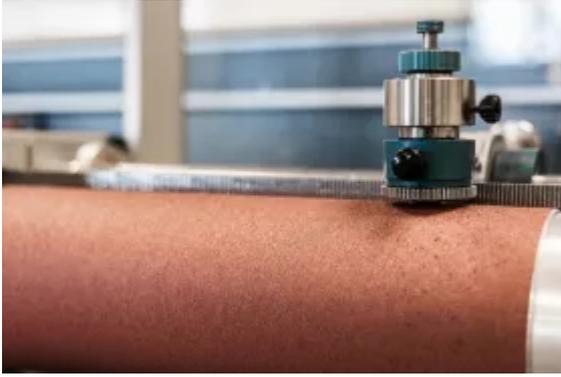
ISO 4649 / DIN 53516 abrasion testing.

The test method for abrasion (ISO 4649 / DIN 53516) is actually quite simple. Abrasion resistance is measured by moving a test piece of rubber across the surface of an abrasive sheet mounted on a revolving drum. It is expressed as volume loss in cubic millimeters, for instance 150 mm<sup>3</sup>. The most important thing to remember when comparing abrasion test results (or promises! ) is that higher figures represent a greater loss of surface rubber which means that there is a lower resistance to abrasion. Conversely, the lower the figure the better the wear resistance.
