Case Study

## **BEUMER assists Cement Manufacturer in Modernisation of Bucket Elevators**

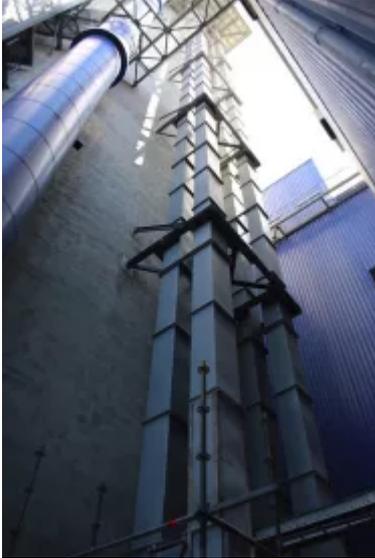
With this modernisation, the cement manufacturer was able to increase the conveying capacity of the bucket elevators for the cement silo feed.

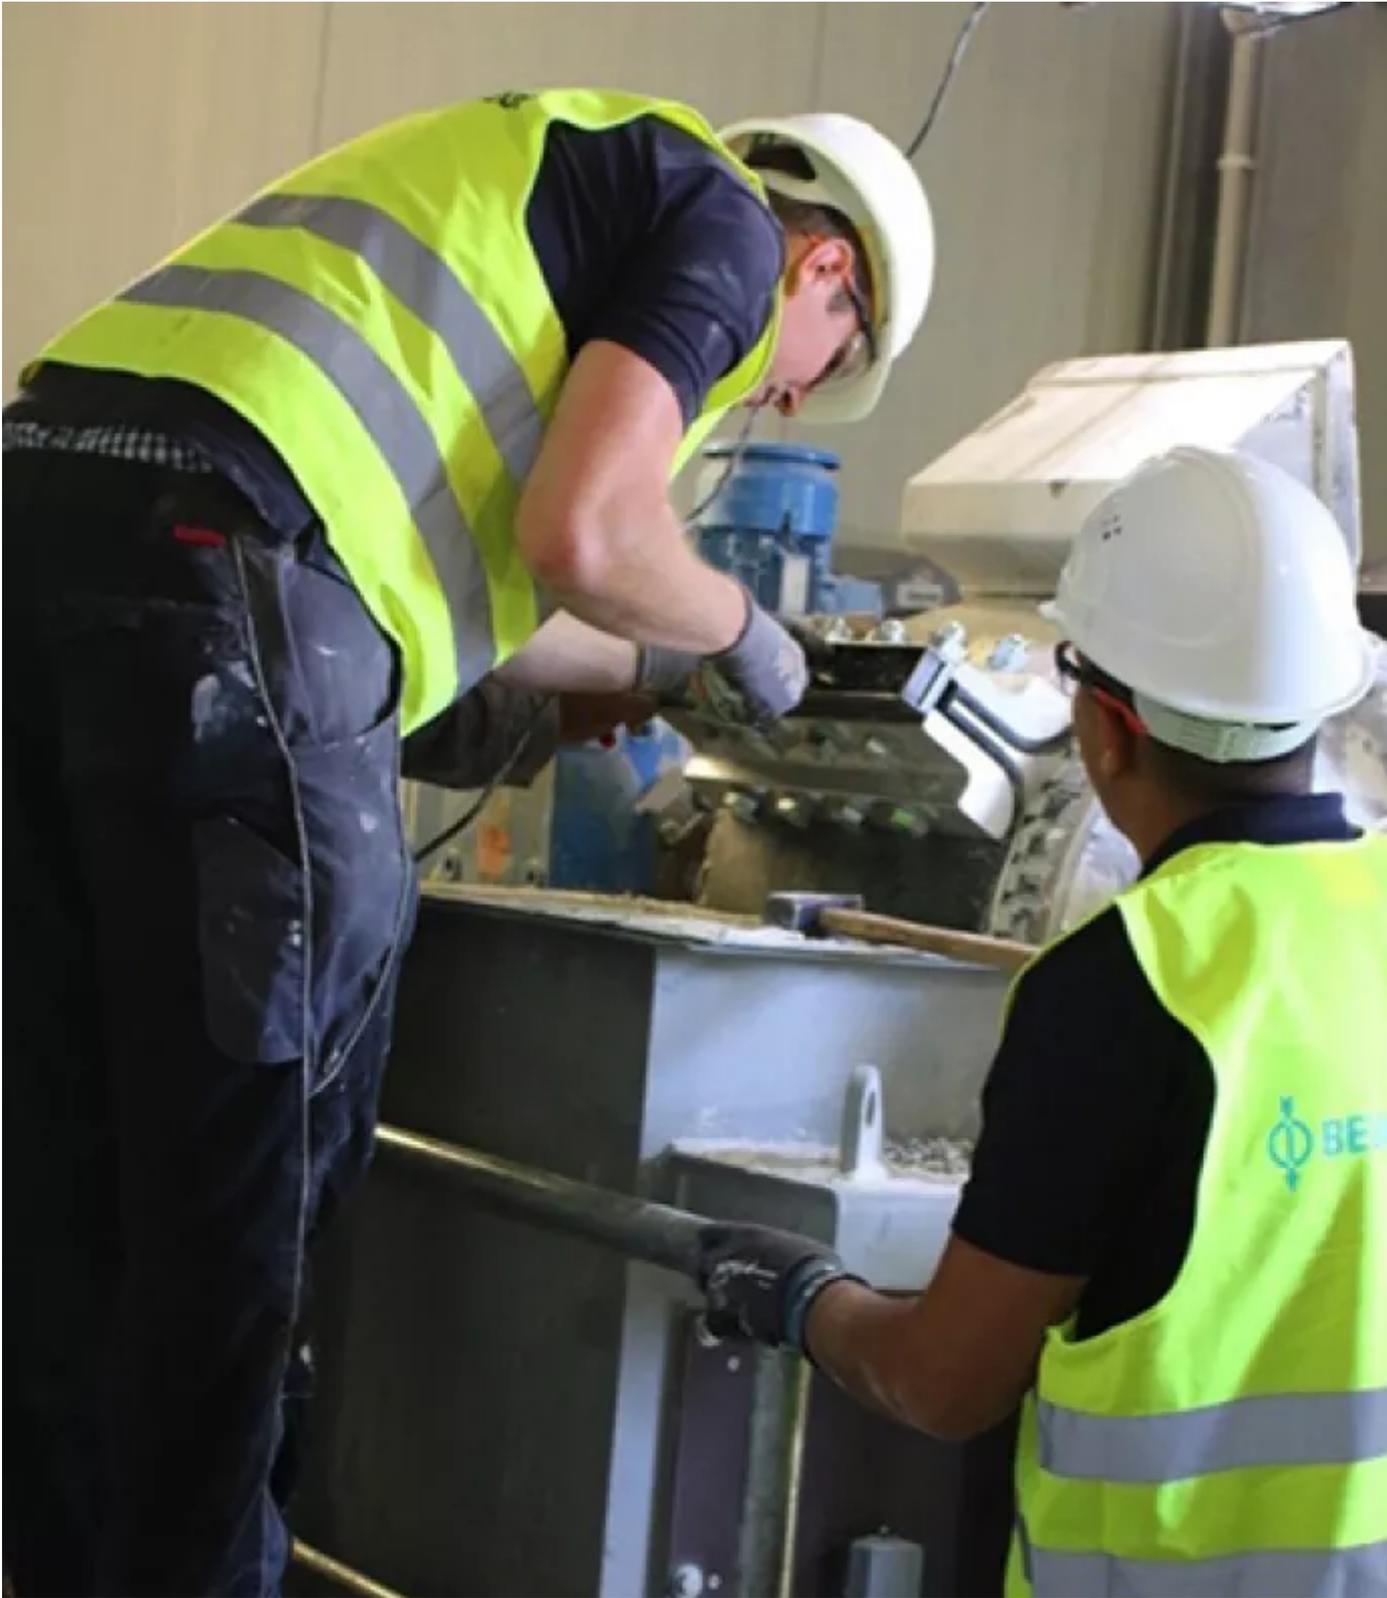
The ends of the steel cords are divided into individual strands in the U-shaped part of connection, twisted and cast with white metal.

Another important factor is the belt clamping connection: The rubber of the steel cord ends is first removed on all BEUMER steel cord belts.

The technicians divide the ends into individual strands in the U-shaped part of the belt clamping connection, twist and cast it with white metal.

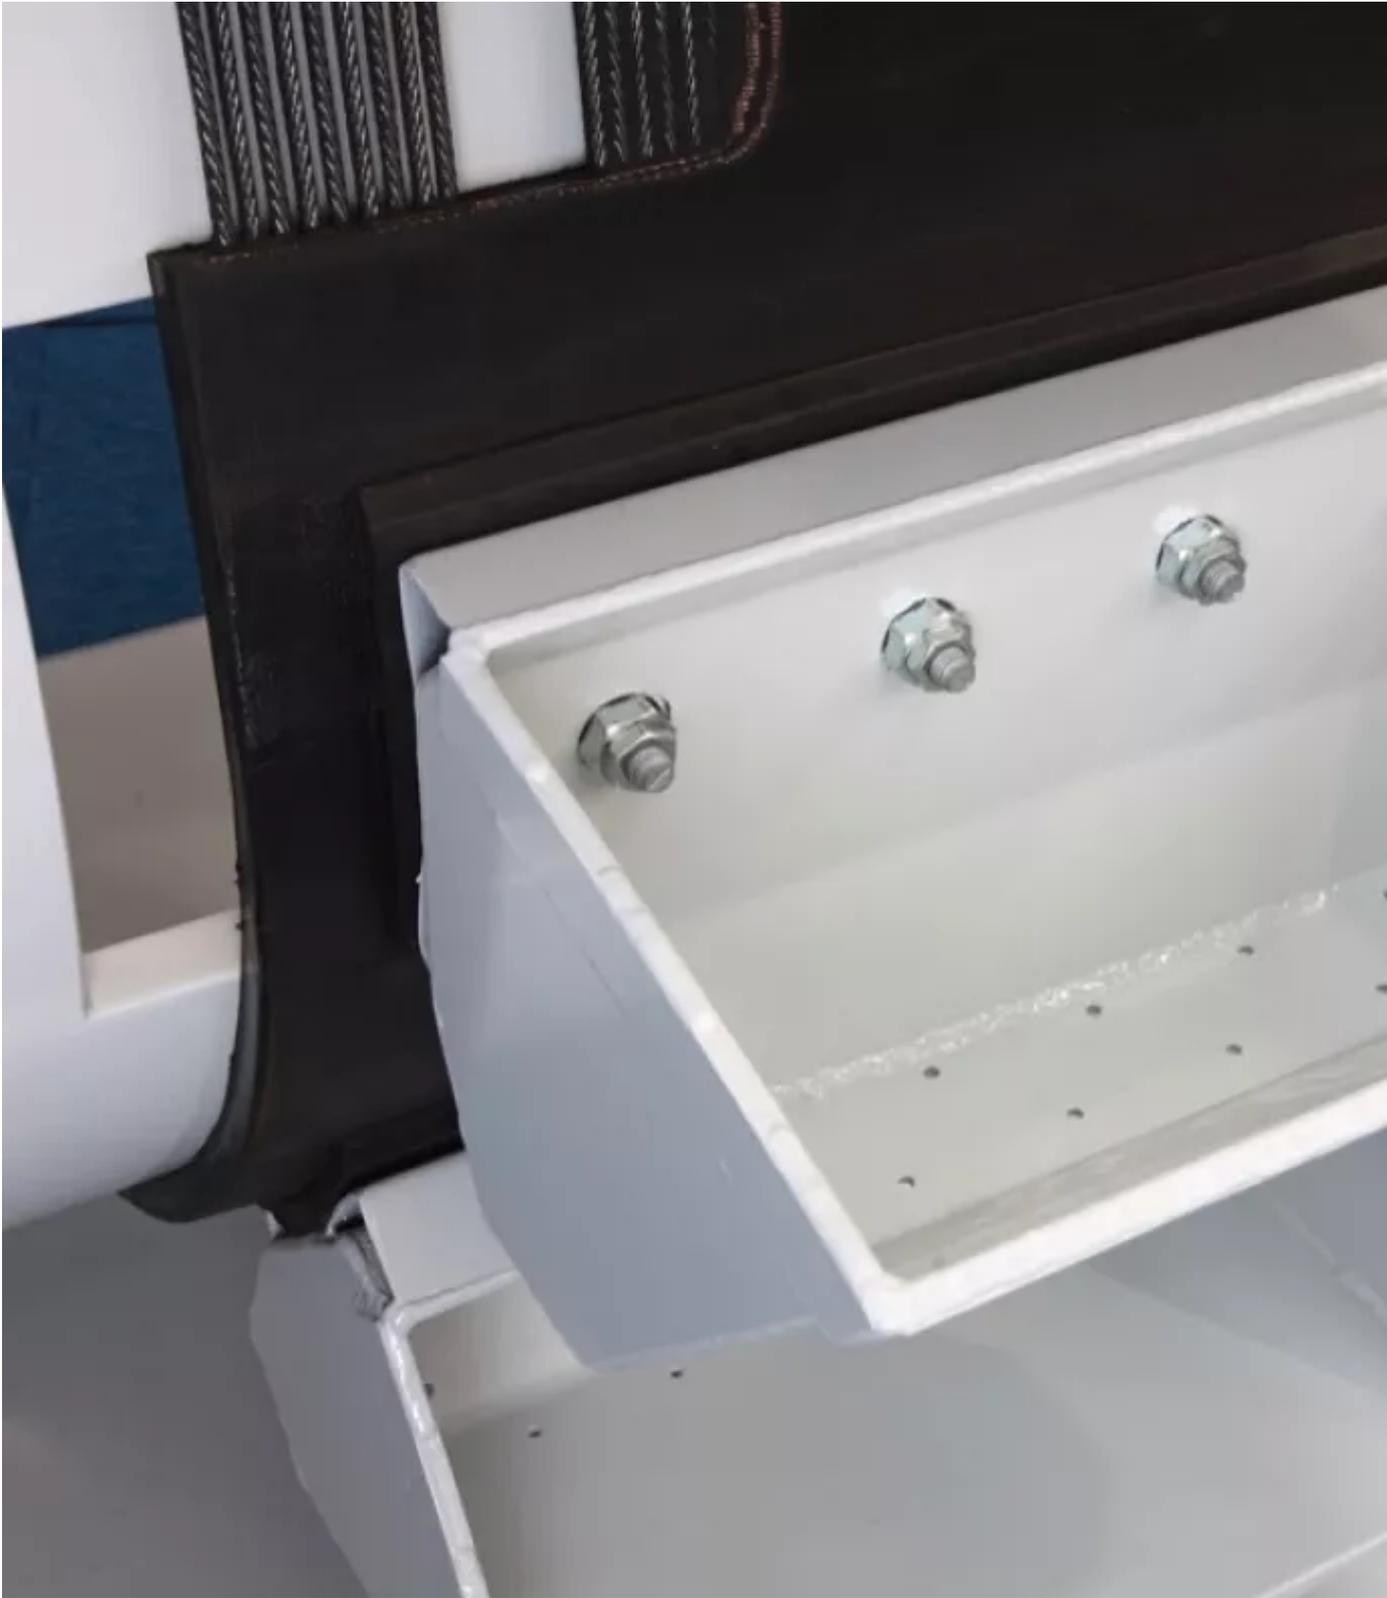
The drive pulleys are equipped with segmented laggings. A steady running of the belt (BEUMER Group GmbH & Co KG)

In order to enable a steady running of the belt and to extend the service life in view of the abrasive material, the BEUMER team exchanged the existing segmented laggings of the drive pulley by specially adapted ones equipped with ceramic. These are crowned for a steady straight run.

The design, which is easy to maintain, enables to quickly replace the single segments of the segmented lagging through the inspection hatches. Thus, it is no longer necessary to exchange the complete drive pulley. The segmented laggings

are rubberised, with linings made of full ceramics or steel. The choice depends on the material conveyed.

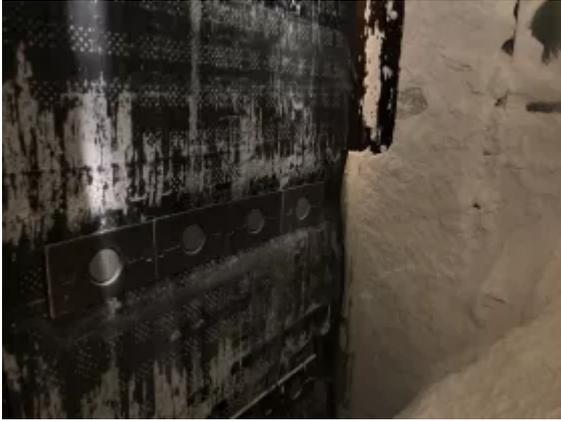
The buckets are mounted with forged segments and screws on the back side of the belt.

The buckets are adapted to the crowned shape of the drive pulley and thus lie flat on, which considerably increases the service life of the belt. Their shape allows for smoother running and therefore less noise generation.

The proven BEUMER HD technology impresses with a special bucket connection: In order to prevent coarse-grained material from penetrating between bucket and belt, the bucket is provided with an elongated back plate, which can be mounted flush to the bucket elevator belt.

In addition, with the HD technology, the buckets are mounted firmly to the back of the belt with forged segments and screws. “All the screws would have to get lost for a bucket to tear out,” explains Papenkort.

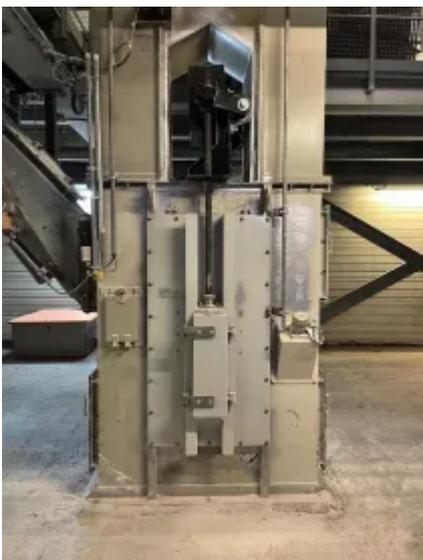
The parallel take-up device ensures that the take-up pulley is limited to parallel movement.

In order to achieve a permanently correct tensioning of the belt, BEUMER mounted an external parallel take-up device without product contact in Duisburg, which ensures that the take-up pulley is limited to parallel movement. The tension bearing is designed as inner bearing in a completely encapsulated construction. The bearing housings are filled with oil.

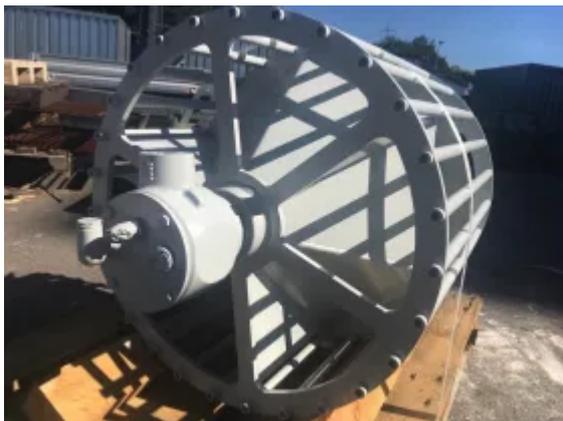
To avoid caking, the take-up pulley is designed as cage-type foot pulley and is provided with a double deflection cone. For this order, the screwed and hardened version of the cage-type foot pulley has been used.

“A part of our HD technology is the cage-type foot pulley which is easy to maintain. The bars are hardened due to the abrasive material conveyed and screwed into the cage-type foot pulley to enable a rapid replacement. The take-up pulley is equipped with a double deflection cone, which reliably prevents damage to the belt caused by jammed bulk materials,” explains Papenkort.
