White Paper

Don't get tired repairing Tyres - OTR Tire Repair: A Look behind the Scenes

[Published in bulk solids handling, Vol. 34 \(2014\) No. 5](#)

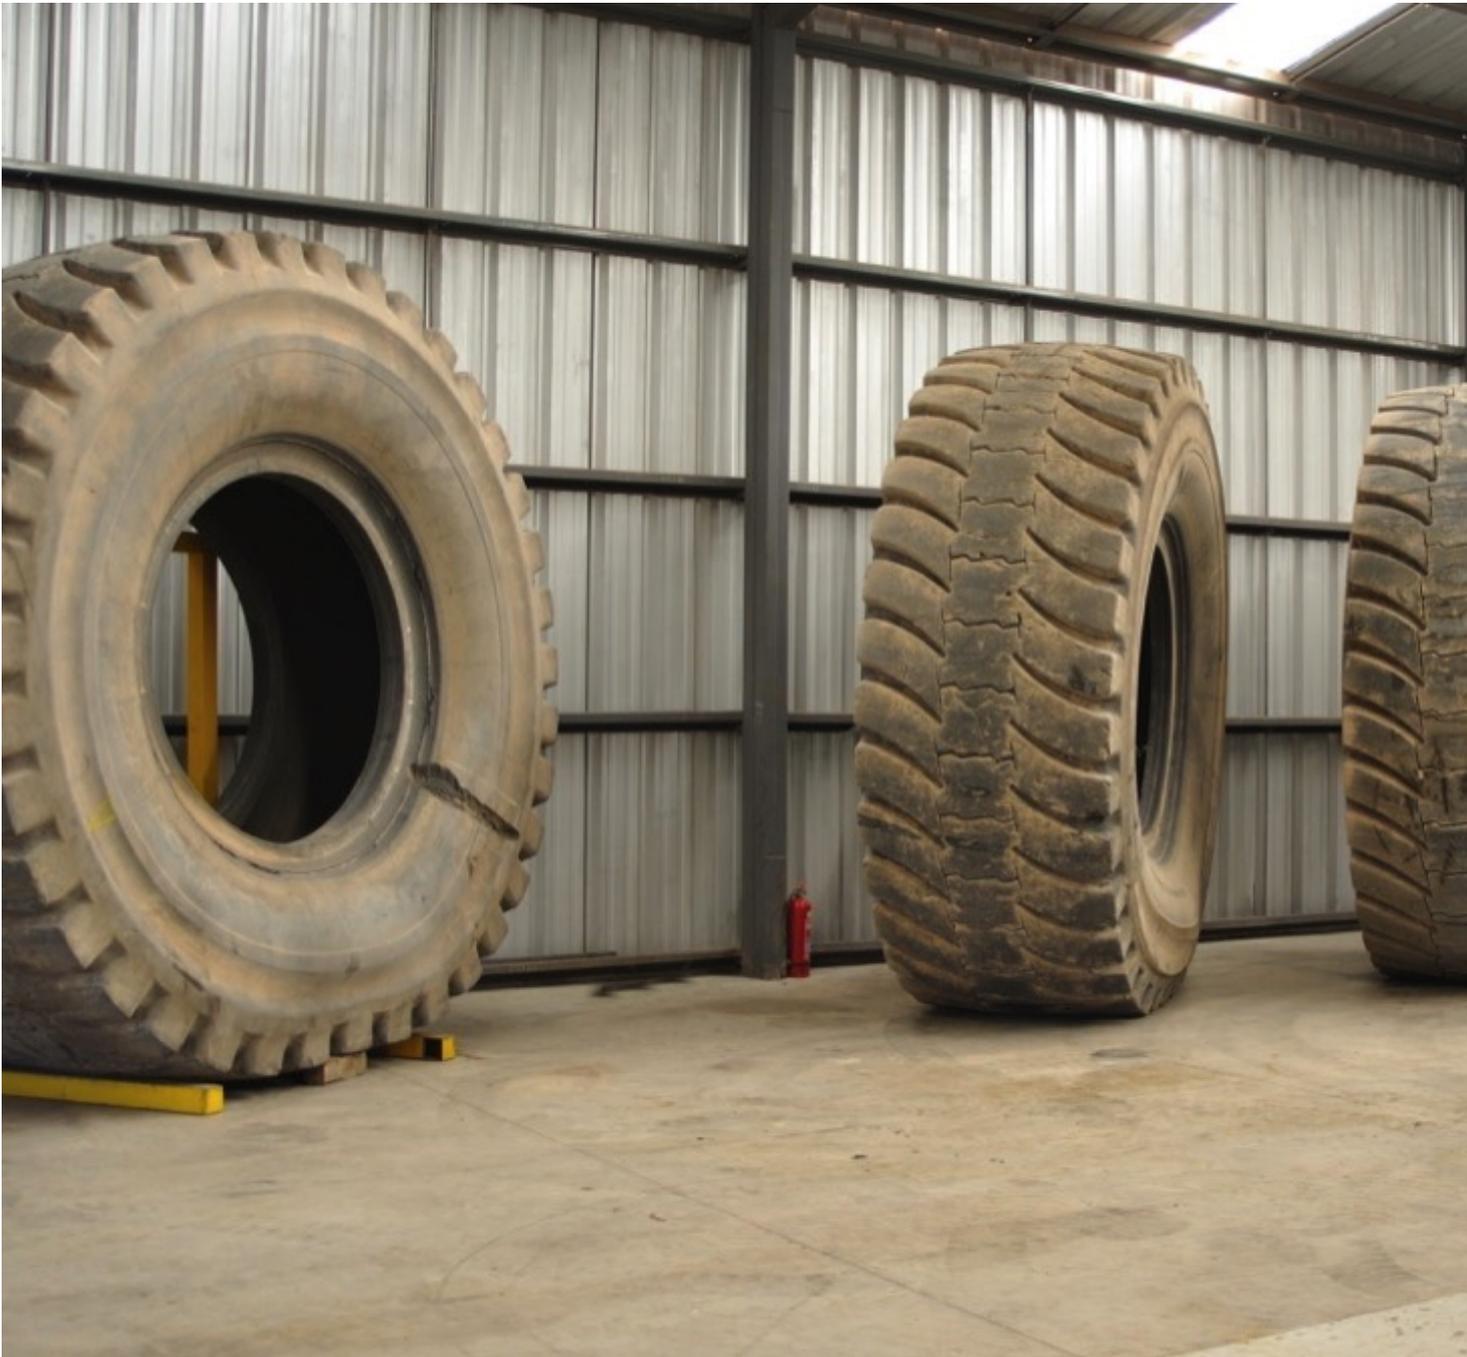
Tyres in the OTR workshop waiting for repair. (Pictures: © Rema Tip Top)
