## **Static Electricity Hazards - Dust Cloud Ignition caused by Static Electricity**

After emptying a powder from a plastic drum into a metal hopper, a spark occurred when the operator removed the drum, igniting the dust distributed in the air. The following paper presents an explanation about the “why” and “how not” of this accident.

This case study investigates the factors behind the ignition of a combustible dust cloud during a manual powder processing operation. In this example a process operator was tasked with manually tipping approximately 18 kg (40 lbs) of powder from a plastic drum, constructed from polyethylene, into a metal process vessel. The plastic drum contained a combustible powder that had a minimum ignition energy of 12 milli-joules. A metal chime was positioned around the circumference of the top of the plastic drum to provide it with impact protection from daily usage in the plant.

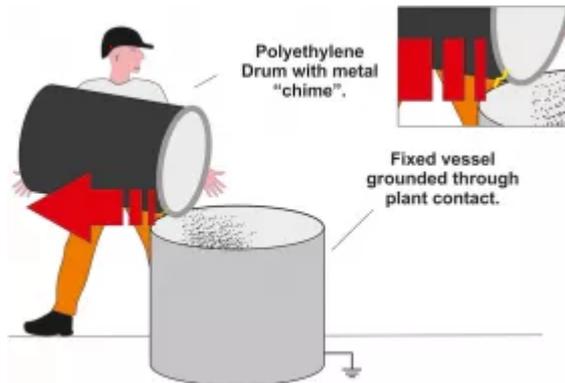
The operator tipped the powder into the process vessel, resting the drum on the edge of the vessel. As he removed the drum from the vessel when the powder was fully deposited there was an ignition of the dust cloud that had

It was postulated that the accumulation of electrostatic charge on the chime resulted in a static spark discharge from the chime as it came into close proximity with the vessel when the drum was removed. The vessel was grounded through its own fixed connection to the plant.

The situation in the plastic processing plant, when the powder cloud ignited.

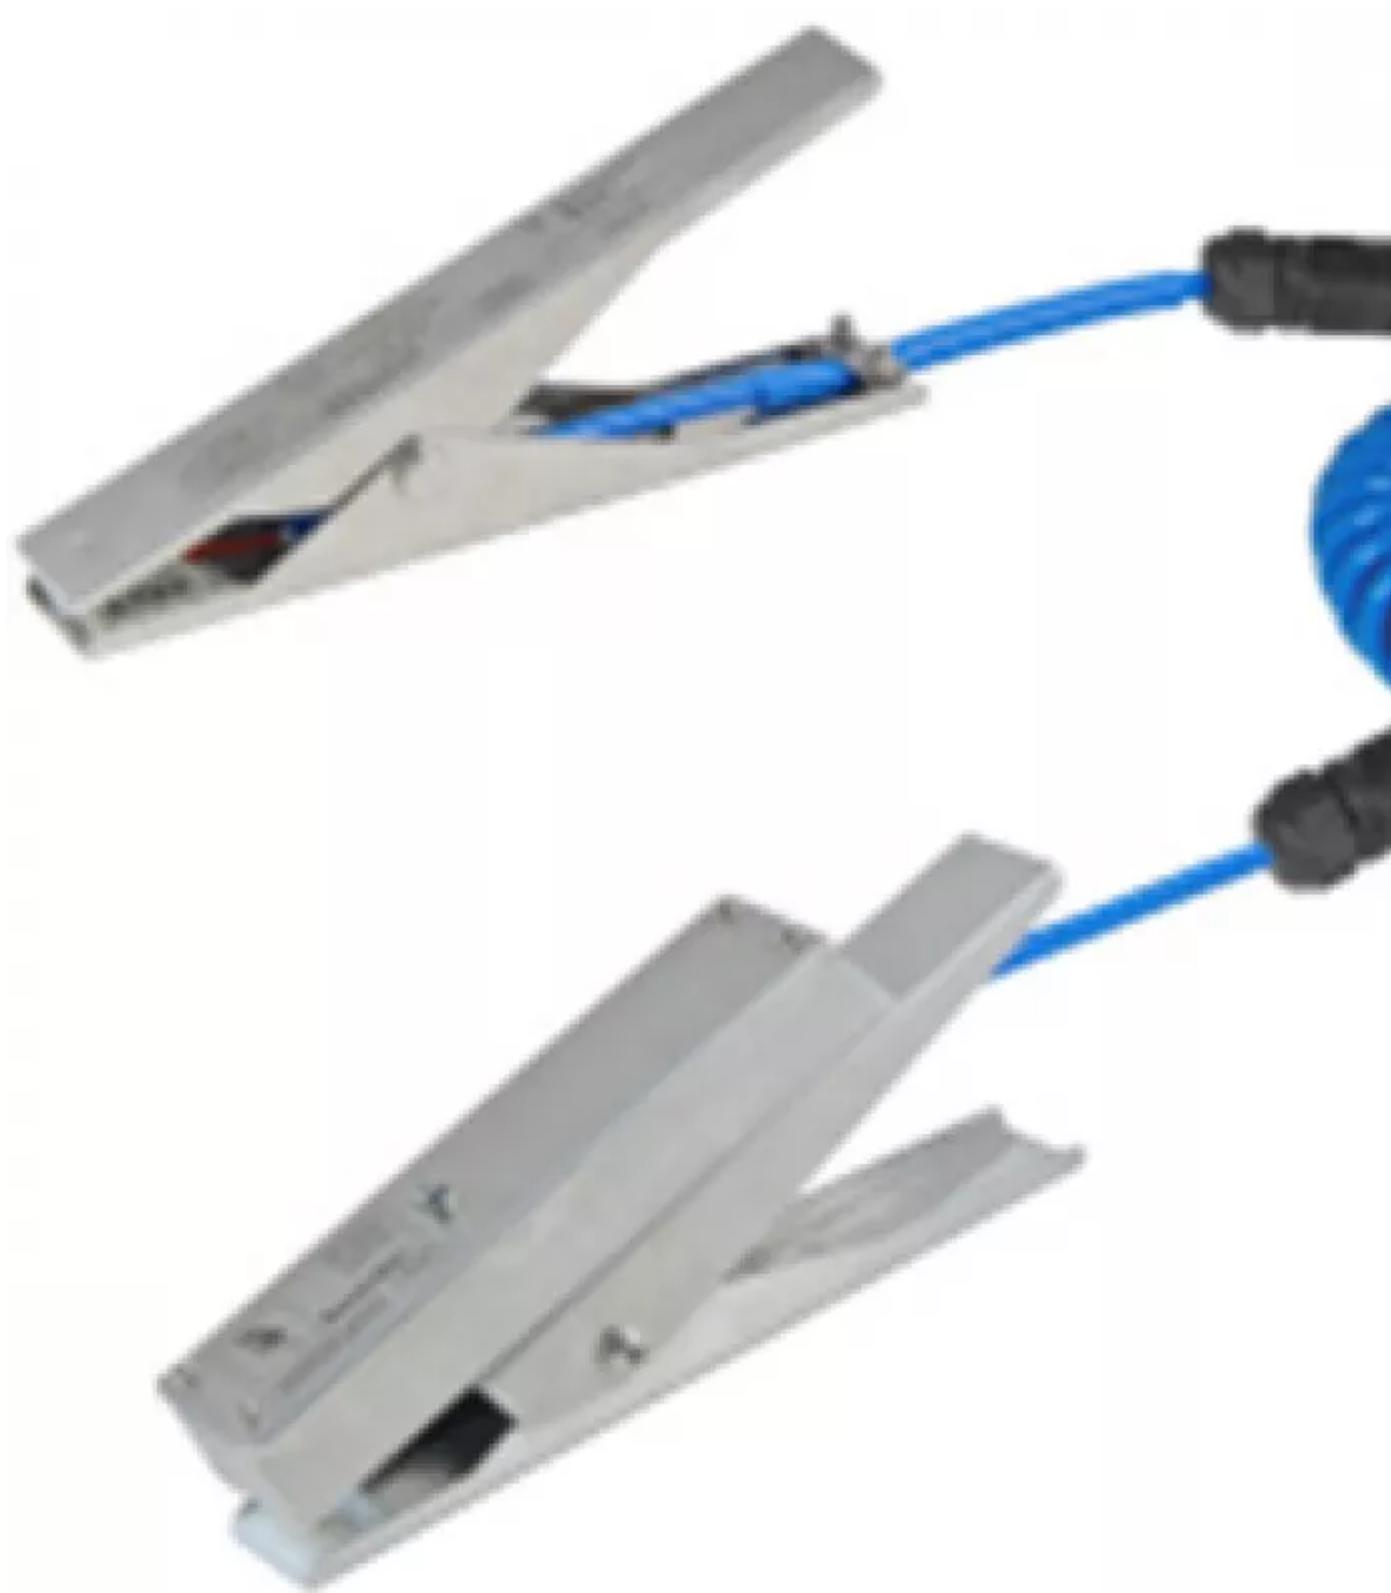
A clamp mounted LED indicates when a connection resistance of 10 ohms or less is met.

The first place to start is to determine why electrostatic charge was “permitted” to accumulate on the chime. In this case electrostatic charge accumulated on the chime because the chime was electrically isolated from a true earth ground. Had the chime been connected to the grounded process vessel, charge would not have accumulated on the chime. Excess electrostatic charges would simply have found their way to earth. So in accordance with industry guidelines like NFPA 77 and IEC 60079-32-1, the isolated metal component should have had a connection to a verified ground (in this case the process vessel) with a resistance of 10 ohms or less.

Devices like the ones highlighted in the pictures above can be used to connect the drum to the grounded process vessel. At minimum a grounding clamp with FM/ATEX approvals, like the example in the picture on the right, should be specified so that any physical impedances like paint coatings and product

deposits are fully penetrated to make contact with the base metal. The picture on the left shows a device that will inform the operator when a connection resistance of 10 ohms or less between a metal drum and the process vessel has been achieved. This is indicated via a pulsing green LED mounted in the grounding clamp that provides the operator with a simple GO / NO GO instruction to tip the powder into the process vessel.
