Case Study

Flexco Europe: Korn Recycling opts for Secondary Belt Cleaners with Finger Segments

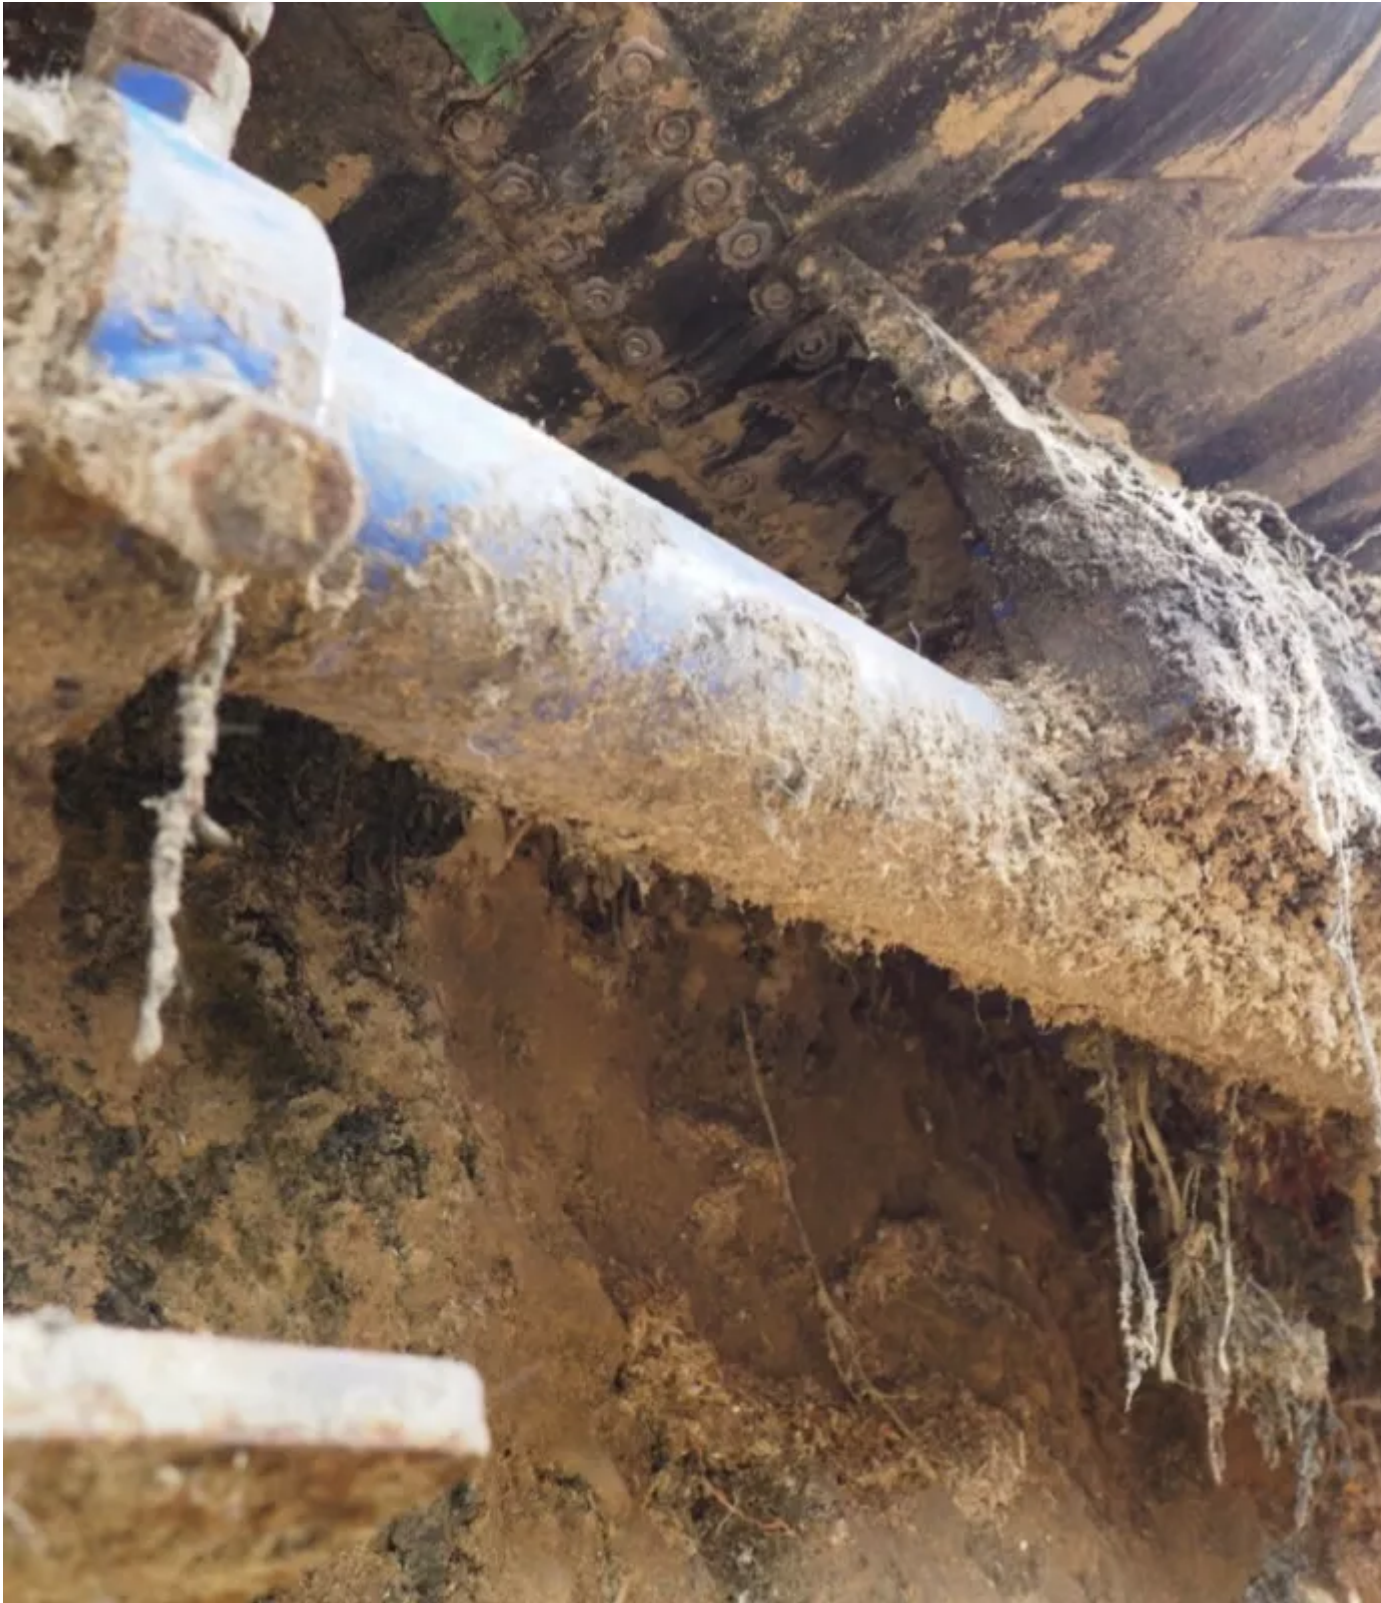
The prototype is still installed.

The CFC cleaner is now ready to be installed below the load zone of the conveyor, in direct contact with the running belt. Weigold, standing on the work platform, opens the bolts of the prototype. Some are a little stiff, but he manages. "Installation is relatively simple, because the cleaner has only a few parts," says

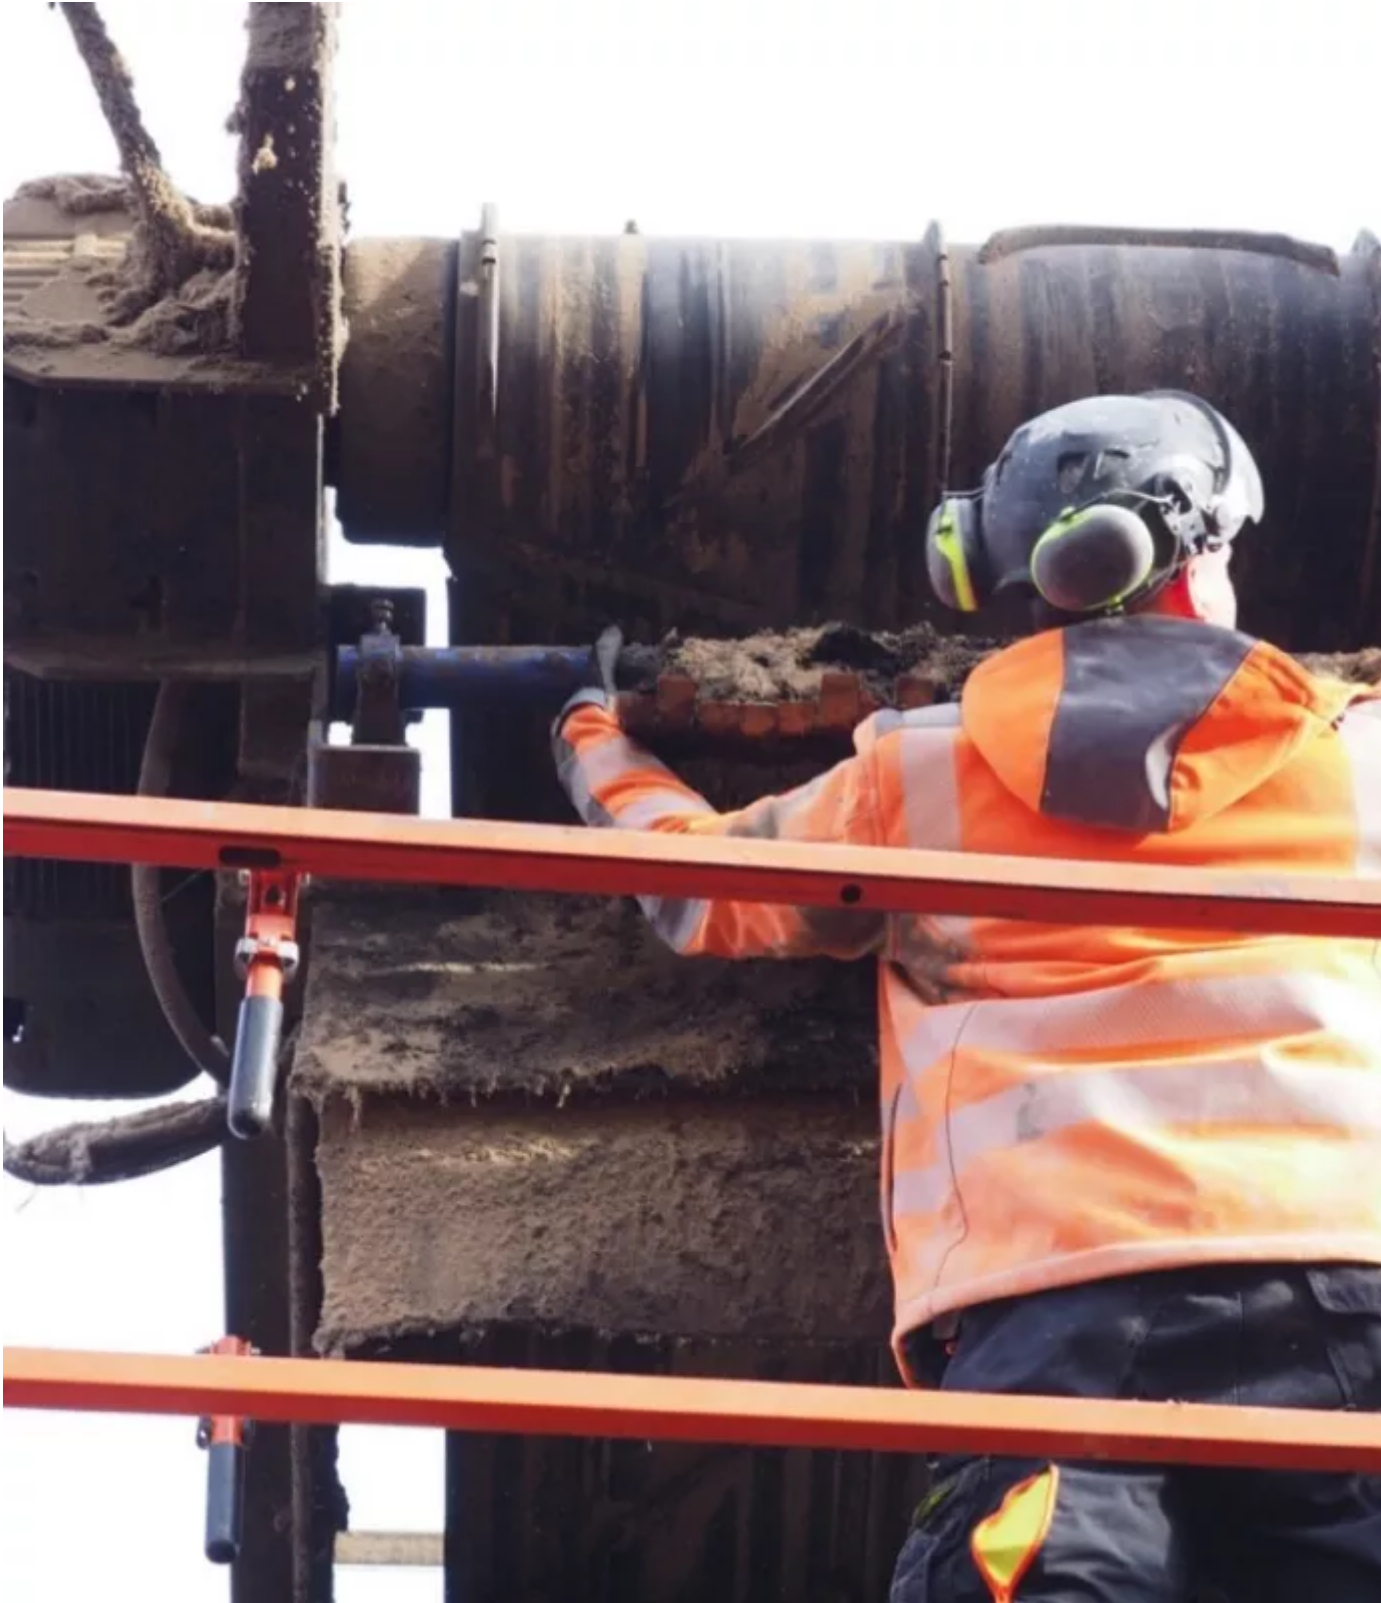
Now the prototype can be removed.

Weigold removes the cleaner from its support and brings it down on the work platform. “When we installed the prototype, we didn’t yet have a name for it,” he says. “All we knew was that we were going to develop a cleaner with finger segments.”

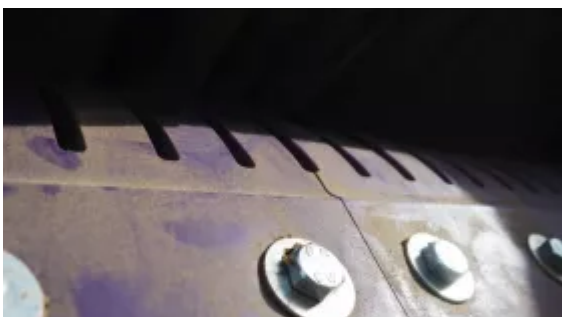
Installed and ready for operation: the new Flexco belt cleaner.

The device has worked well over the past year. Its segmented blades with flexible finger contours are especially effective for cleaning chevron belts with ribs, even with cleat heights of up to 32 millimeters and belt speeds up to 2.5 meters per second. Another key factor is the high-quality polyurethane used for the fingers. The wear is low, which means a longer service life.
